HERITAGE IMPACT ASSESSMENT

7059 Second Line West: Proposed Addition

Rotherglen School, Meadowvale Campus
929 Old Derry Road & 7059 Second Line West
Mississauga, ON

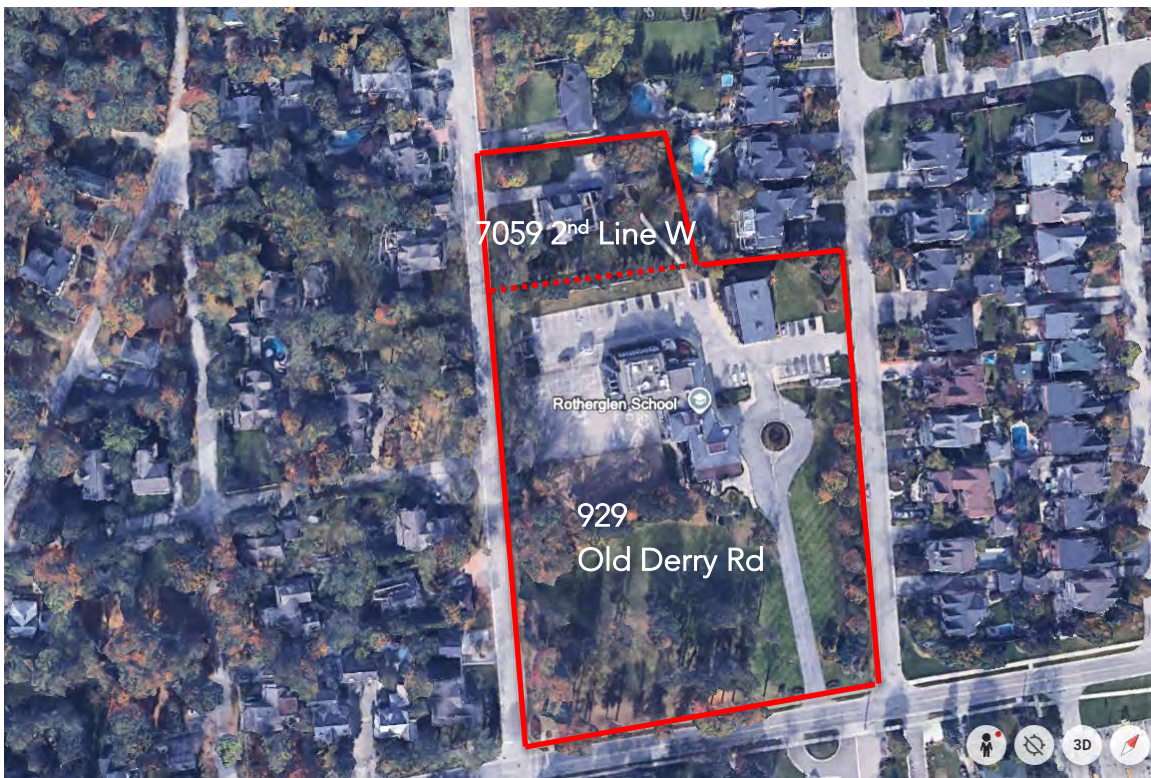
ROTHERGLEN's MEADOWVALE CAMPUS – 929 Old Derry Road & 7059 Second Line West will be combined as one lot

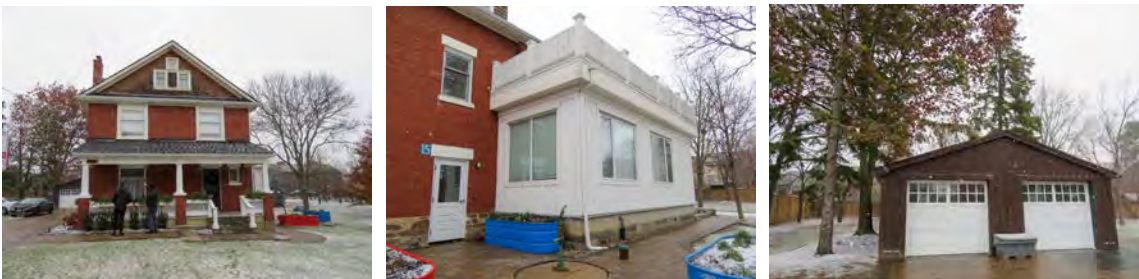
7059 SECOND LINE WEST – the existing dwelling will be retained (left) – the existing rear addition and the detached garage will be demolished to accommodate a proposed 2.5-storey addition at the rear (center and right)

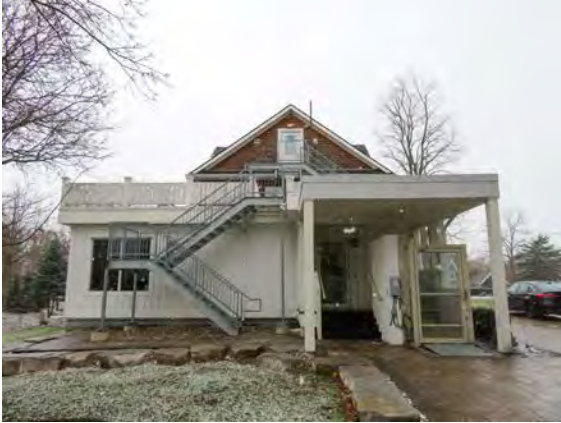
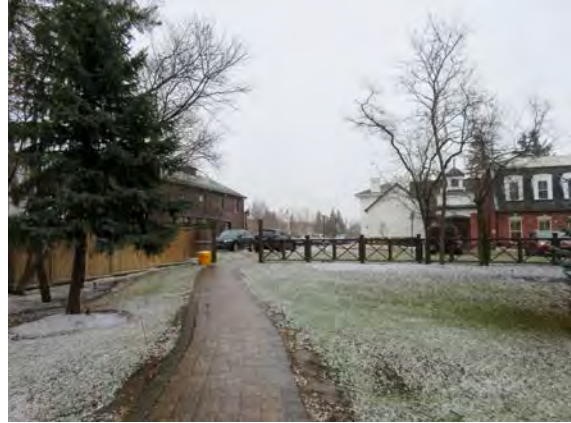
7059 SECOND LINE WEST – the existing rear addition to be removed (left) and the pedestrian walkway to the main campus (right) will remain.

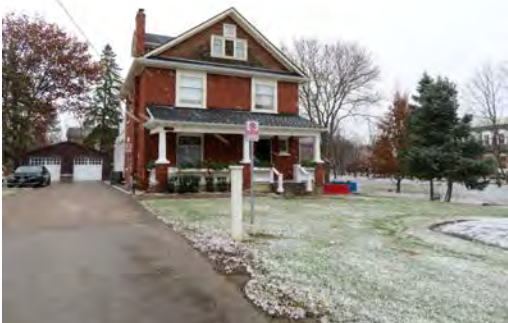
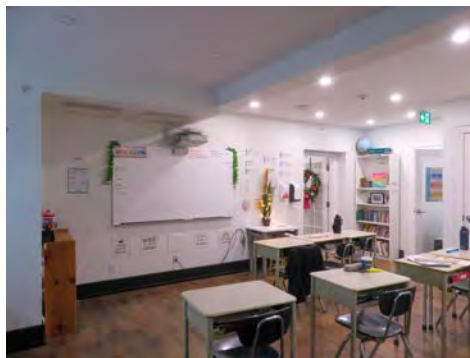
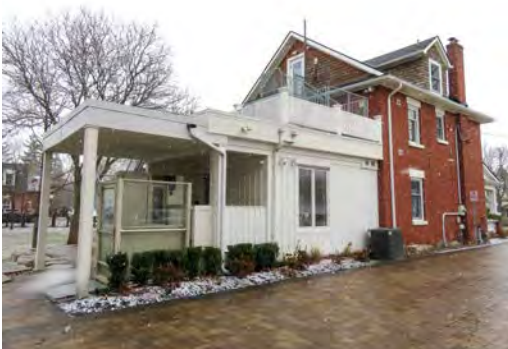
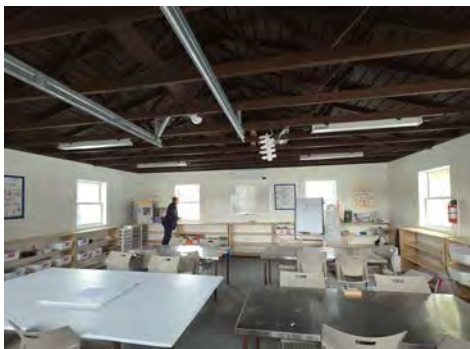
BACKHOUSE RESIDENCE, 7059 Second Line West – 1-3: c.1920 brick house converted for educational use with a recent rear addition built by the Rotherglen School – 4: late-20th century detached garage converted for education use

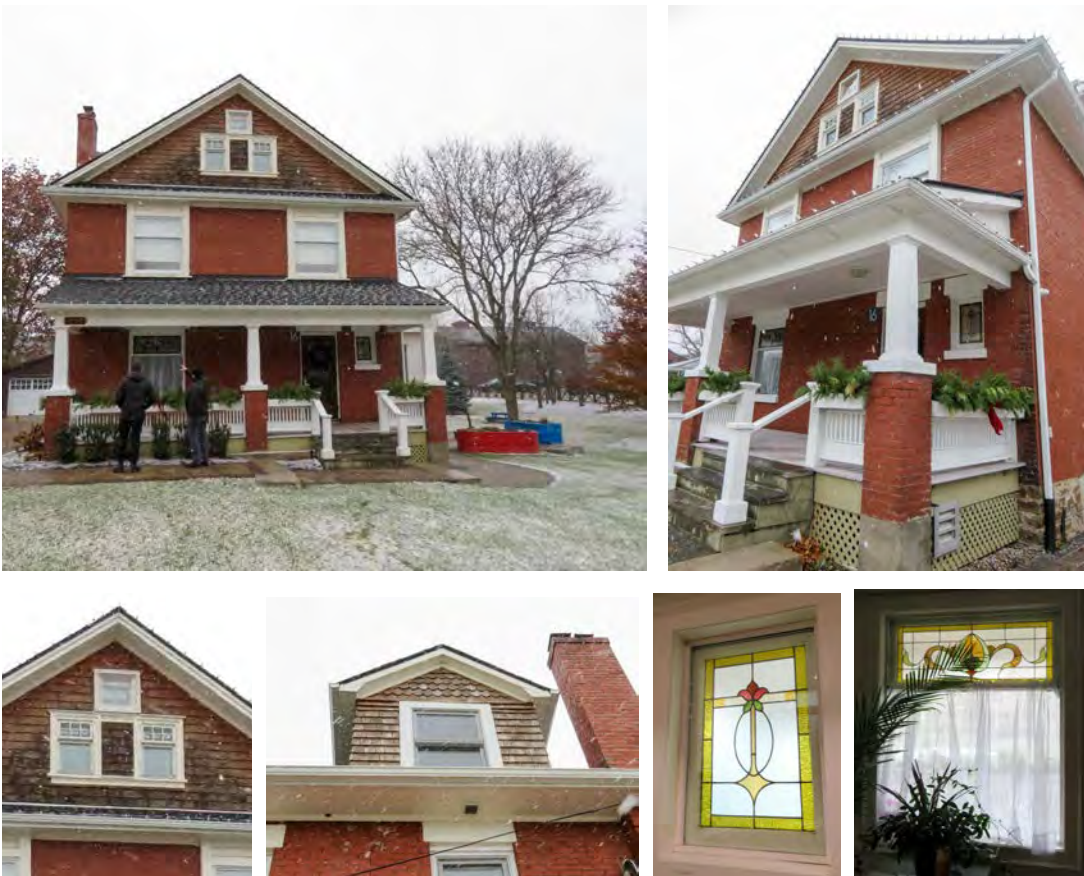
7059 Second Line West – current conditions

The 2.5-storey brick dwelling at 7059 Second Line West is a representative example of an Edwardian Classical Foursquare dwelling. It is constructed of pressed brick laid in common bond with red mortar that was perhaps originally tuckpointed. The rubble foundation is constructed from locally sourced Credit Valley sandstone.

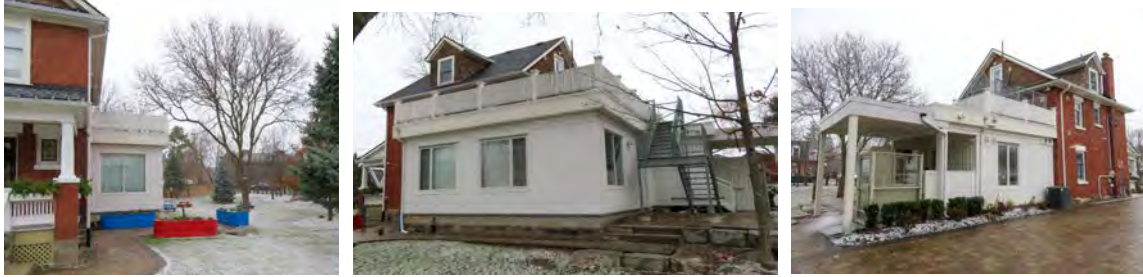
REAR ADDITION - the existing 1-storey rear addition built by Rotherglen School in 2019 is to be demolished

The existing 1-storey rear addition is a small addition that cannot accommodate the school's projected increase in enrollment. It will be demolished so that a larger 2.5-storey addition can be built in the same location. The larger footprint of the new addition will require demolition of the detached garage located behind the house.

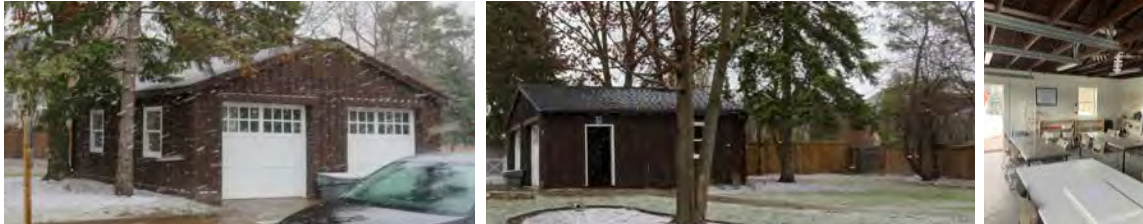
GARAGE - the existing garage renovated by the Rotherglen School in 2019 is to be demolished. It appears to date from the 1970s or 1980s.

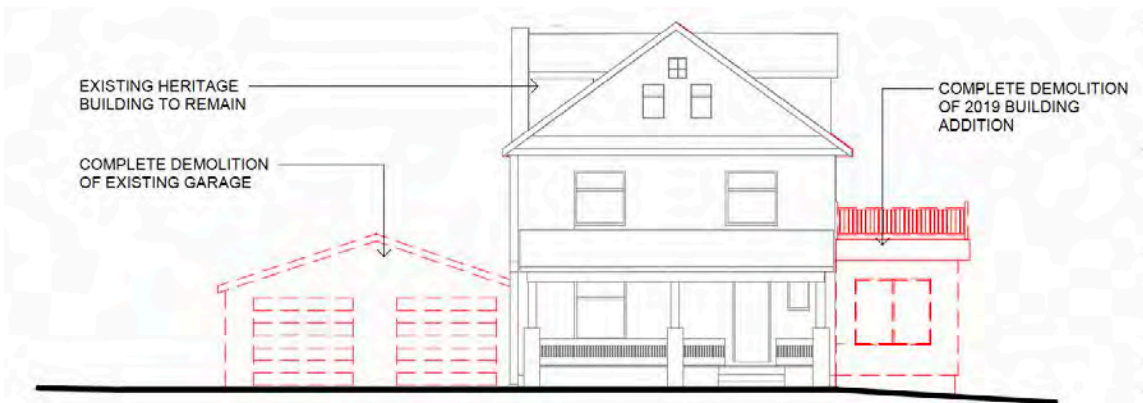
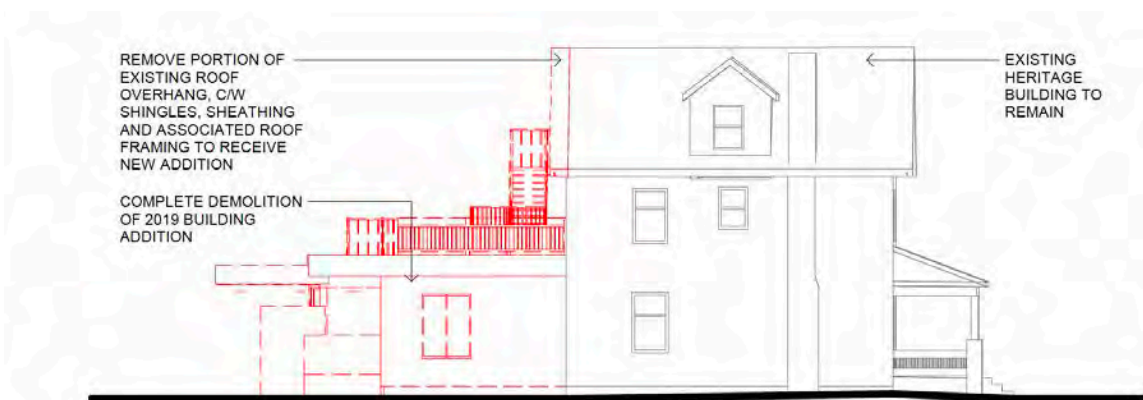
DEMOLITION PLANS – demolition plans have been provided by the architect – the non-historic garage and rear addition will be removed – impacts to the heritage building are very minor and are limited to the rear eaves of the roof that will be removed where the new addition will attach to the heritage building and enlarging existing openings in the rear wall for new through connections.

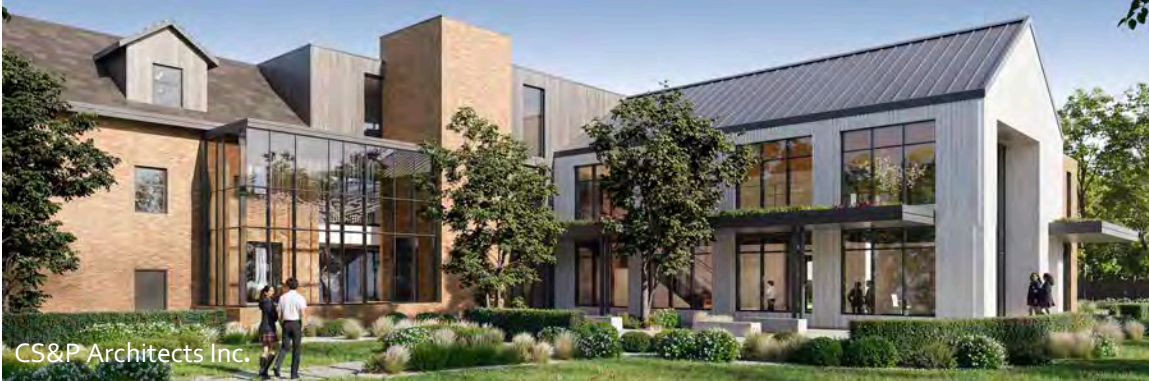
RENDERING – glazed link creates transparency that reveals and highlights the heritage building – the new configuration creates an outdoor space that is framed by the heritage building and new addition

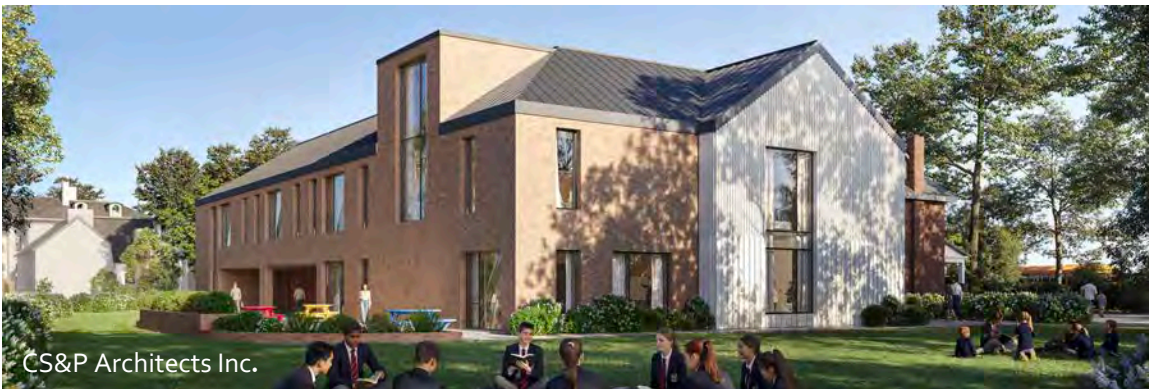
RENDERING – side and rear yard with ample green space around the addition – red brick and wood cladding articulate the massing and reference the heritage context – the Gooderham Mansion is visible in the background on the left

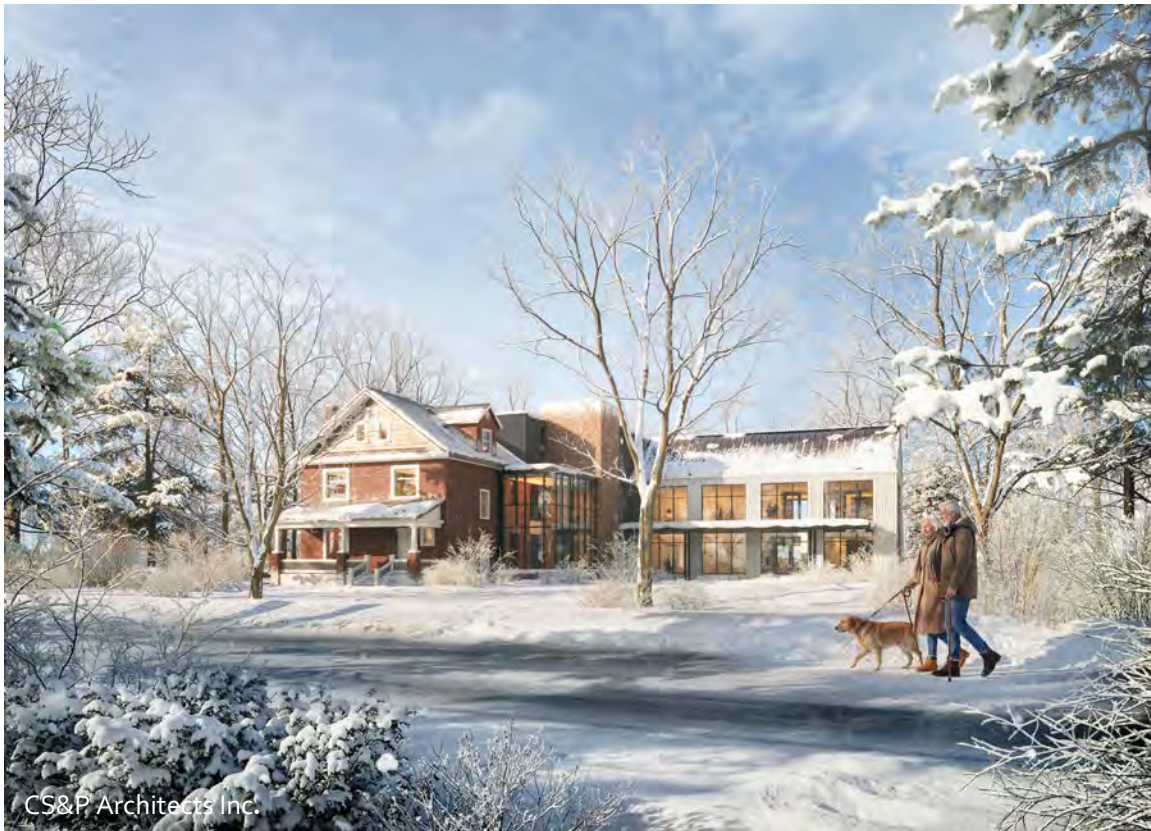
RENDERING – STREETSCAPE VIEW – a view from Second Line West in winter when the site is most exposed – in spring, summer and fall there is mature vegetation on the property that screens views to the addition.

The impact of the proposed addition when viewed from the street will be minimal because the heritage building is setback significantly from Second Line West. The bulk of the massing is positioned behind the rear wall of the house and separated from it by a link that corresponds to the footprint of the existing rear addition and the height of the addition matches the 9.9 m height of the heritage building.

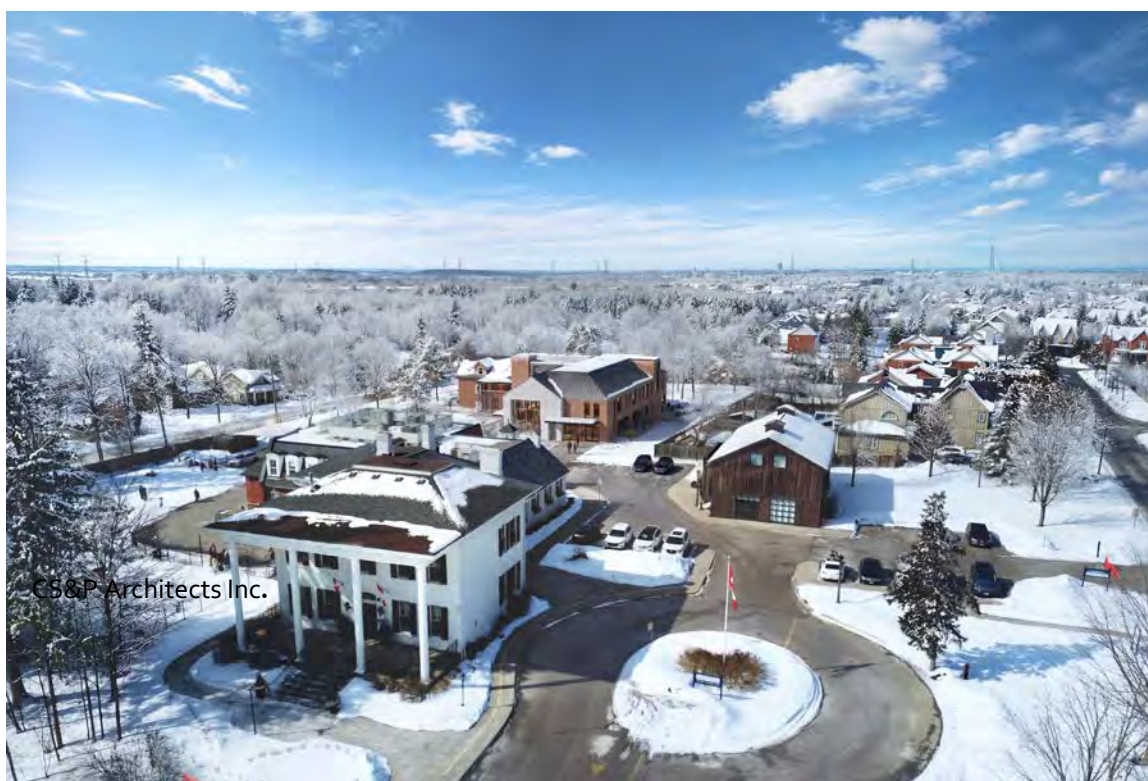
RENDERING – AERIAL VIEW – this view shows the addition within the context of the school campus as a whole and the surrounding residential neighbourhood

The 2.5 storey addition is 9.9 m in height and corresponds to the height of the existing building which is also 9.9 m in height. The existing GFA of the heritage building is approximately 124 sq. m. and the GFA of the addition is approximately 897 sq. m. Within the context of the entire 4.5-acre campus site comprised of 5079 Second Line West and 929 Old Derry Road, the addition will create a GFA of approximately 1,800 sq. m., whereas the zoning by-law permits up to approximately 3,800 sq. m., so the proposed GFA with the addition remains significantly below the maximum that is permitted. Similarly, a lot coverage of up to 20% is permitted across both properties, whereas the proposed lot coverage including the new addition will be 10.5%, well below the maximum permitted. Within the context of the entire 4.5-acre campus site, the open space after the addition is built will be 82.5 %, well above the minimum 40% that is required. Therefore, the scale of the addition is appropriate given the large size of the combined properties.

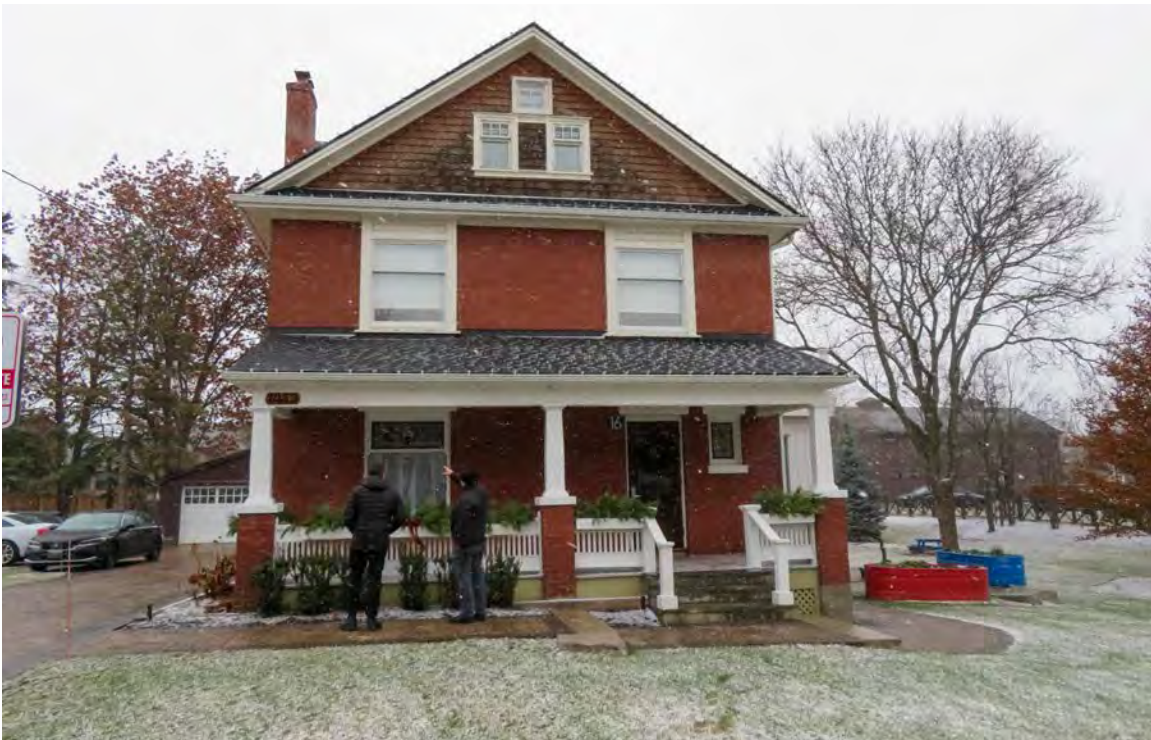
FRONT ELEVATION – paved path to the front entrance – the house is in excellent condition and the property is very well maintained

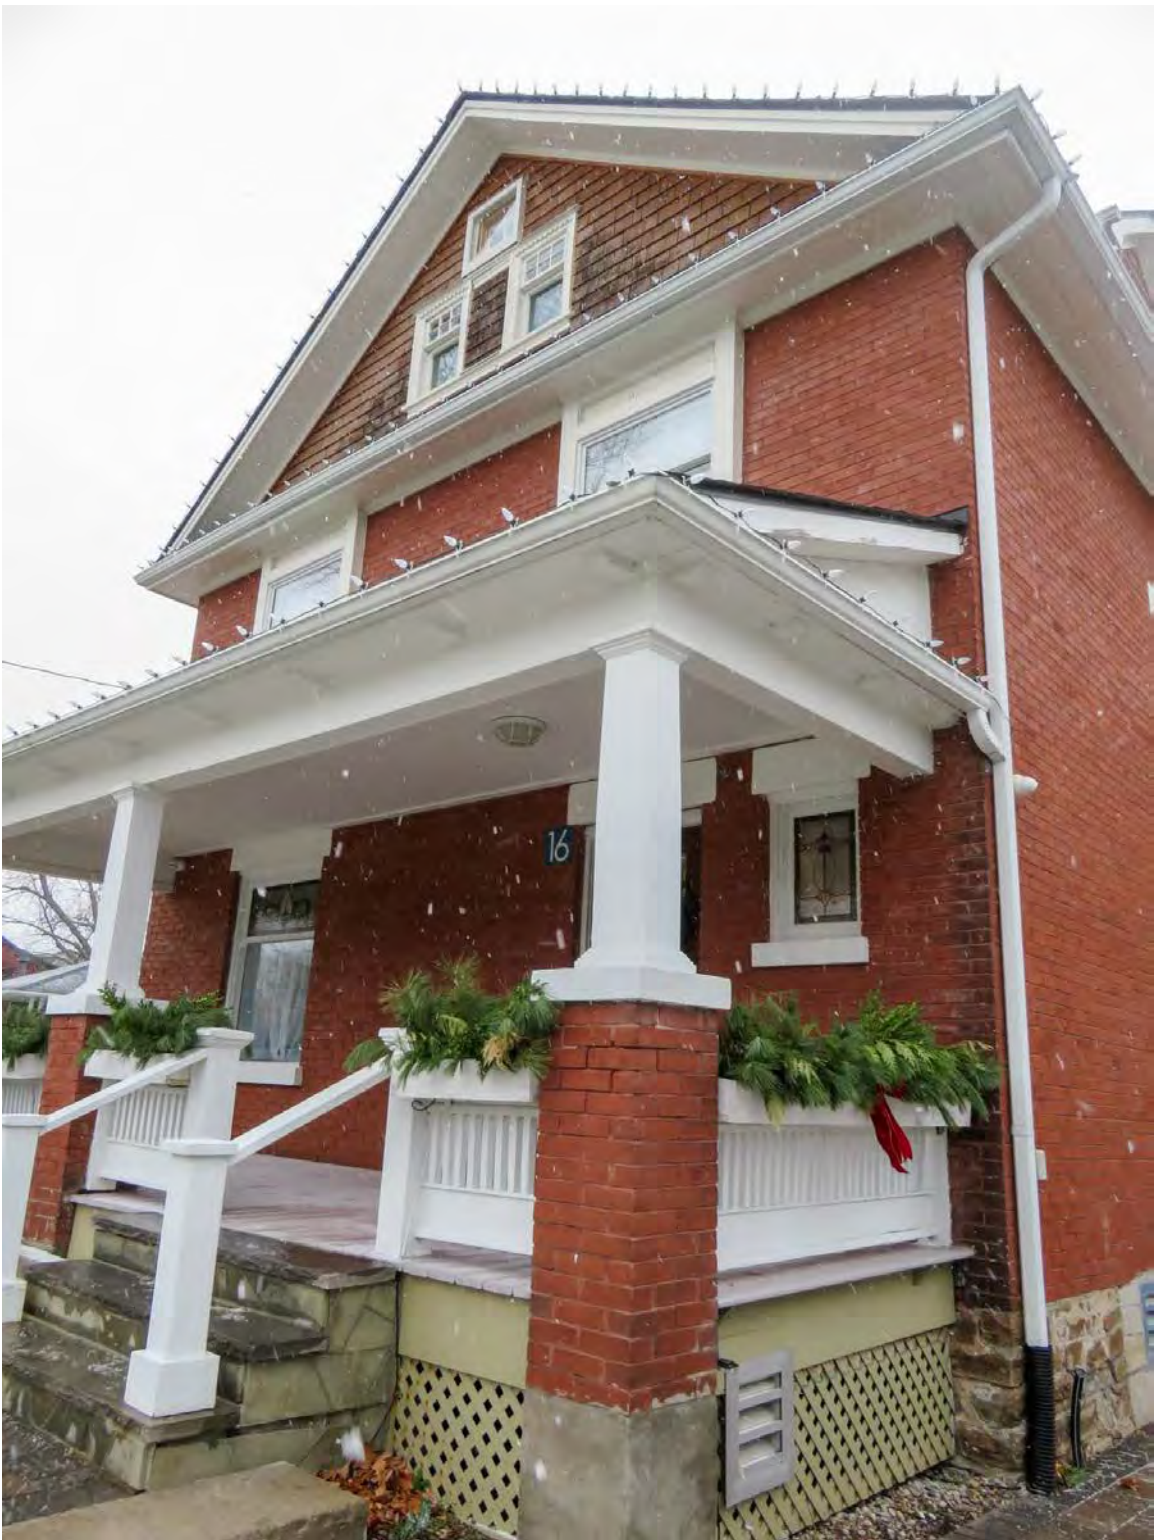
FRONT PORCH – raised entrance (not accessible)

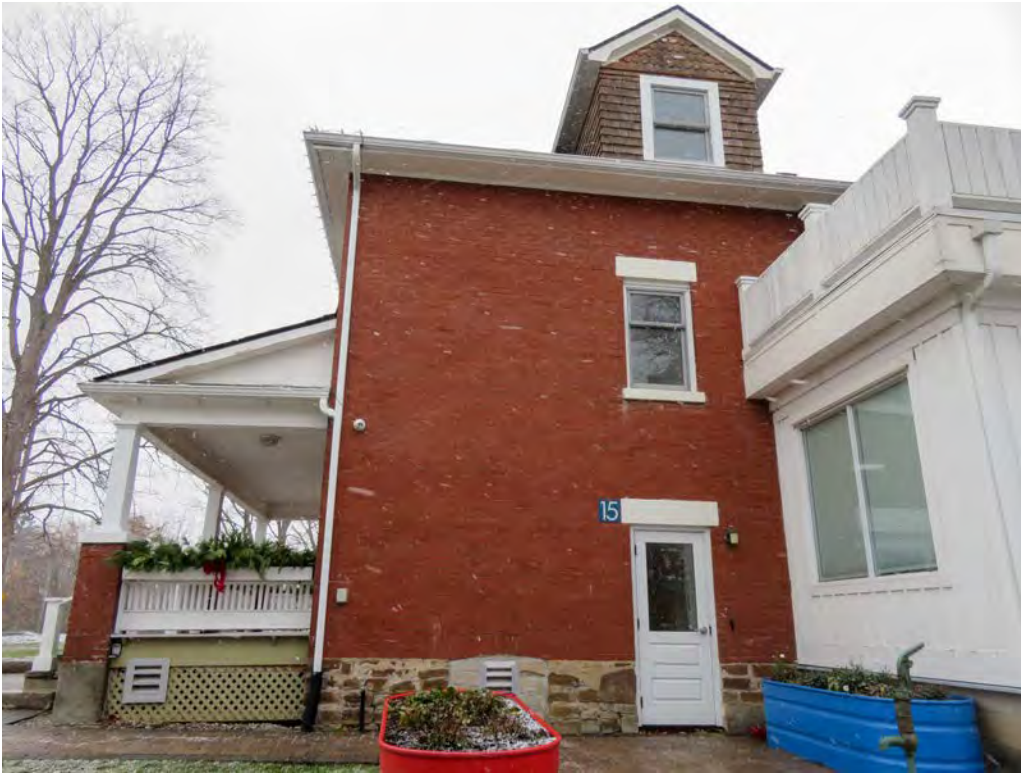
SIDE ELEVATION – side entrance onto stair landing between basement and 1st floor

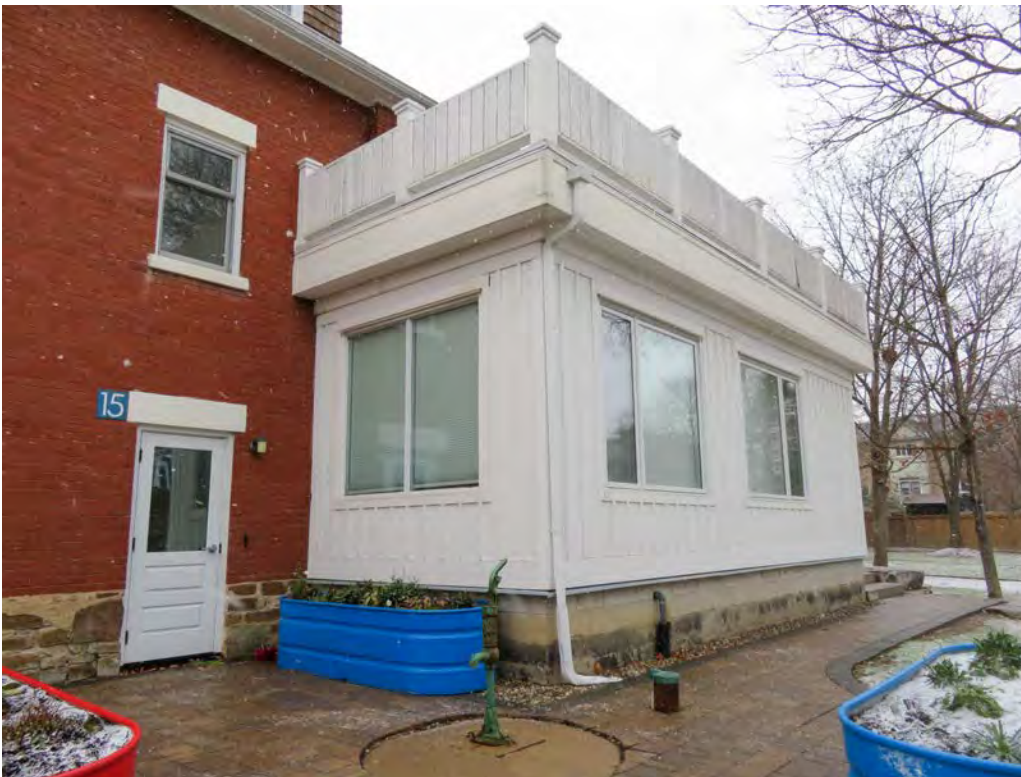
REAR ADDITION – TO BE DEMOLISHED – non-historic addition to be demolished – wraps around the back corner of the building – it has a concrete block foundation and is frame construction with aluminum windows

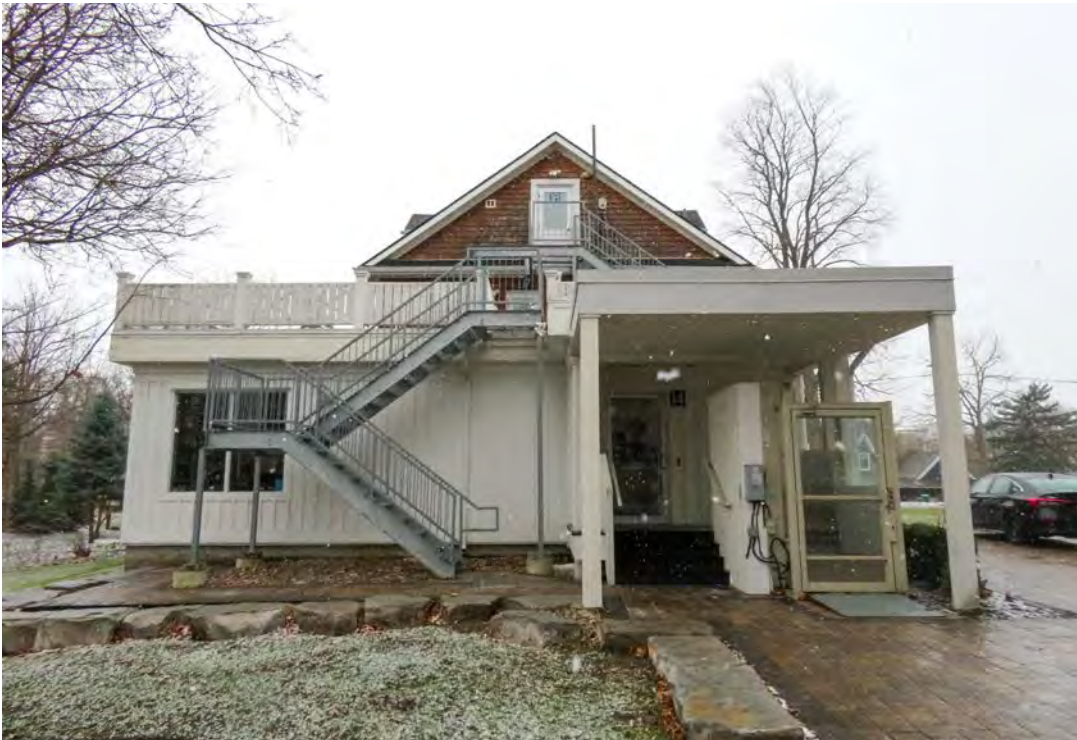
REAR ELEVATION – REAR ADDITION WITH METAL FIRE EXIT AND WHEELCHAIR LIFT TO BE DEMOLISHED

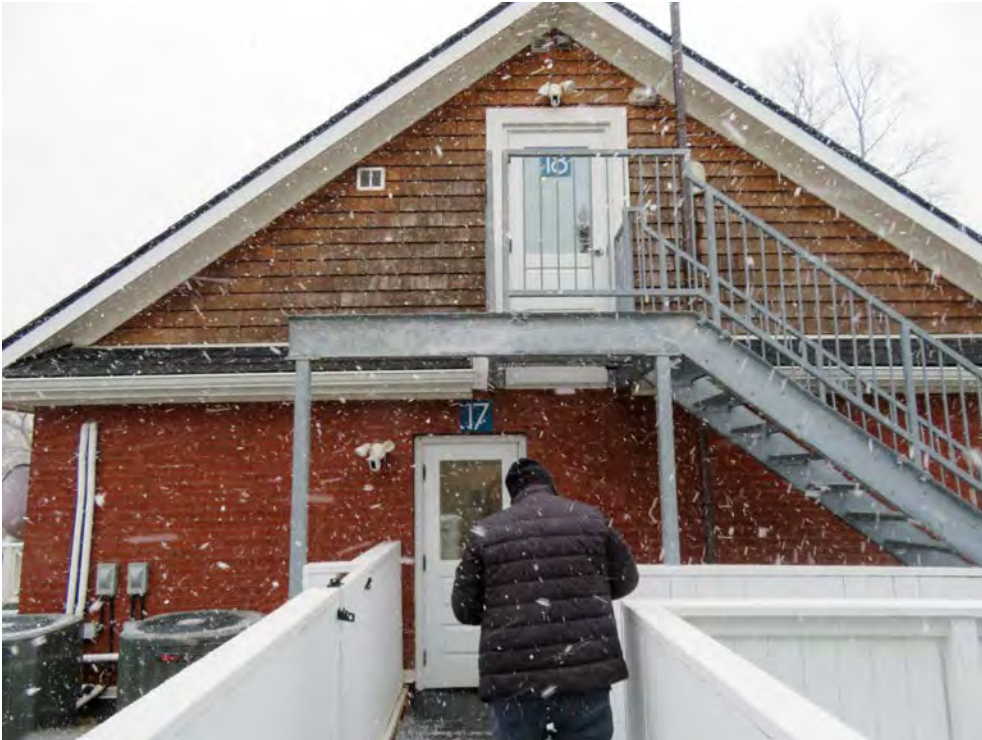
REAR ELEVATION, 2nd & 3rd floor level – the exterior brick wall of the house will be retained as a feature wall inside the new addition with new through connections that utilize existing openings – existing a/c units will be relocated

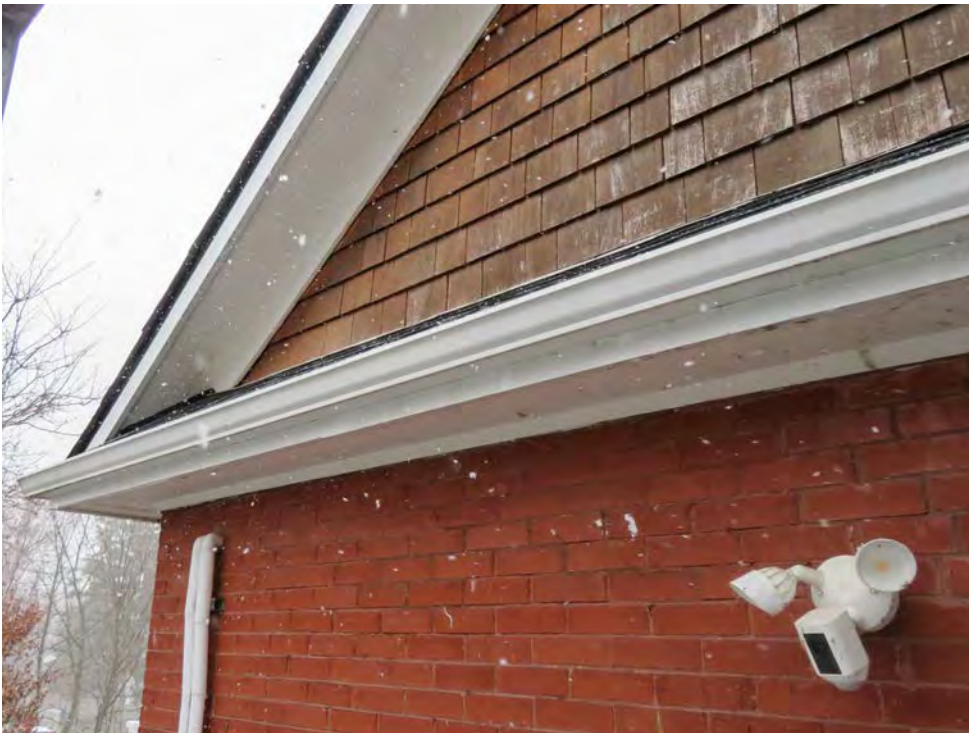
REAR ELEVATION – soffits at the rear will be removed to accommodate connection with the new addition – the wood shingle in the gable is not original

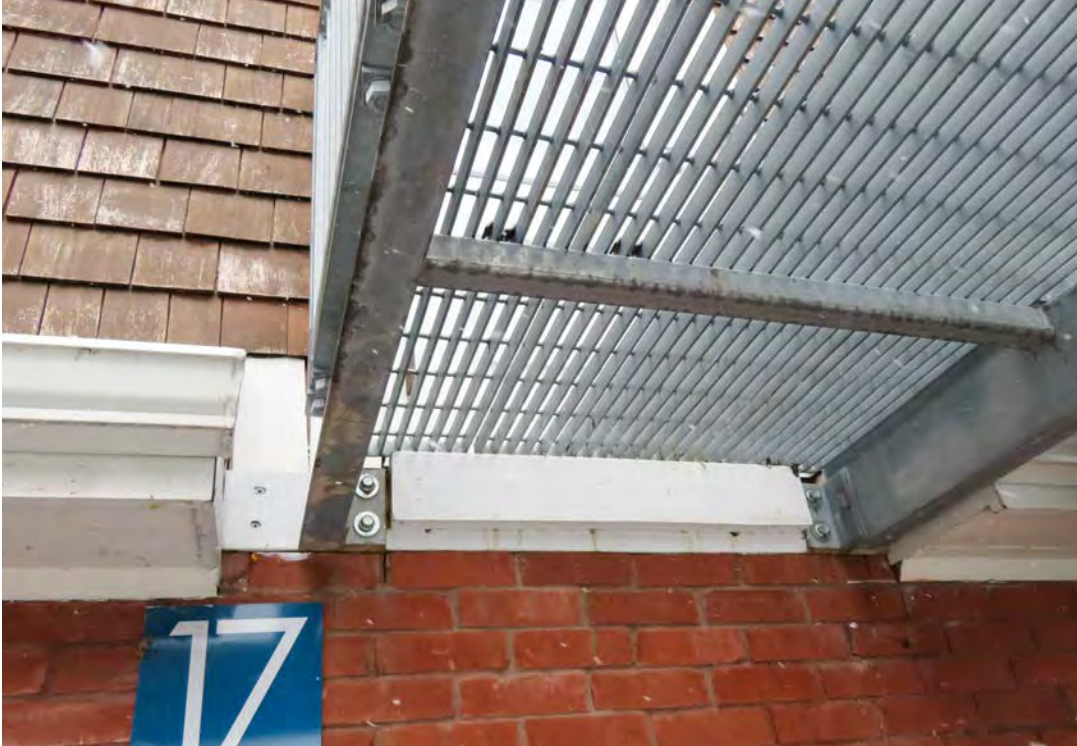
REAR ELEVATION – external fire exit stair from the 3rd floor is to be removed – it is bolted into the masonry

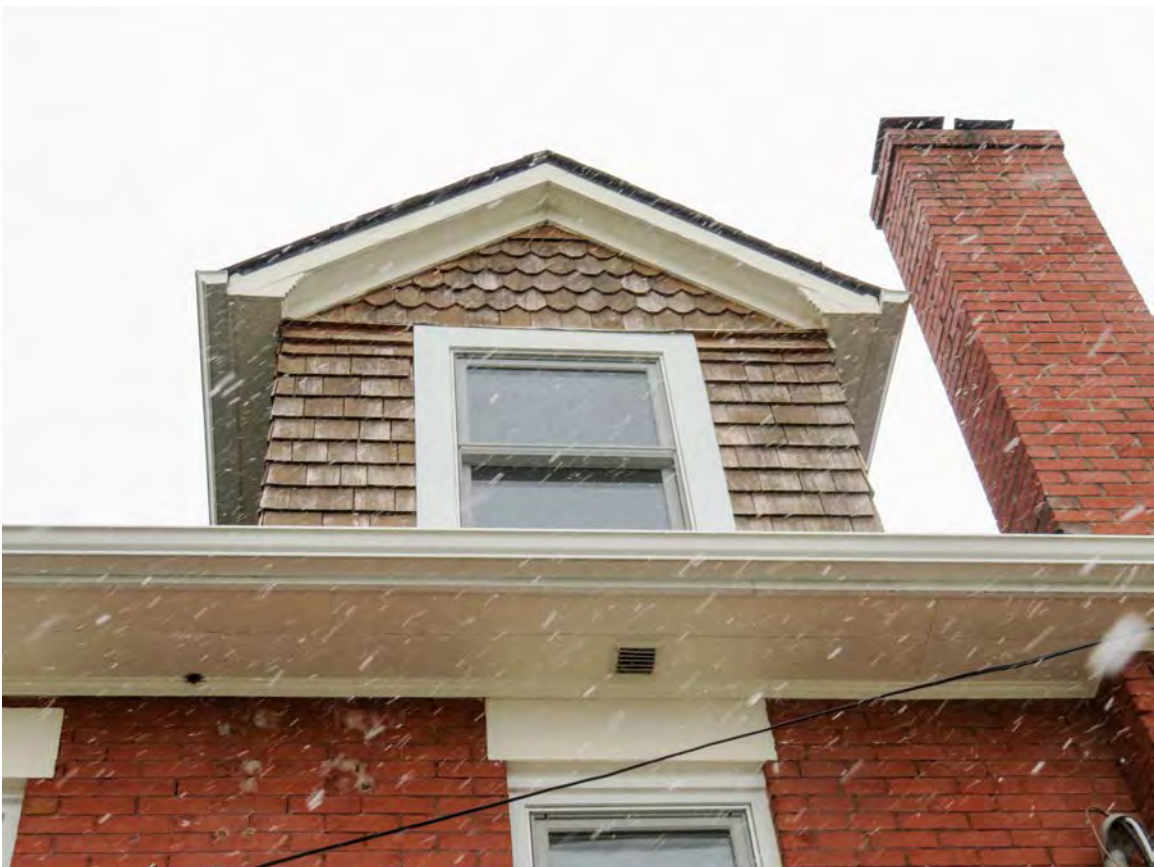
ROOF DORMER & BRICK CHIMNEY – the roof has a wide overhang – the wood shingles on the dormer are not original

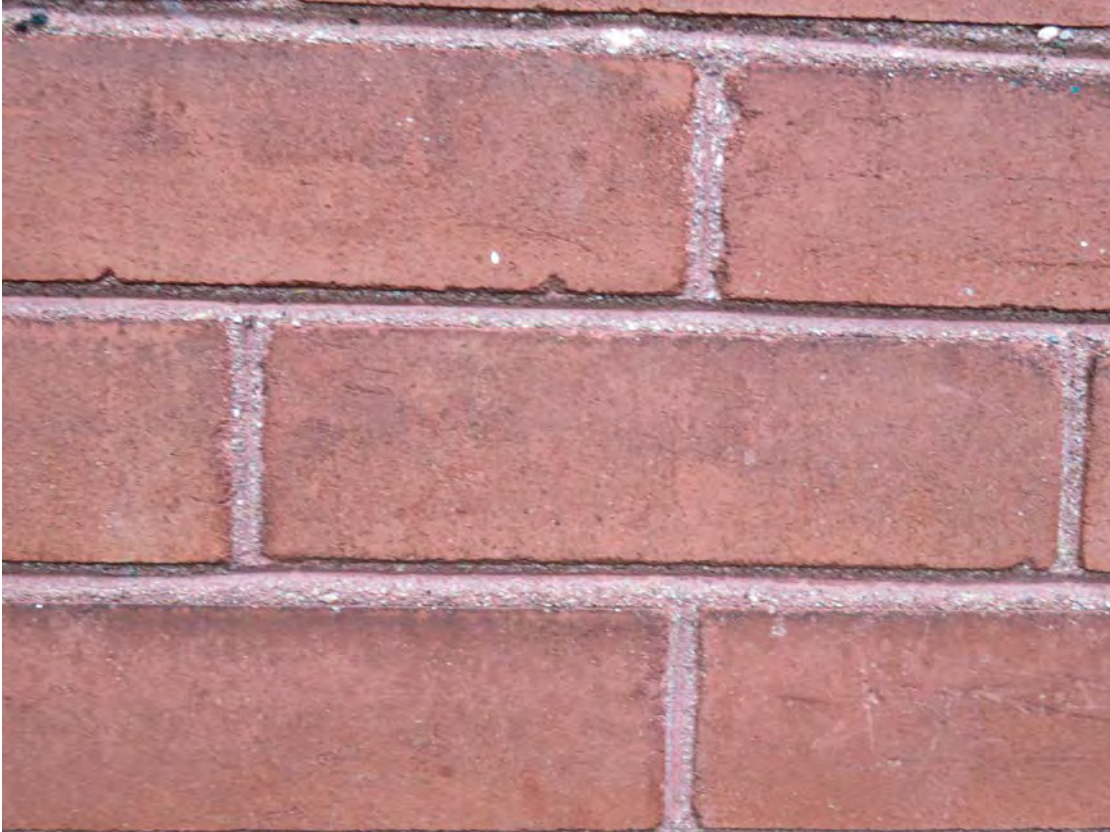
RED BRICK MASONRY – grooved mortar joint with red mortar – may have originally been tuck pointed

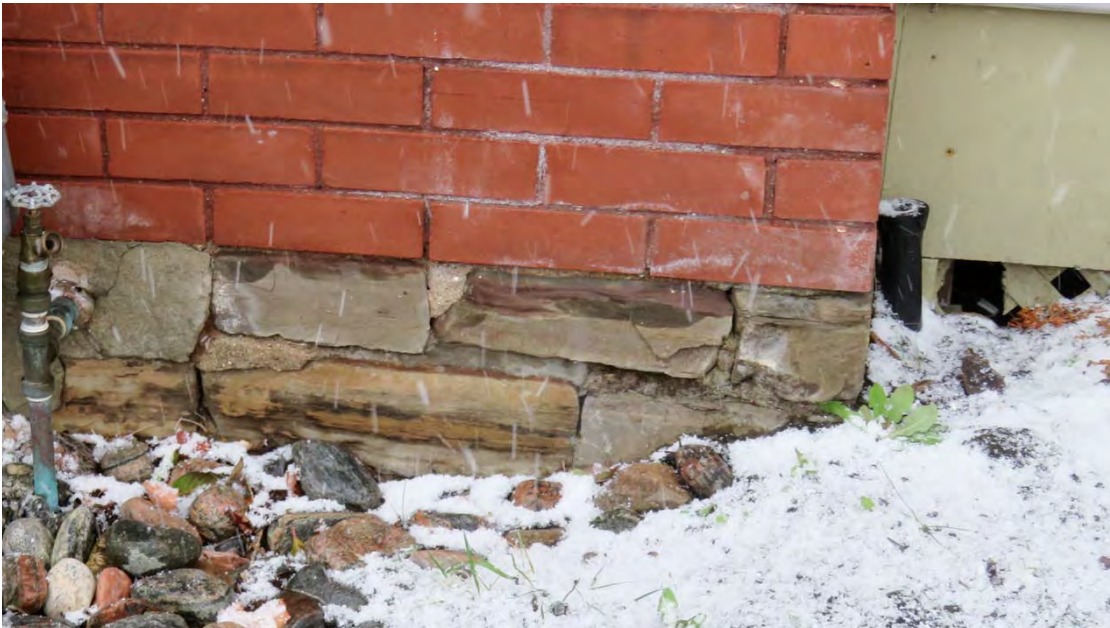
FOUNDATION – rubble foundation with credit valley stone and lime mortar – open joints and missing mortar in some locations

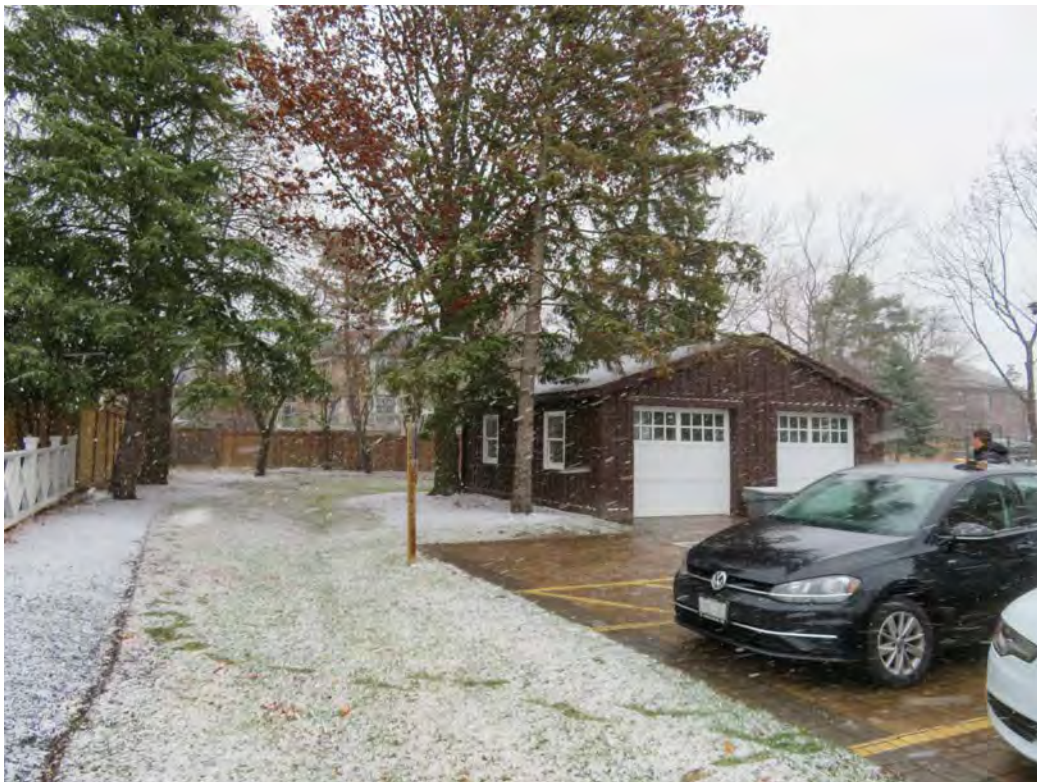
REAR YARD – non-historic outbuilding to be demolished

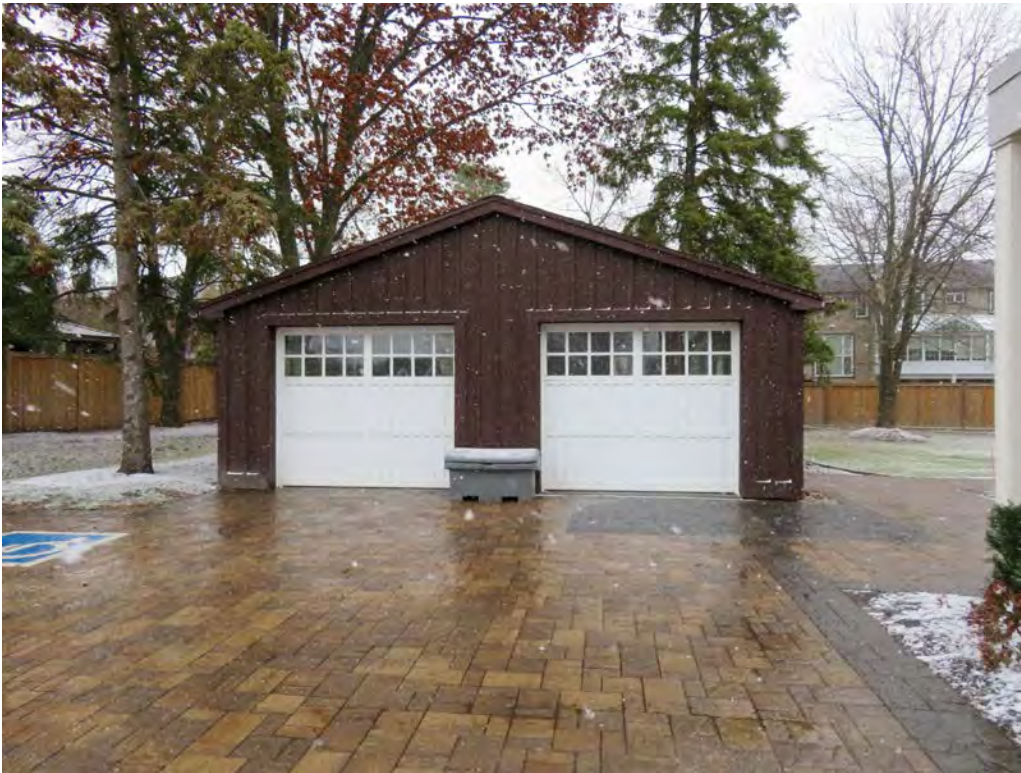
GARAGE – TO BE DEMOLISHED – a modern structure that has no cultural heritage value - concrete pad foundation – board & batten siding, aluminum doors - date of construction estimated to be c.1970s or 1980s

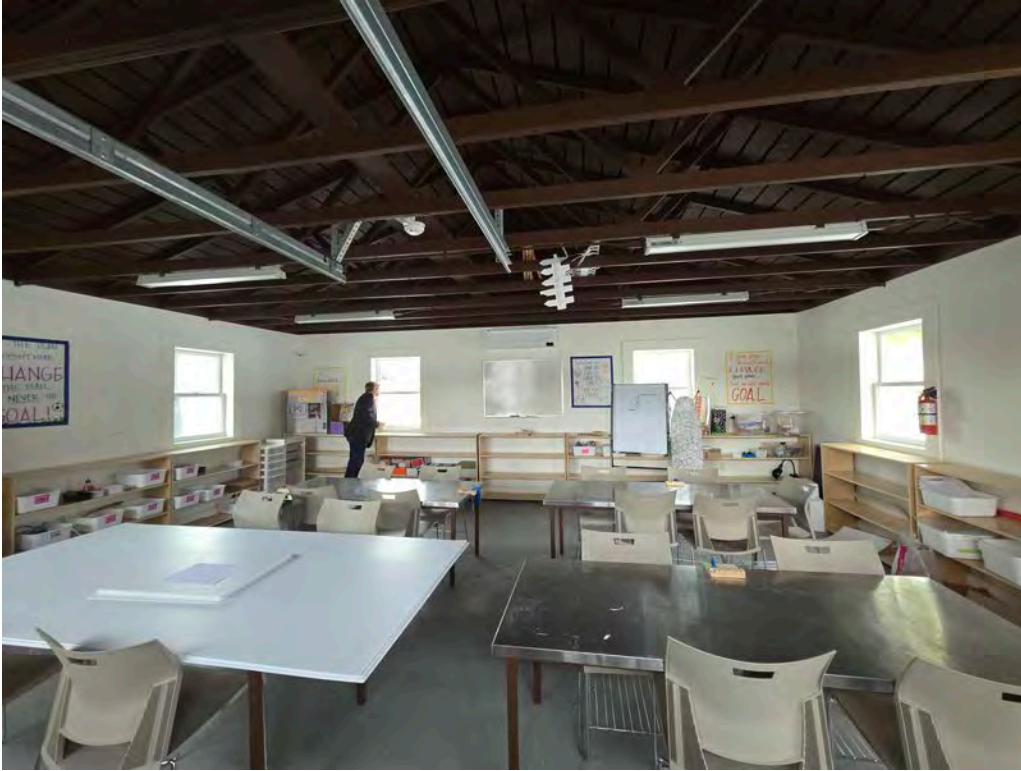
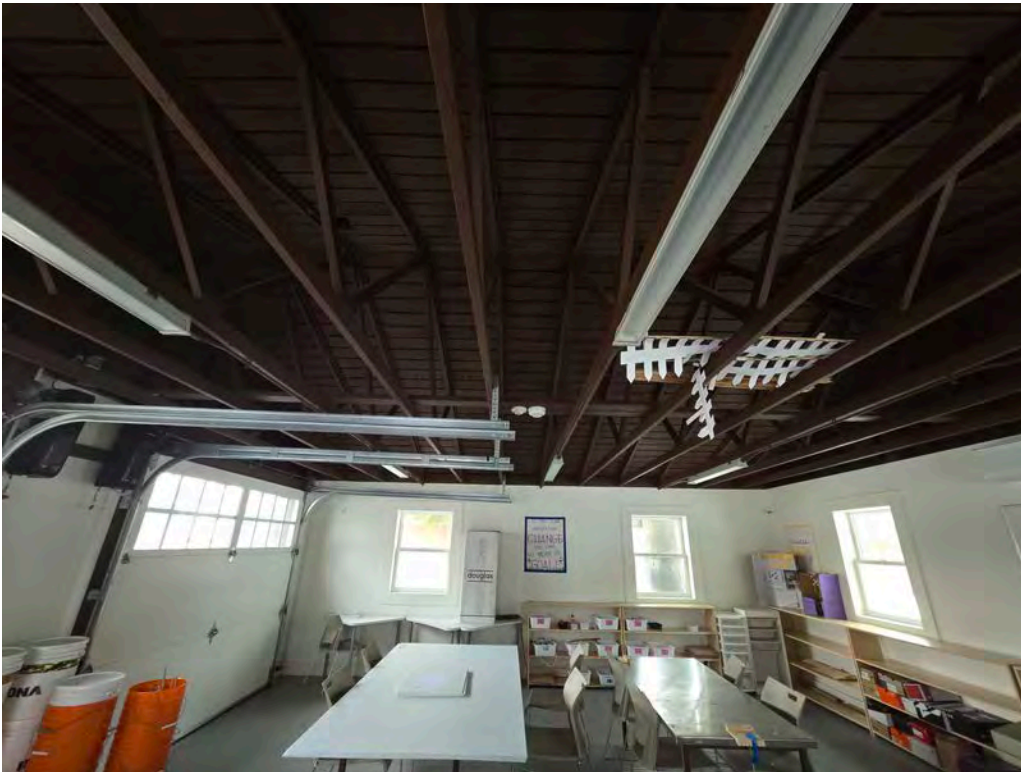
GARAGE – TO BE DEMOLISHED – a modern structure that has no cultural heritage value - concrete pad foundation – exposed roof rafters are modern dimensioned lumber – interior walls are drywall - date of construction estimated to be c.1970s or 1980s
