HERITAGE IMPACT ASSESSMENT

7059 Second Line West: Proposed Addition

Rotherglen School, Meadowvale Campus
929 Old Derry Road & 7059 Second Line West
Mississauga, ON

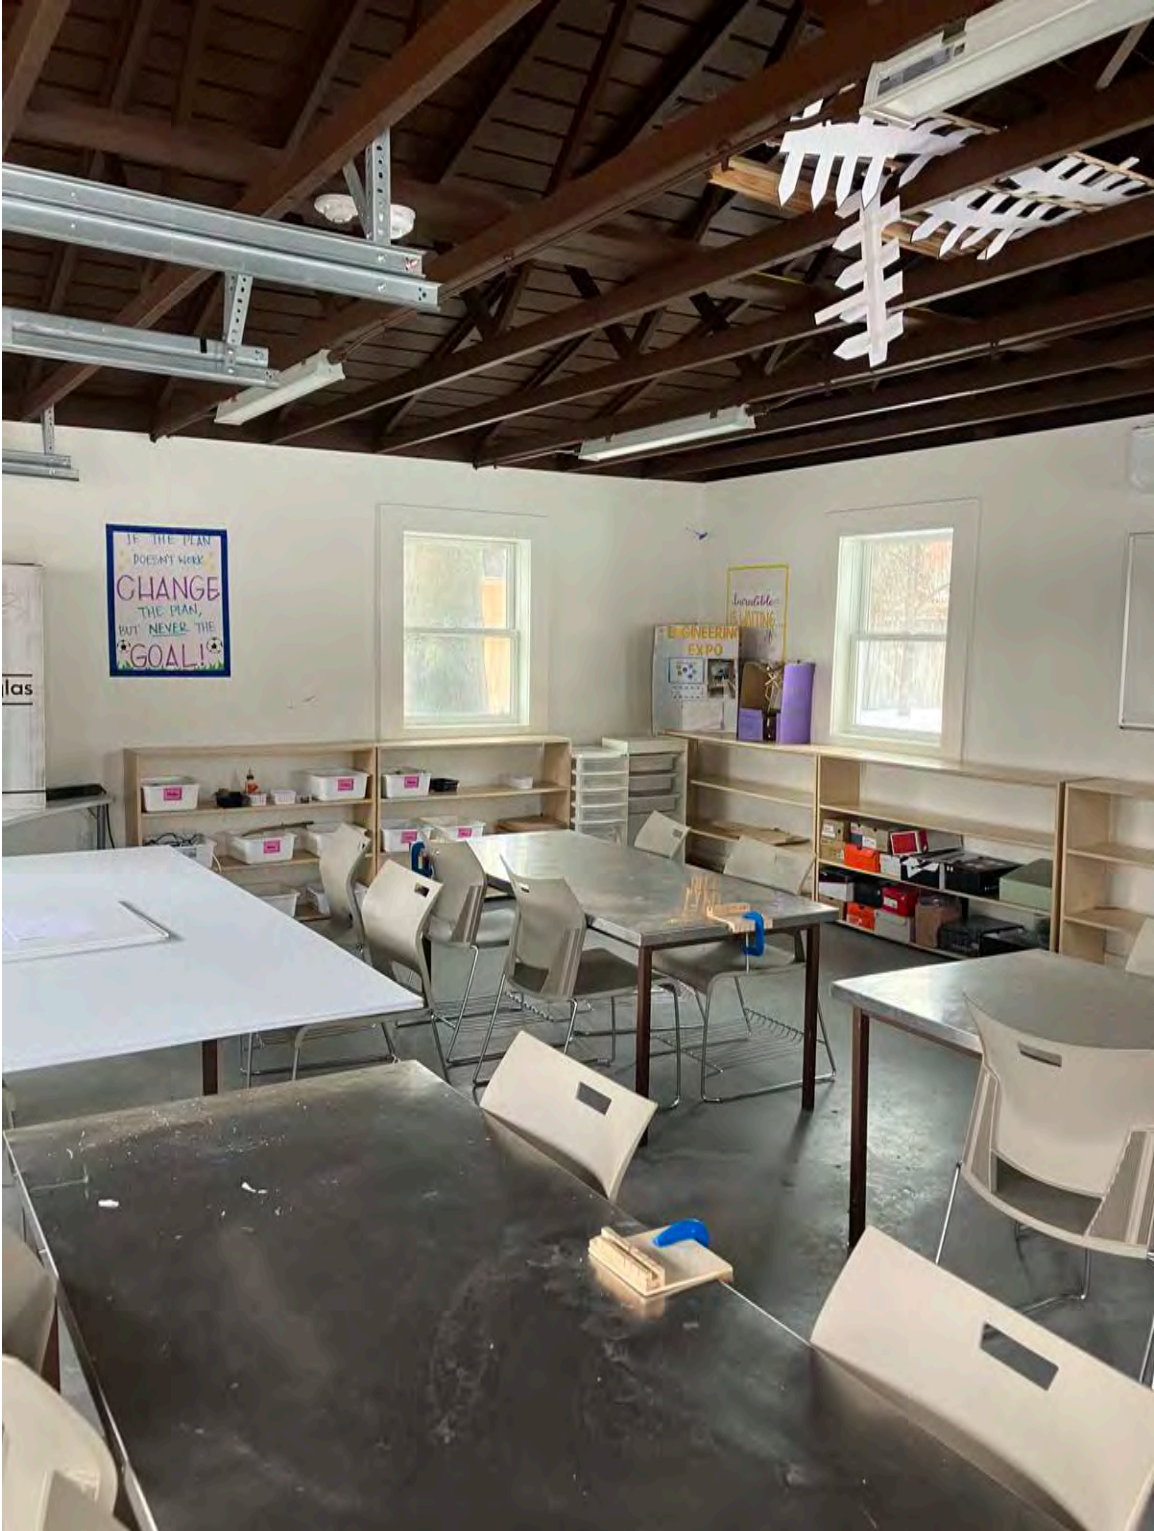
GARAGE – TO BE DEMOLISHED - a modern structure that has no cultural heritage value - concrete pad foundation – exposed roof rafters are modern dimensioned lumber – interior walls are drywall - date of construction estimated to be c.1970s or 1980s

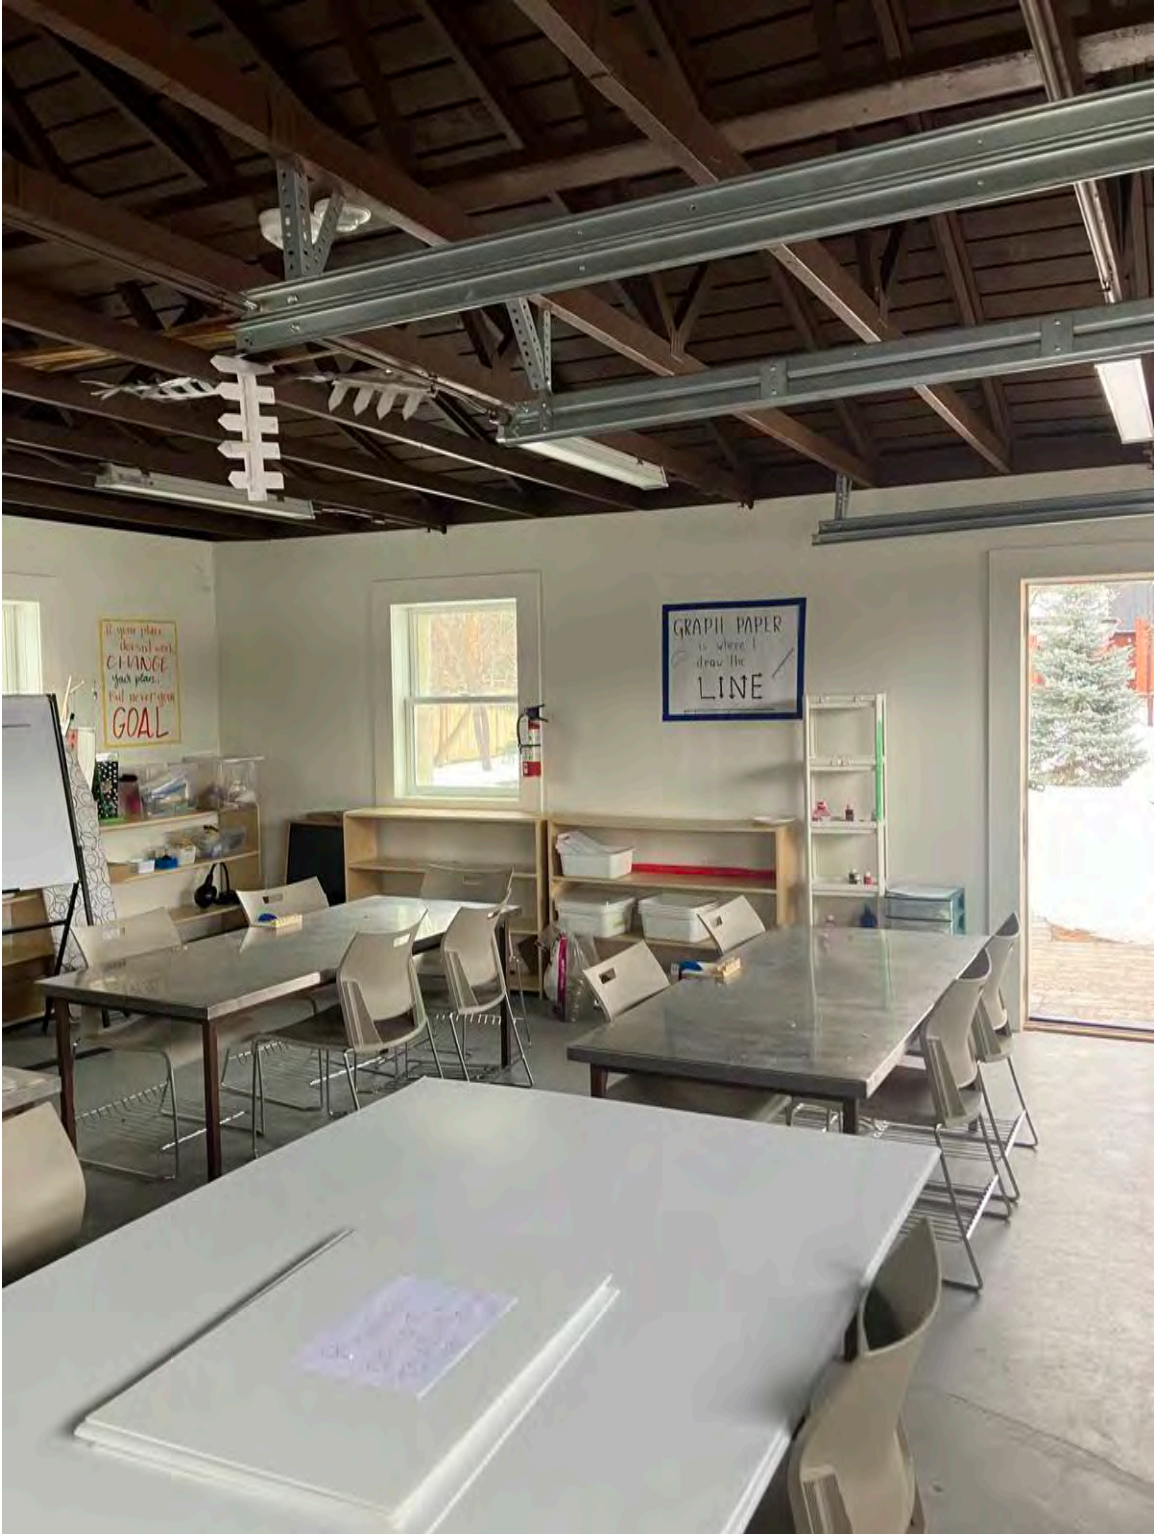
GARAGE – TO BE DEMOLISHED - a modern structure that has no cultural heritage value - concrete pad foundation – exposed roof rafters are modern dimensioned lumber – interior walls are drywall - date of construction estimated to be c.1970s or 1980s

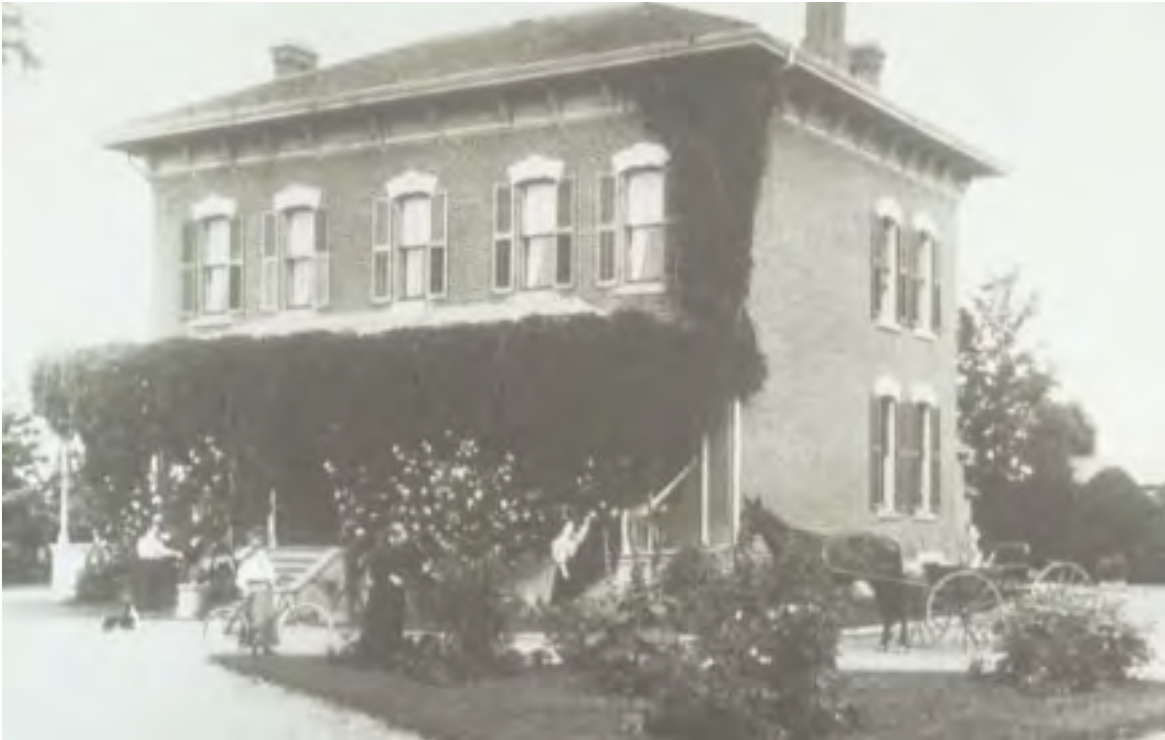
Gooderham Mansion, 929 Old Derry Road - built c.1870 for C.H. Gooderham (1844-1904)

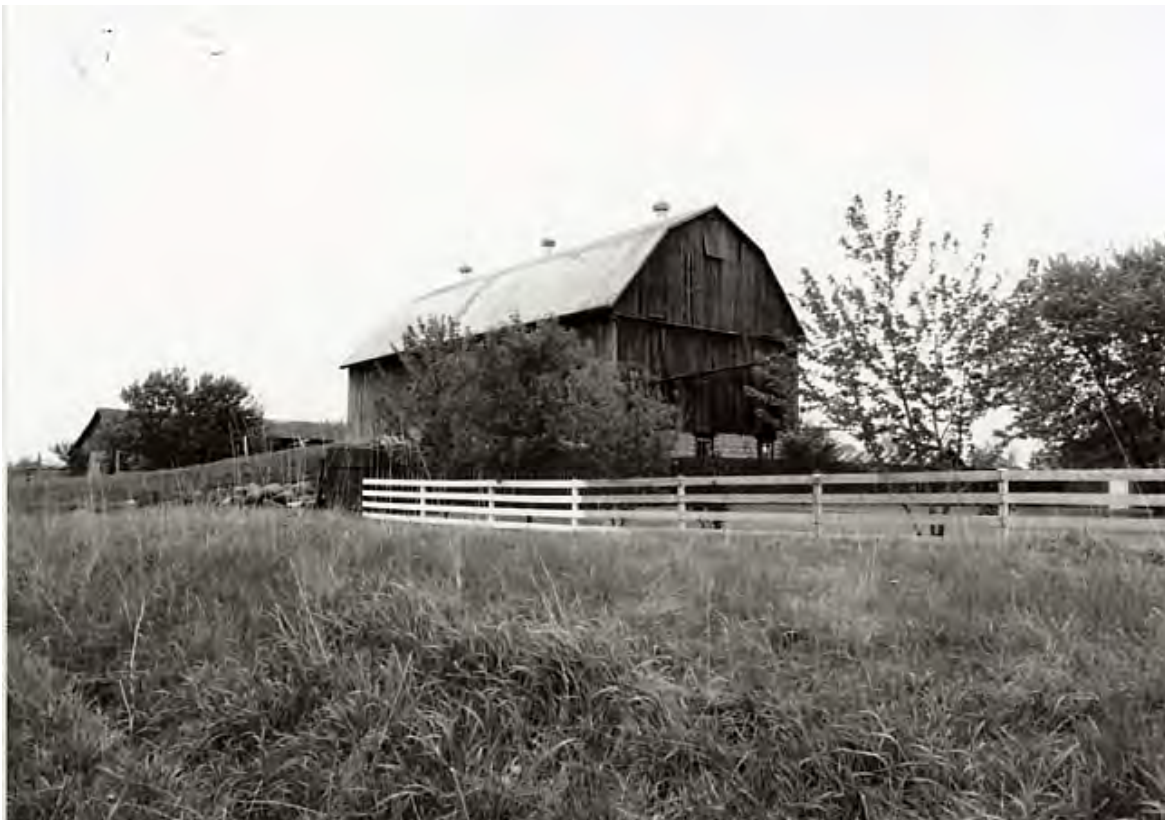
Gooderham barn, probably built c.1880 – one of several outbuildings on the estate

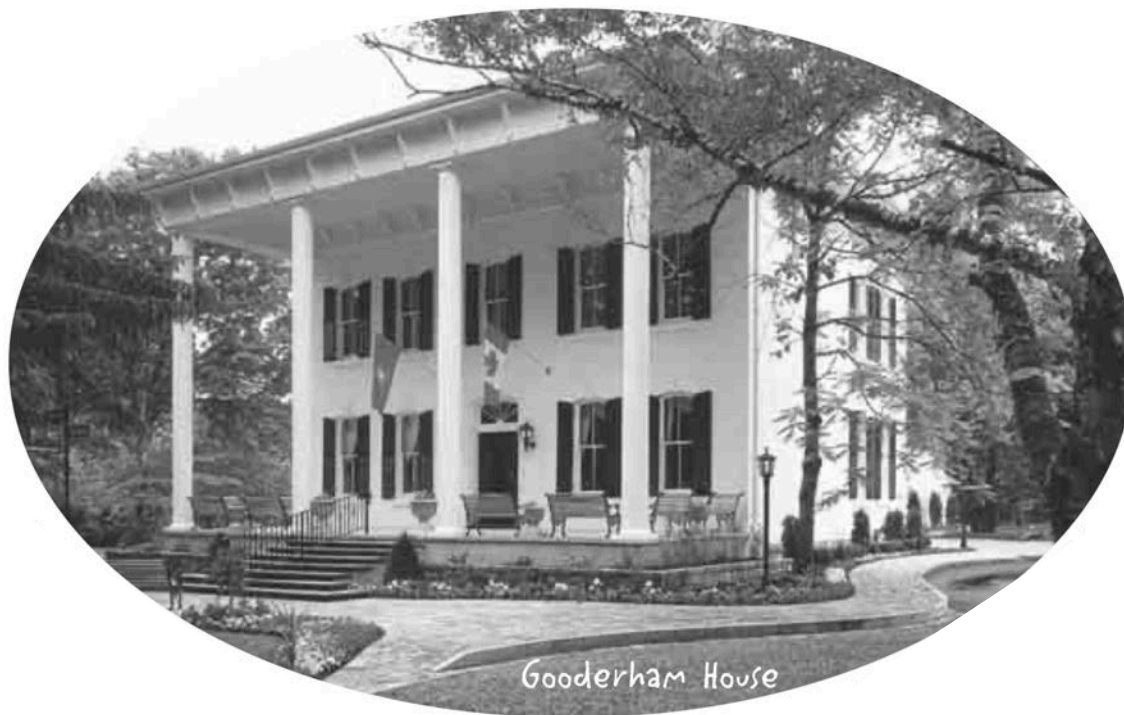
Rose Villa, 929 Old Derry Road – the Gooderham mansion was turned into a tourist hotel by John Watt in 1895 *the columns were added in the 1970s

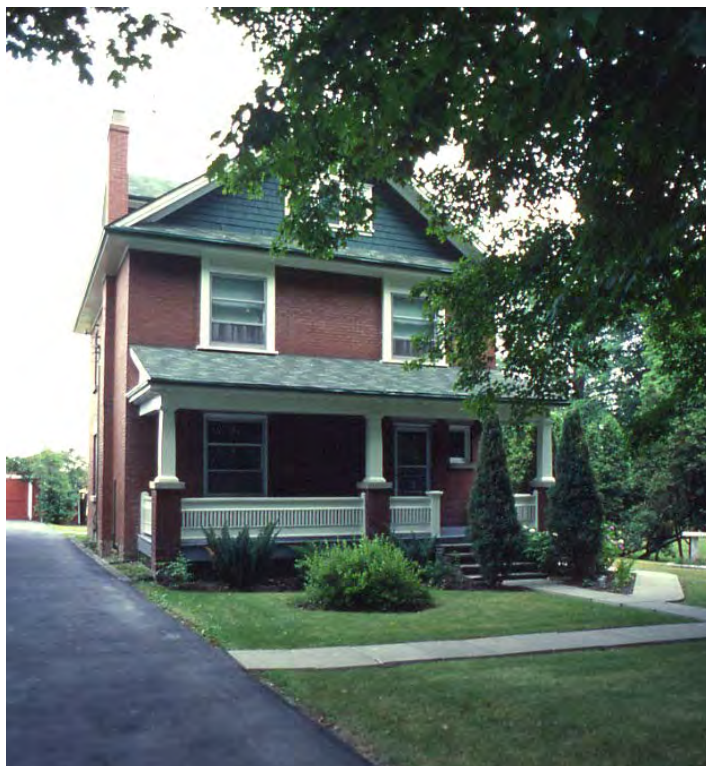
Backhouse Residence, 7059 Second Line West – built c.1920 after part of the Gooderham estate was subdivided for new residential lots on Second Line West
