Heritage Impact Assessment, 5768 Ninth Line, Part of Lot 5, Concession 9, Trafalgar Township, now City of Mississauga, Ontario

Project number: PHC-2020-79

City of Mississauga

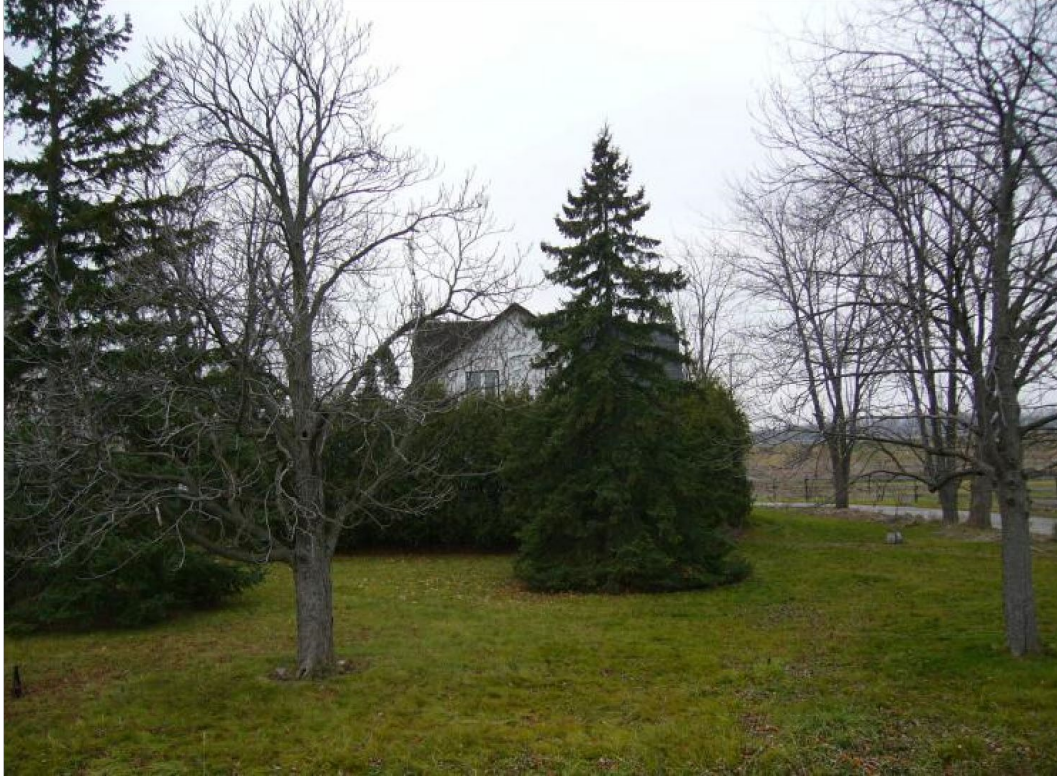
Image 11: East façade of 5768 Ninth Line

For the most part the east façade is screened from public view by a dense cedar hedge. The façade has been substantially altered with the application of multi-colour masonry cladding on the lower storey. All original windows have been replaced with larger multi-paned windows at the lower story together with a remodeled entrance and doorway. Vinyl casement windows have been installed on the upper floor. The former red brick has been painted white.

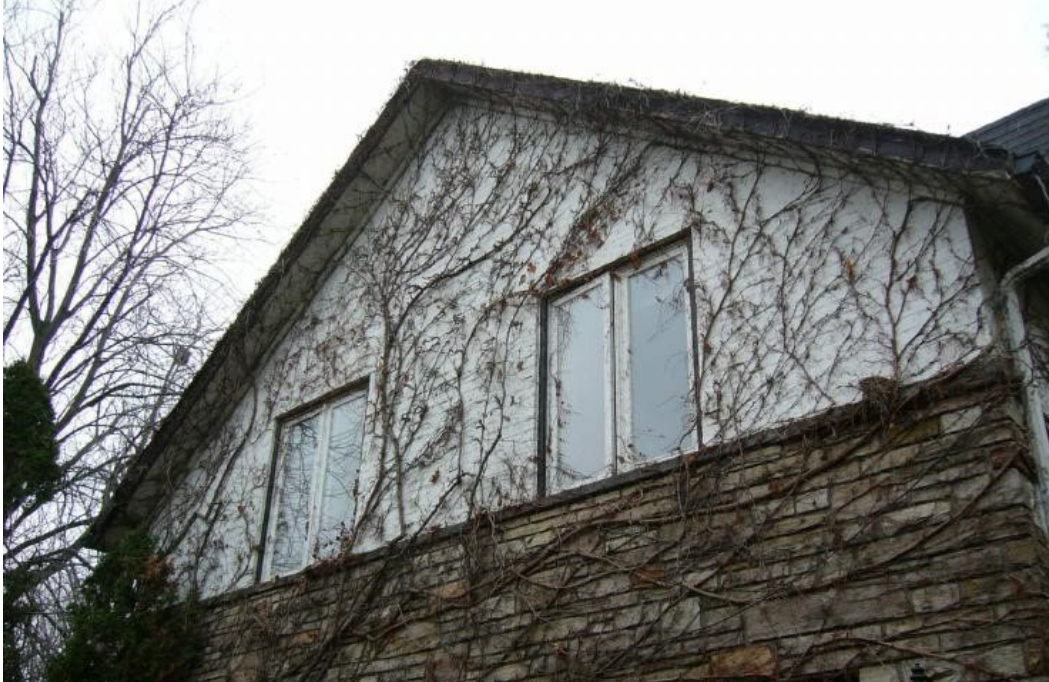
Image 12: modern casement windows on upper storey with painted brick

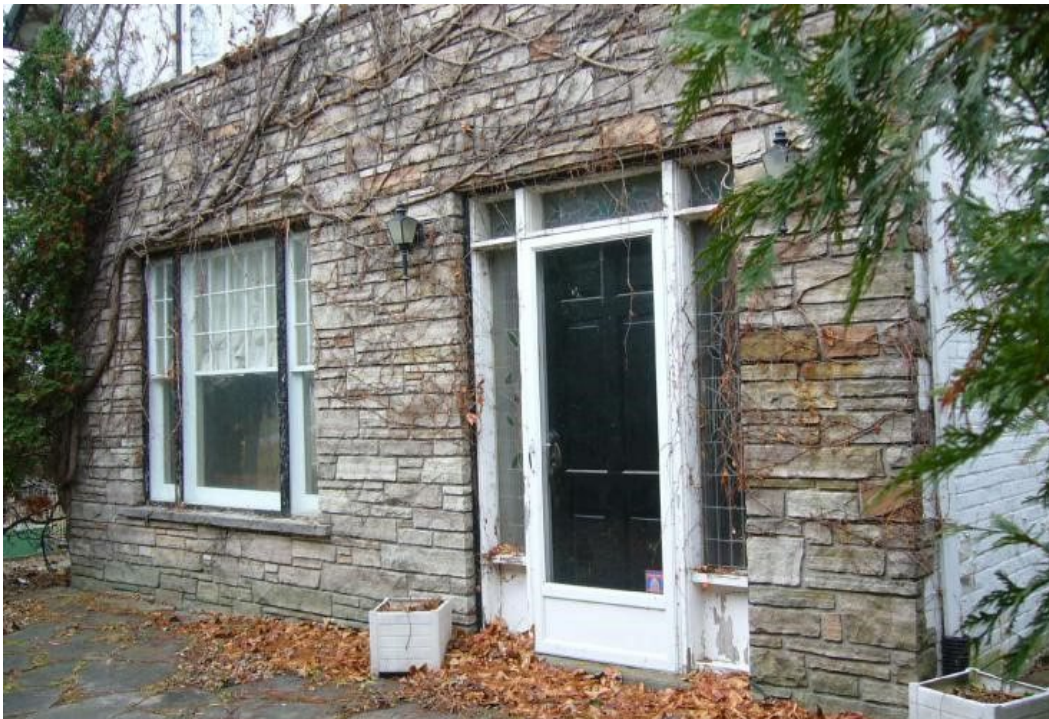
Image 13: Modern tri-partie window and doorway with sidelights and transom on lower level with applied multi-colour stone façade

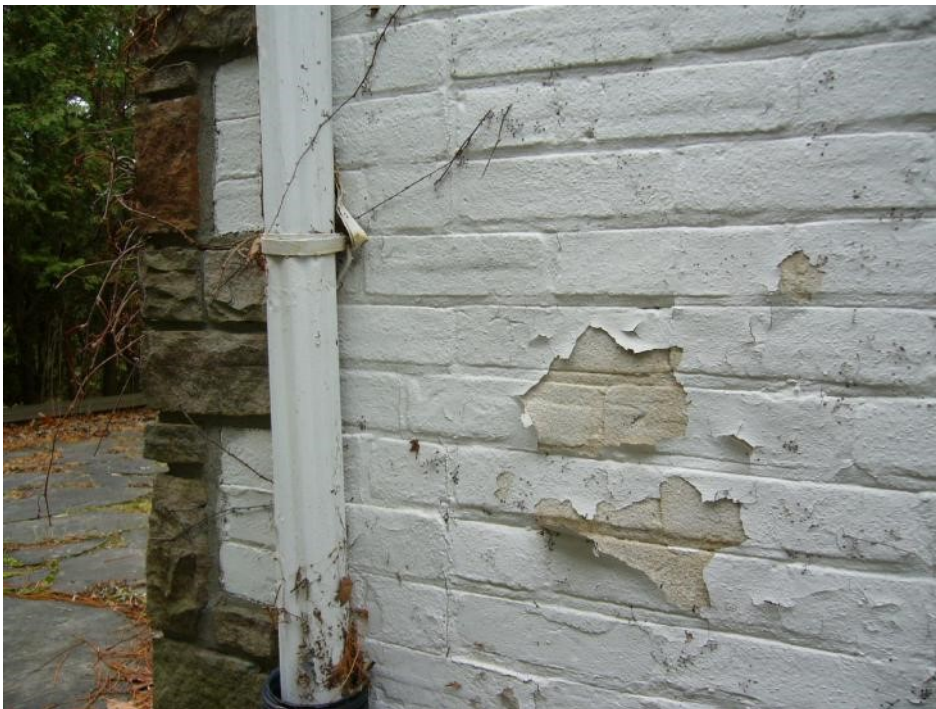
Image 15: Applied stone finish over painted brick wall

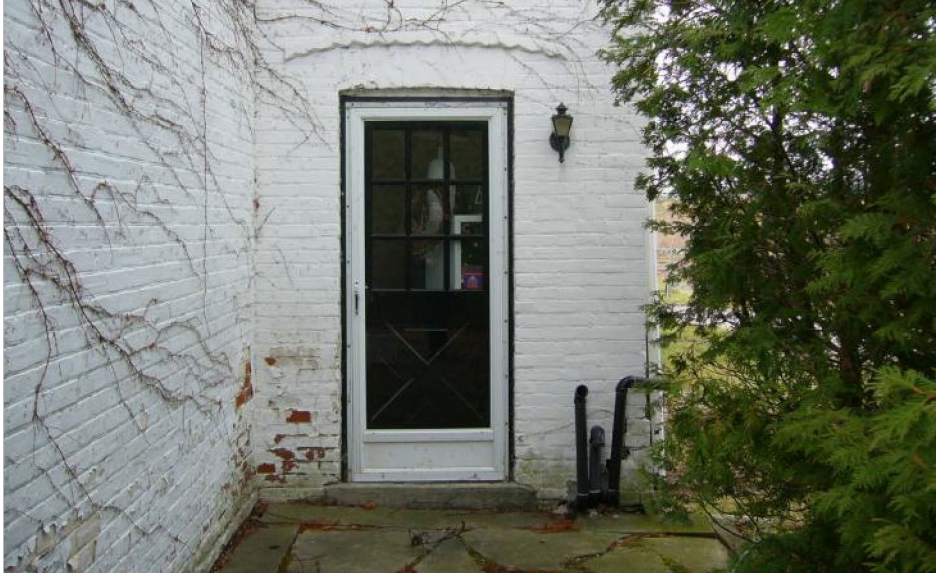
The recessed original entranceway allowing access at the north side also features a more recent door. Paint deterioration in a corner adjacent to the doorway permits the original red-brick to be seen.

Image 16: Side entrance on east elevation, note recent interior door and storm with original hood moulding

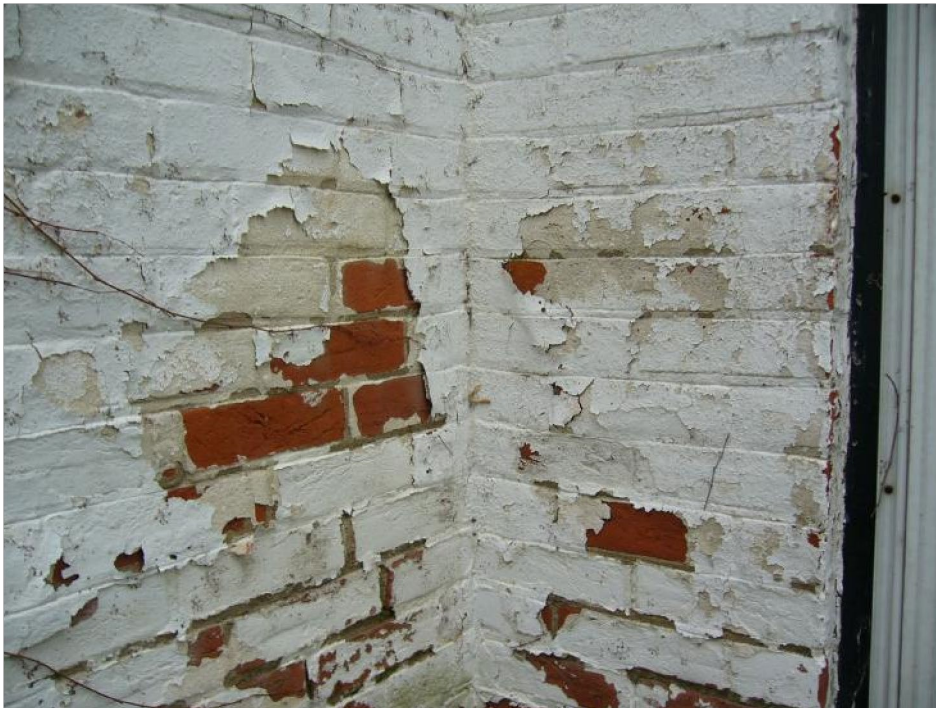
Image 17: Deteriorating paint and cementitious render over original red brick. Interior corner shows aligned brick courses indicating same date of construction.

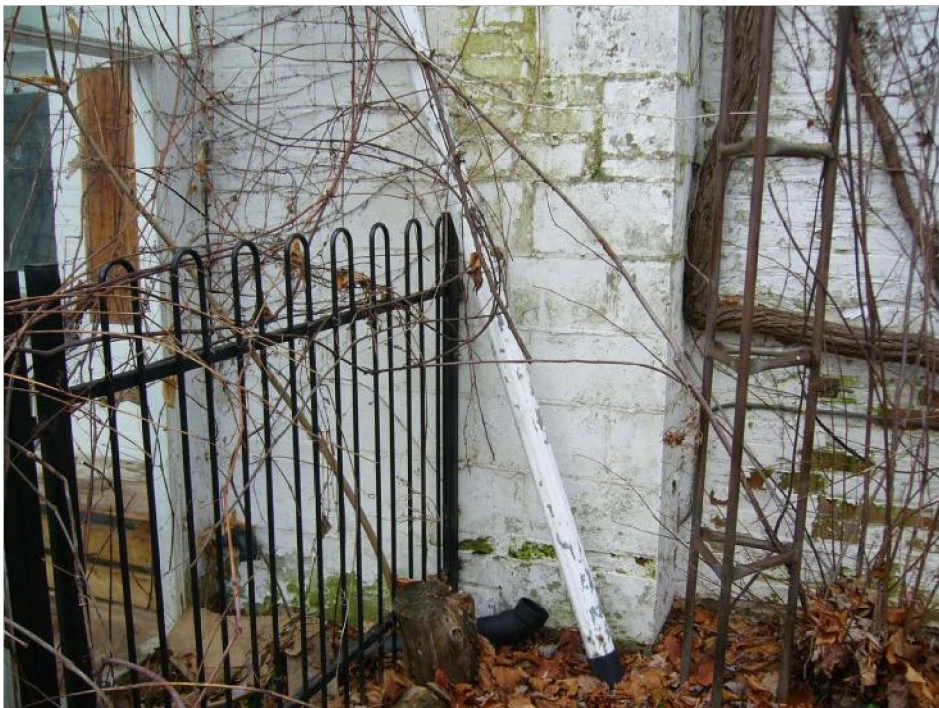
Image 21: Example of exterior degradation resulting from poor maintenance, note disconnected downspout and vegetation growth

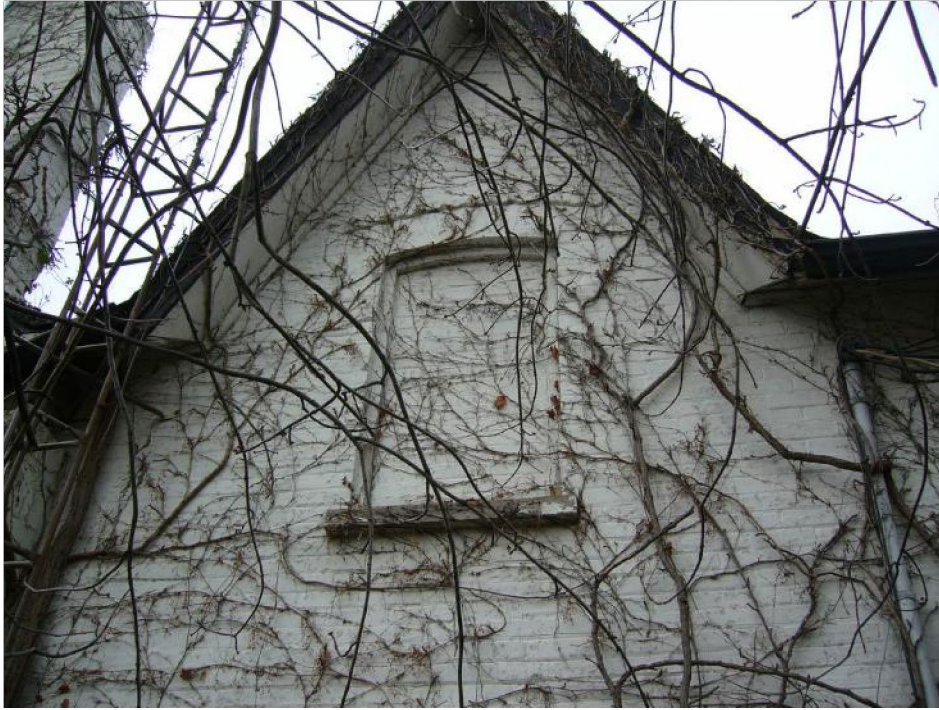
Image 22: Blocked up or “Blind” window second storey

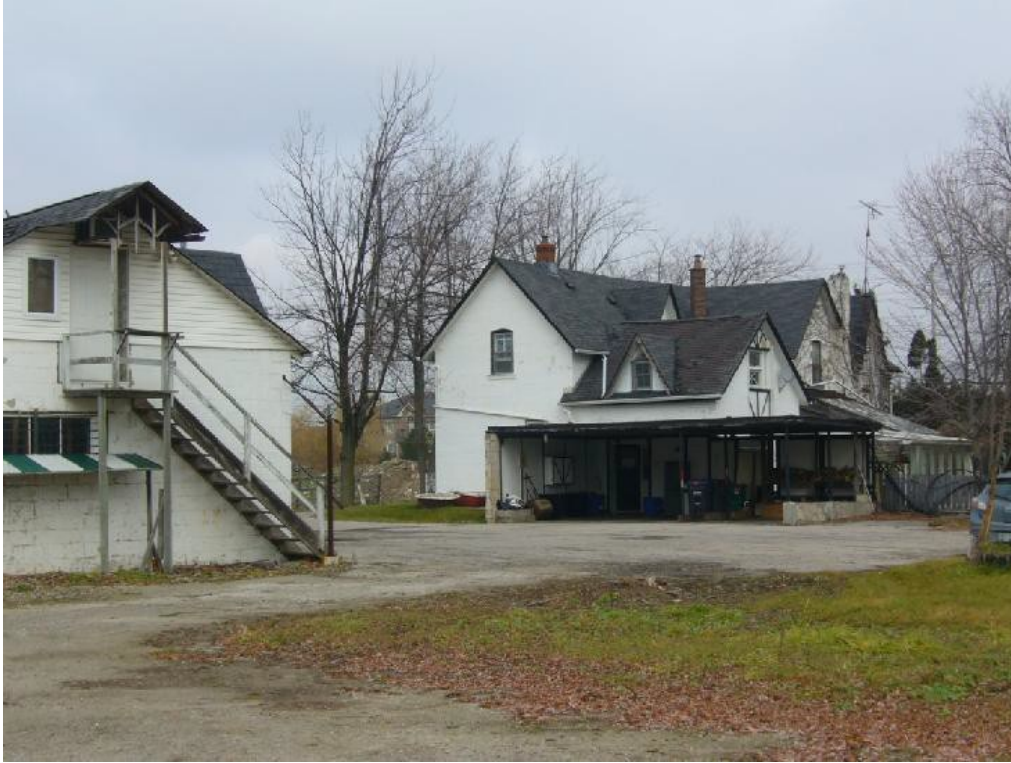
Image 23: West façade showing gable end of 19th century building and later side addition of projecting southerly wing with carport. An ancillary CMU workshop is shown at left and is not considered to be of cultural heritage value or interest.

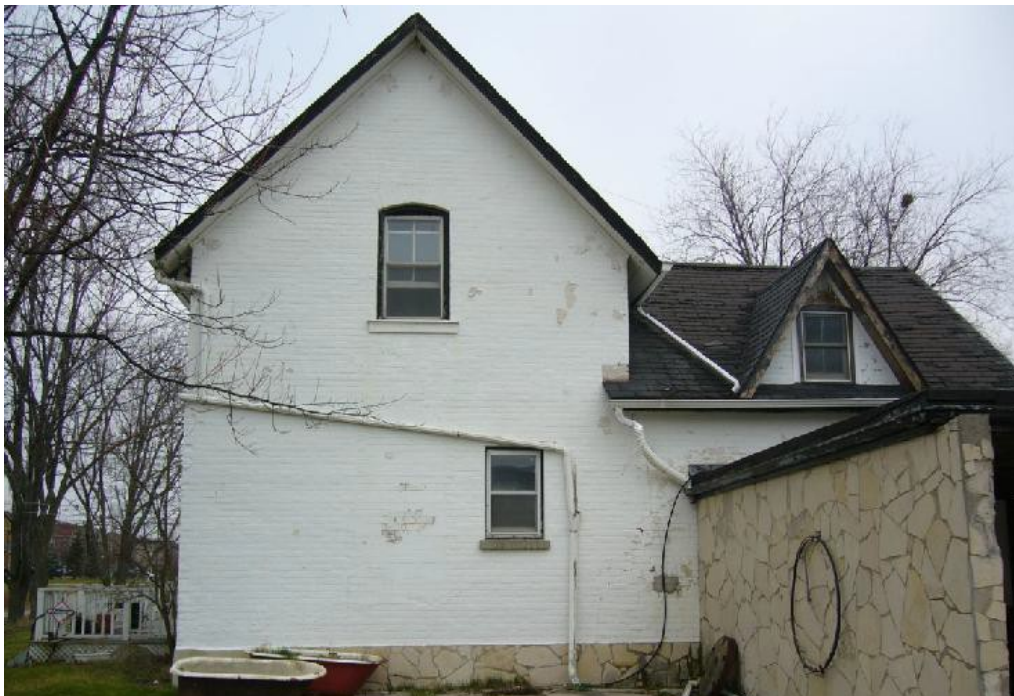
Image 25: West façade showing gable end of 19th century building and later stone clad carport wall. The lower floor window under the upper floor window has been blocked up.

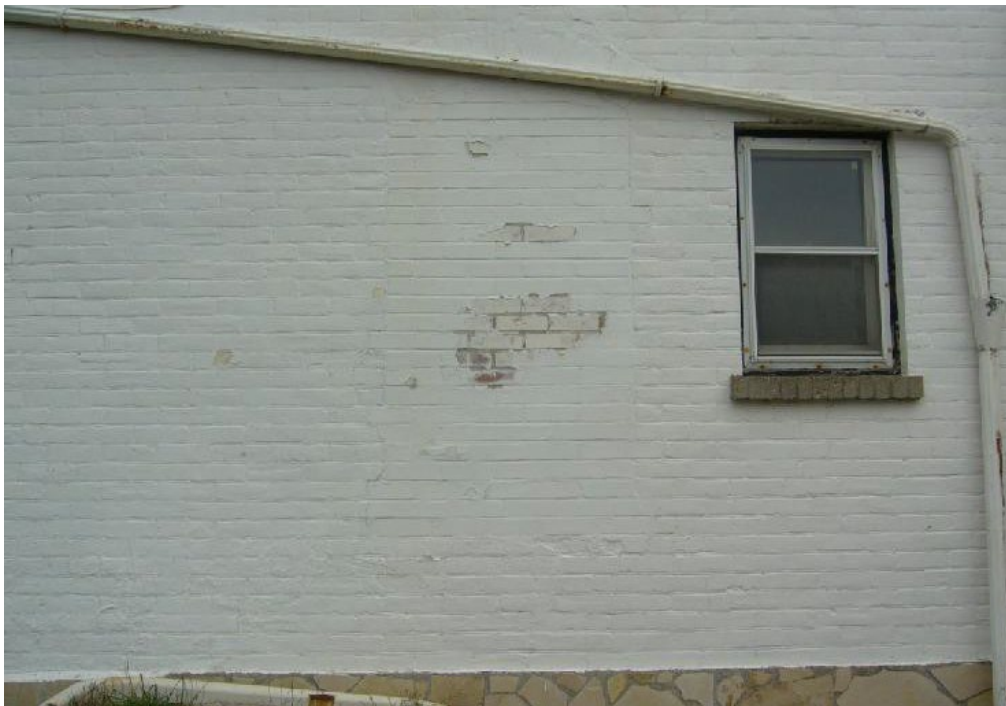
Image 26: The lower floor window under the upper floor window has been blocked up and a new window inserted to the right. The lower brick courses have been covered in masonry cladding.

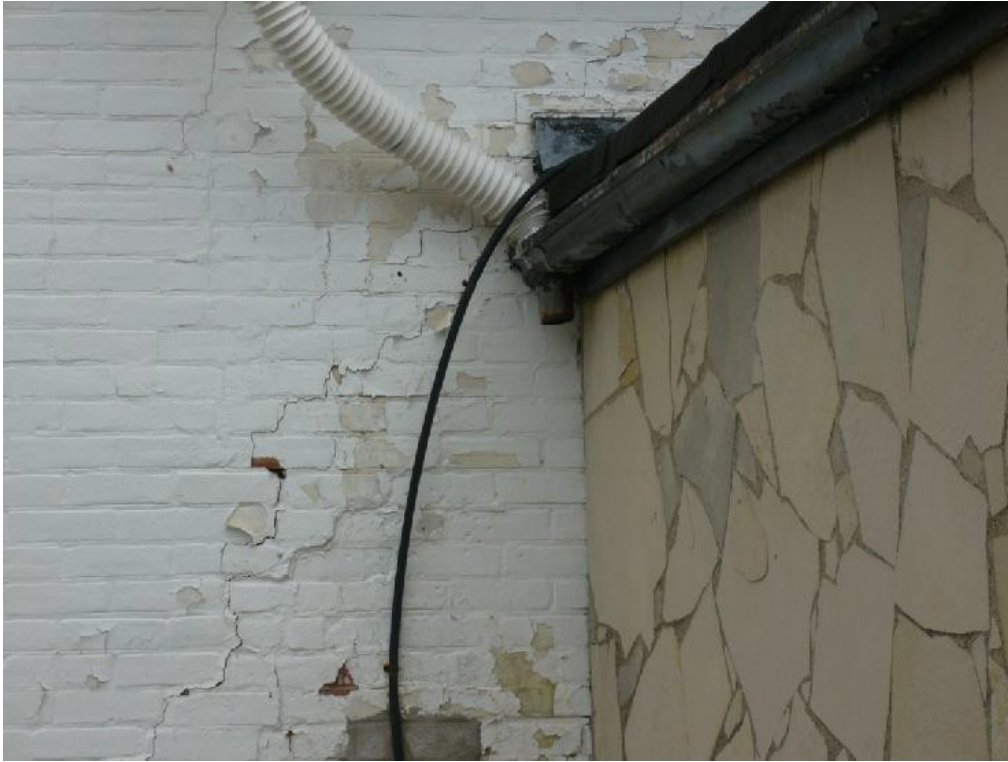
Image 27: Water damage has resulted in cracking of brickwork and mortar joints

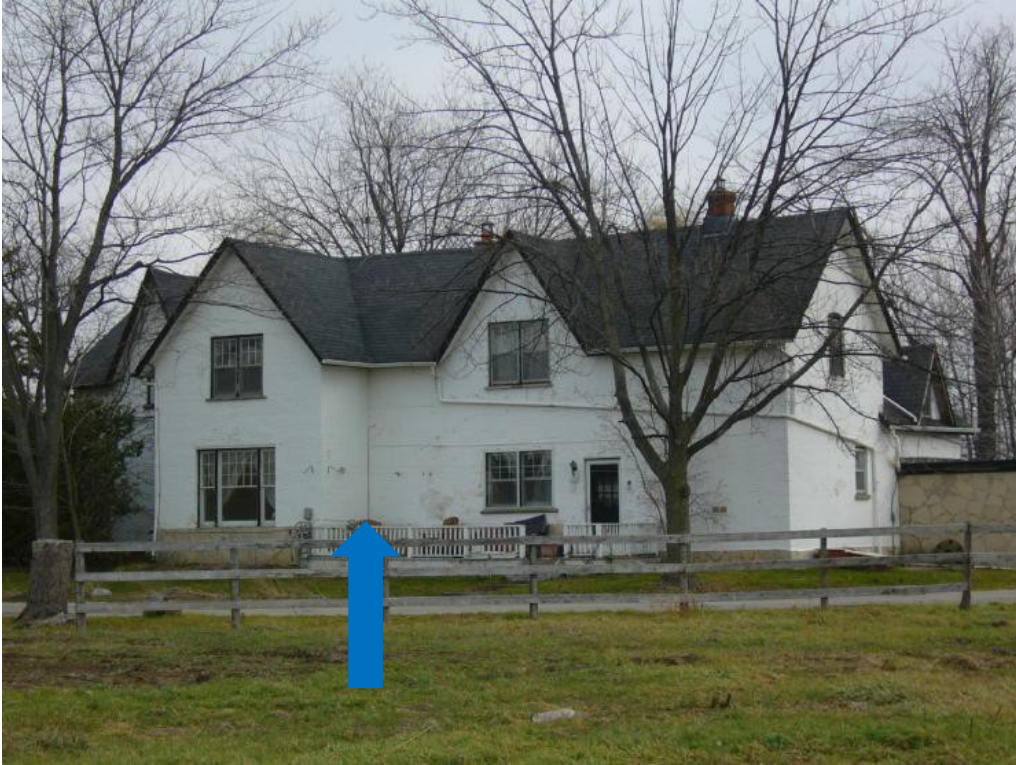
The north projecting cross gable of the L shape plan is also appropriately tied into the main east building mass. The west addition may not have been a much later addition, i.e., twenty years, but could have been added soon after completion of the east building with changing family or farm needs. More detailed photographs show that the brick courses in the west addition are mismatched and appear to be parting from the east building mass as they are not tied in.

Image 28: North face, blue arrow indicates junction between original construction and later addition

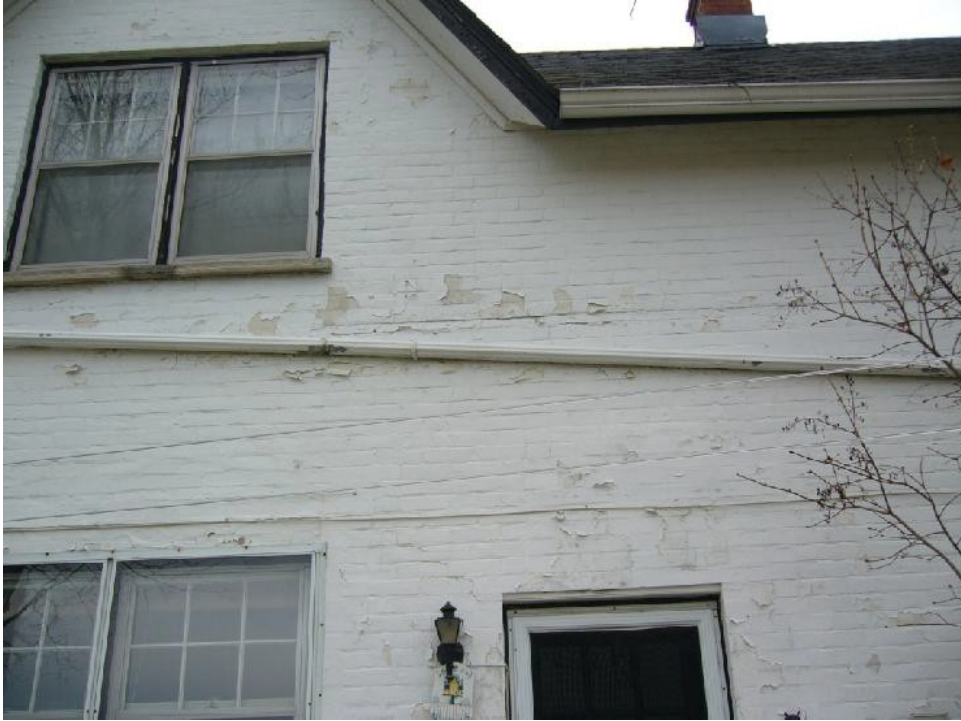
Image 30: Upper and lower windows are enlarged replacements of smaller original windows and openings. Window sills comprise stone units with lintels of steel. The line of a former verandah is discernible above the diagonal drainpipe.

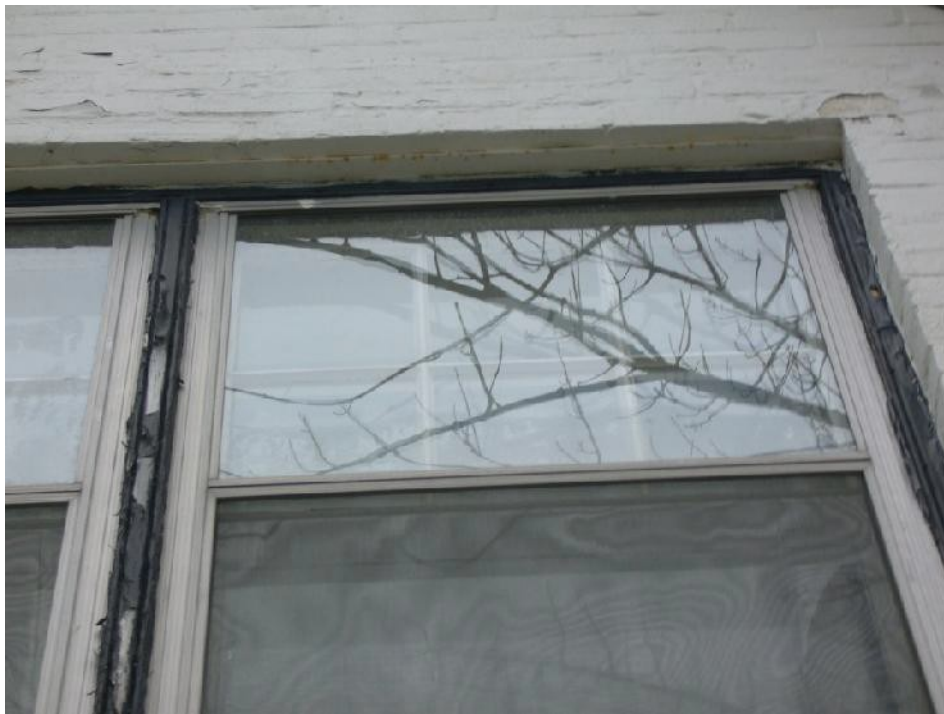
Image 29: Steel lintels support brick courses above. Windows and aluminum storms are not original.

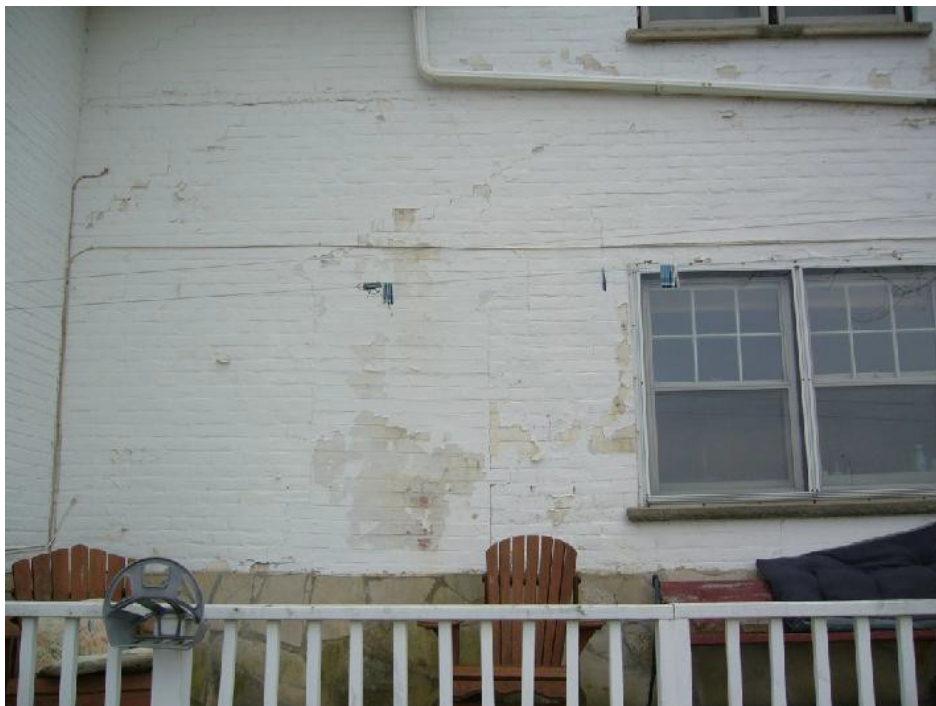
Image 32: An original window opening has been blocked in to the left of the windows. Cracks in the brick work are discernible in the upper corner. Paving has been used to reclad the lower brick courses

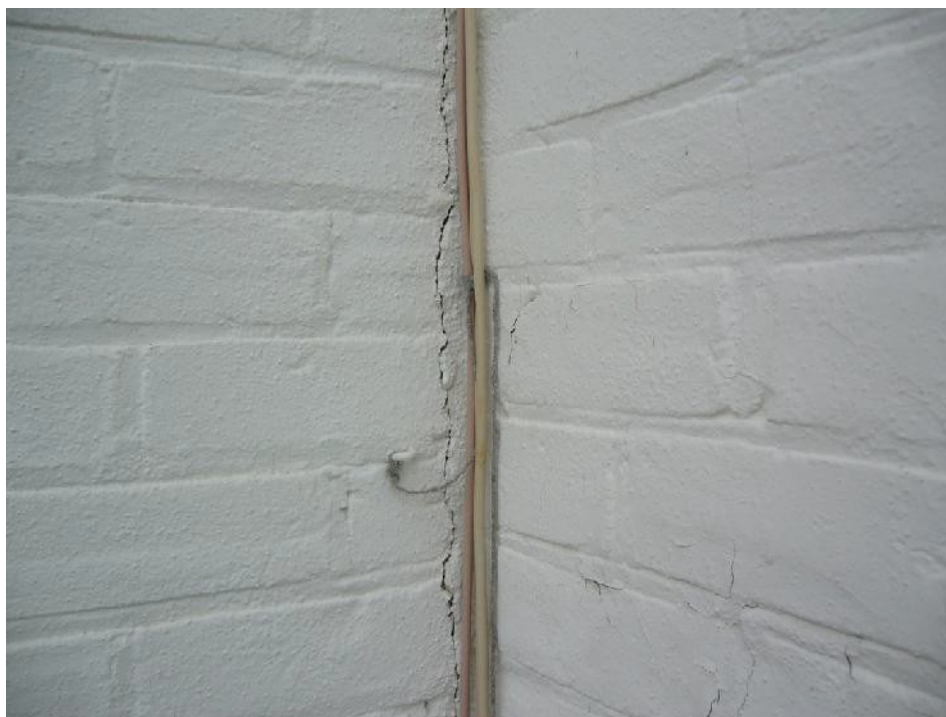
Image 33: Close up of the junction between building masses showing misalignment of brick courses

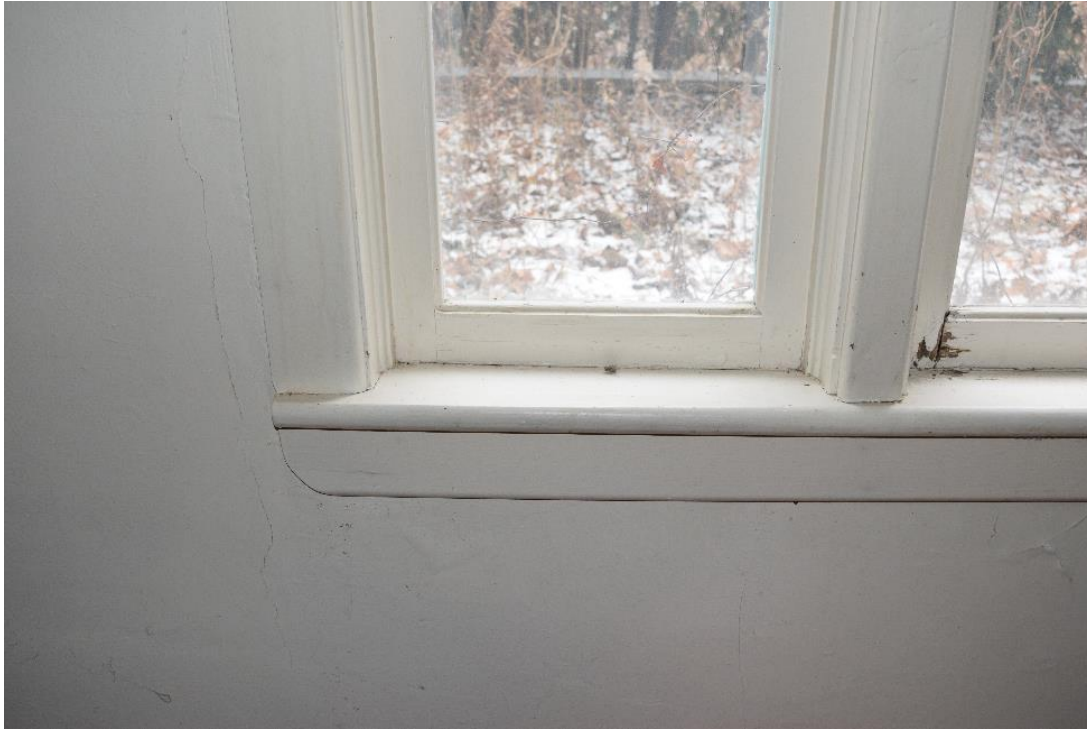
Image 40: Example of typical replacement window trim and non original wood windows

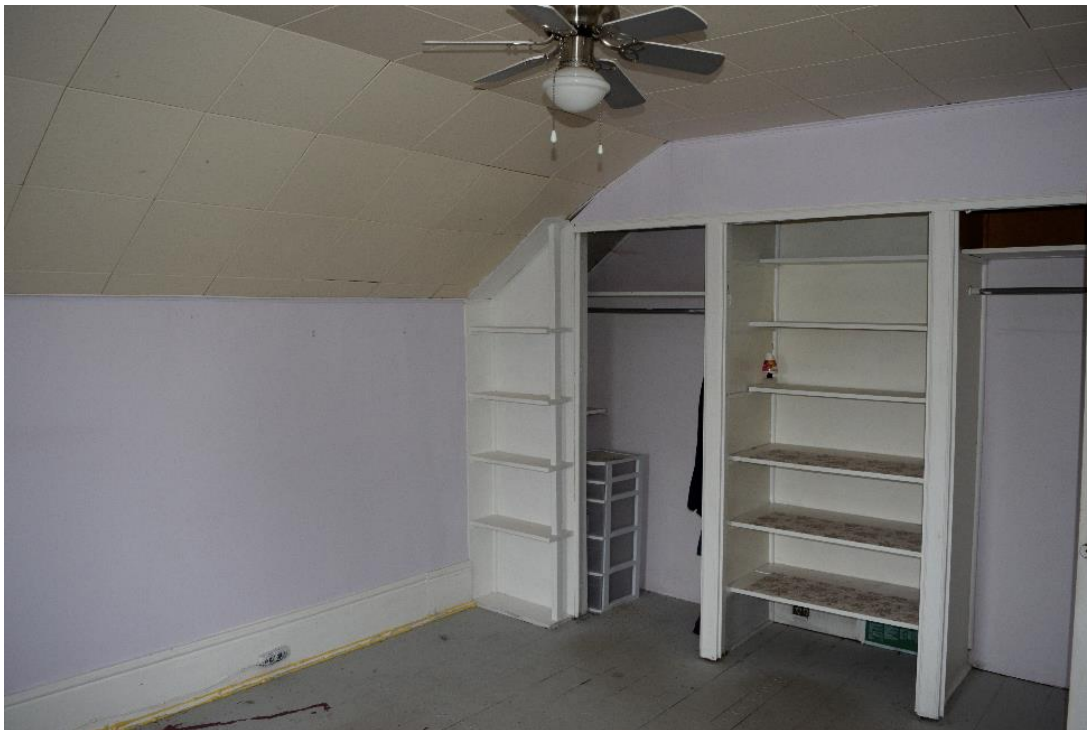
The second floor presents with few original elements. The northeast bedroom contains some original trim and retains its original pine plank floors. The remainder of the second floor has been significantly altered and no longer presents with original finishes. The eastern most room adjacent to the rear staircase presents with original door trim and associated door but it is not clear if these finishes are as built or the result of salvage adaptation. A single stained-glass window resides in the main stairwell and may represent an original finish.

Image 41: Northeast bedroom second floor, note original plank floors and original baseboard, ceiling has been replaced with acoustic tiles

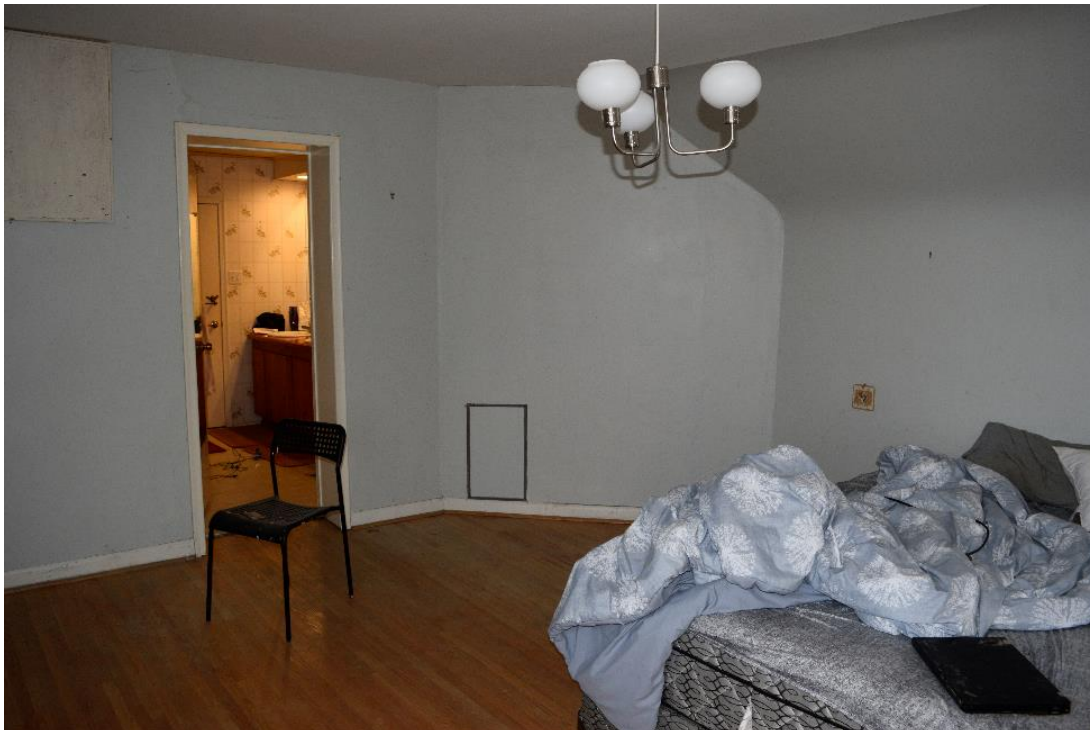
Image 43: Master bedroom, note lack of any original finishes, facing northeast

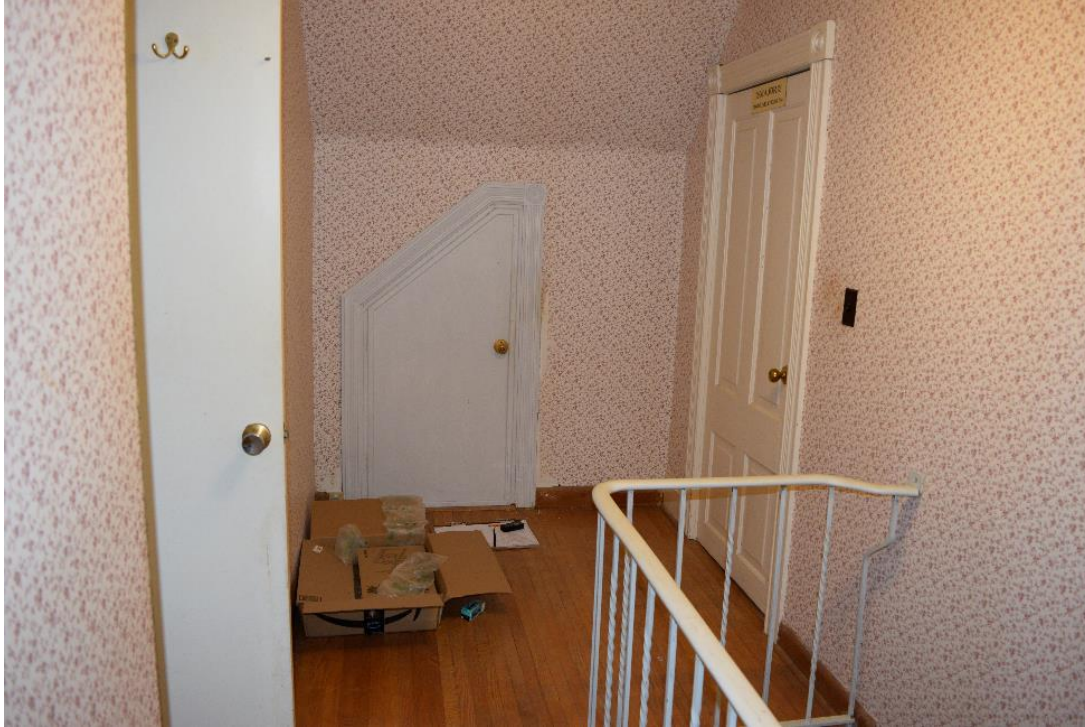
Image 44: Hall at top of rear stairs, note mix of original and replacement finesse, railing is of metal construction and non original, facing west

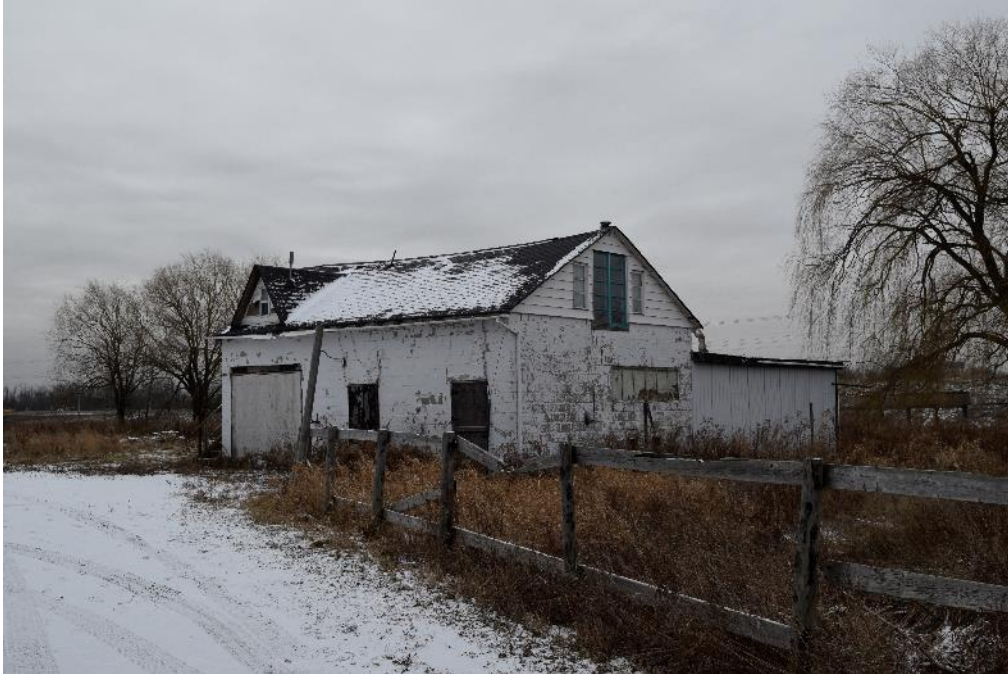
Image 48: Latter 20th century CMU workshop with second storey apartment, facing south

The storey-and-a-half workshop and storage structure is located to the south of the farmhouse structure. The primary portion of the building is slab on grade and constructed of concrete masonry units (CMU). In addition to the CMU portion of the structure two frame additions have been added to the rear. At the time of assessment, the interior of the structure was inaccessible but personal communication with the _____, son of the property owner, indicated that the upper storey of the structure consisted of a small bachelor apartment and the lower level was a workshop. The rear additions comprise non-conditioned space and appear to have been assembled of salvaged materials. Based on the style of construction and its similarity to the carport associated with the farmhouse it is presumed this structure dates to the latter 20th century. While the structure is more than 40 years of age it has no cultural significance and as such does not exhibit cultural heritage value or interest.

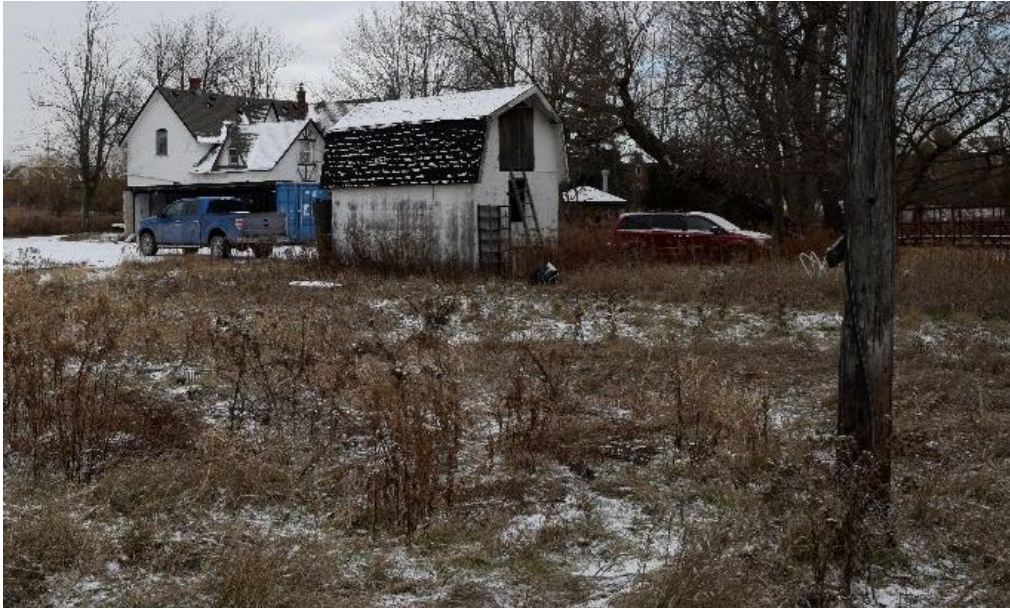
Image 50: Late 20th century “kit” garden shed

A storey-and-a-half frame outbuilding is located to the southwest of the farmhouse. This structure is rectangular in profile and has a gambrel roof. The structure is clad in chipboard sheet goods and likely represents a kit garden shed acquired from a big box store.

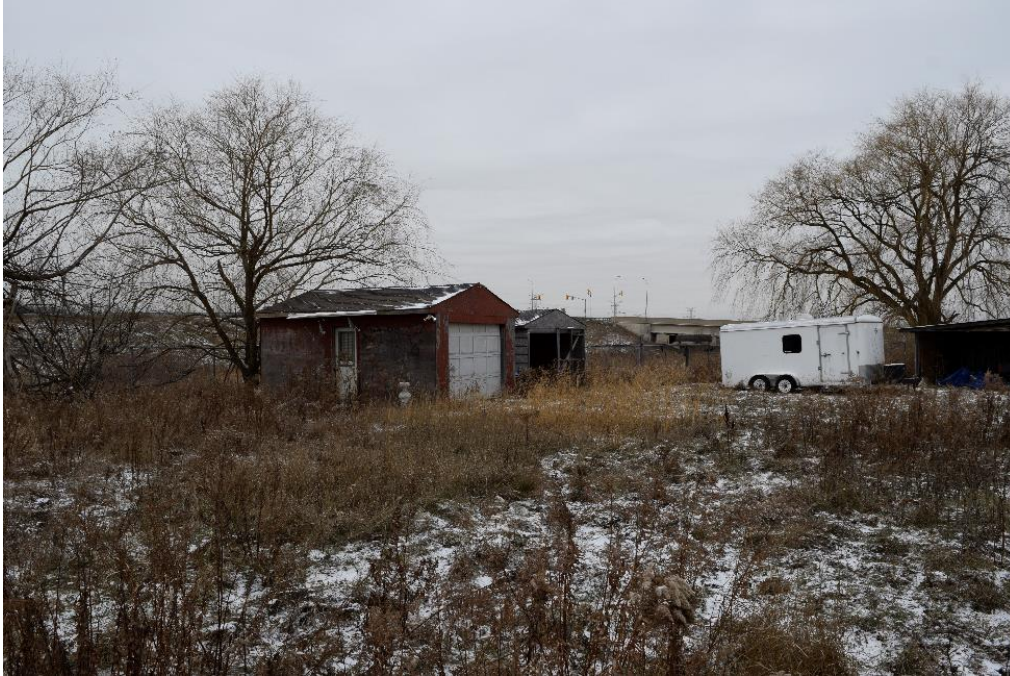
Image 51: Two late 20th century frame single car garages.

Two late 20th century frame single car garages are situated southwest of the CMU structure. These garages are in poor condition and constructed of chip board sheet goods. Like the additions to the CMU structure, they appear to have been constructed of readily available materials and have no cultural heritage value or interest.
