SUBJECT: Arborist Report and Tree Preservation Plan (Heritage report) 1427 Dundas Crescent, Mississauga

## Arborist Report and Tree Preservation Plan

## 1427 Dundas Crescent, Mississauga

February 22, 2021

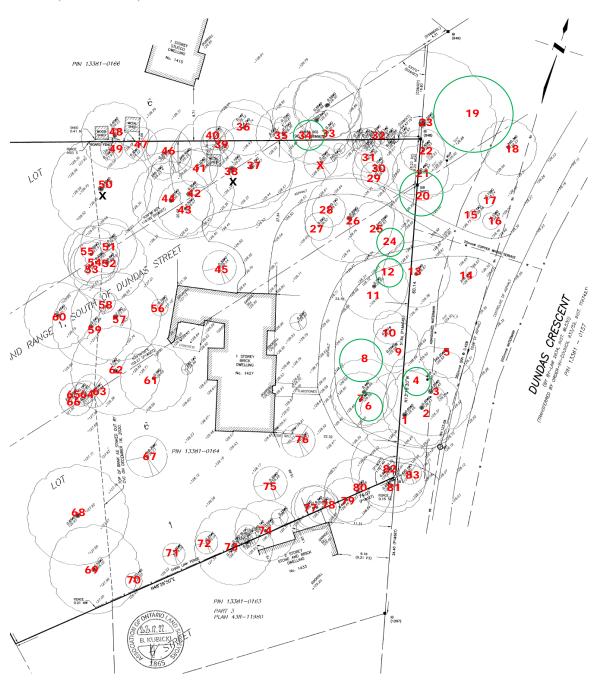
## **Appendix A:** Proposed Site Plan – 1427 Dundas Cres., Mississauga

Note: The locations of Trees #4, 6, 8, 12, 19, 20, 24 and 34 are approximations. No Tree Protection Zone (TPZ) hoarding has been provided as there are currently no finalized building envelopes for this site. **X** denotes two (2) hazard trees recommended for removal (Trees # 38 and 50).
