Heritage Conservation Management Plan
Derry House, 875 Enola Avenue, Mississauga

March 4th, 2021

Heritage Conservation Management Plan – Roof assembly / Soffit / Fascia / Eaves troughs / Rain Water Leaders / Wall Siding / Storm Window and Foundation Wall at Derry House, 875 Enola Avenue, Mississauga Ontario

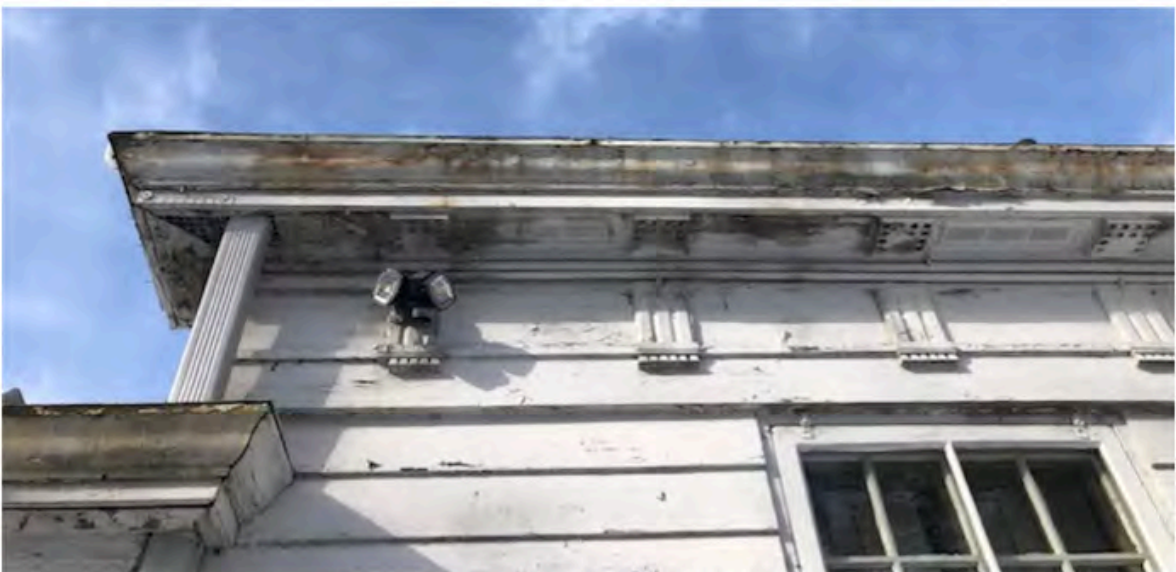
Frieze board with the Triglyph detail – Central part of the building south elevation

Areas where soffit or fascia board are replaced will be primed and painted at the same time when existing soffit, fascia, pediment details at the gable ends and frieze triglyph details at the central part of the building are being painted.

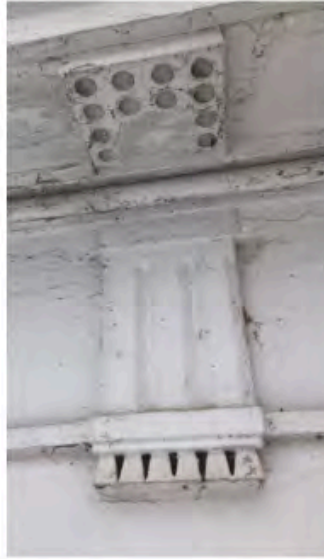
Triglyph detail at the frieze board – Central part of the building south elevation

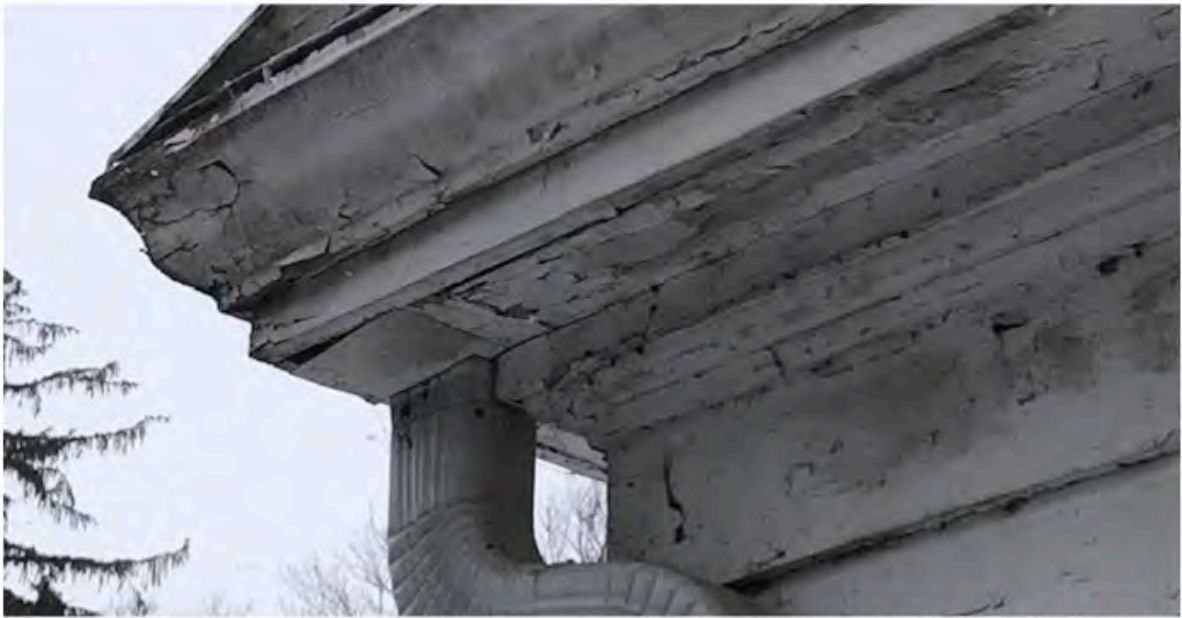
Typical fascia, soffit and frieze detail - West elevation

Even though existing assembly appears to be in fair condition the condition of the all soffit and fascia boards will be inspected after gutters are removed and all deteriorated elements or parts will be replaced with new to match the profiles of the existing boards.

Existing paint will be removed from existing boards and decorative elements, repaired using wood filler and sanded prior to application of a primer.

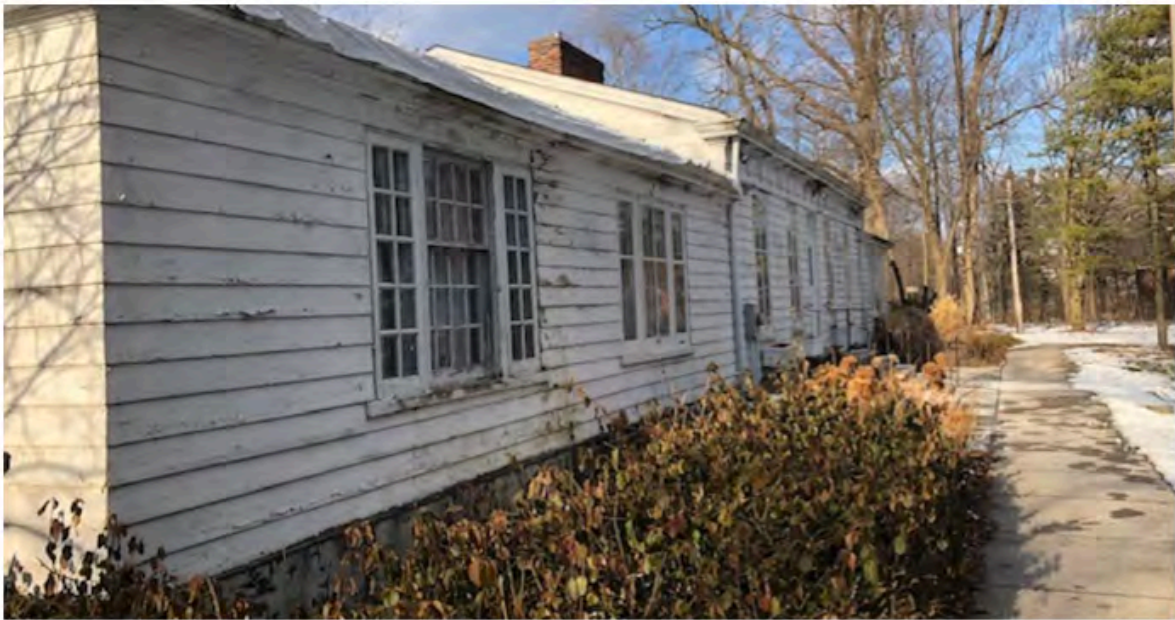
Existing wood siding was found in poor condition at the upper portion of the wall, below the eaves troughs and lower sections of the wall at the transitions to the brick foundation wall. Since insulation inside wall cavity was found in poor condition and would require replacement existing siding would have to be removed. Once siding is removed the condition of the sheathing will be inspected and removed as required in order to replace insulation in the wall

Typical siding detail - south elevation

cavity. Sheathing will be reinstalled or replaced with new to match existing if sheathing boards are found in poor condition.

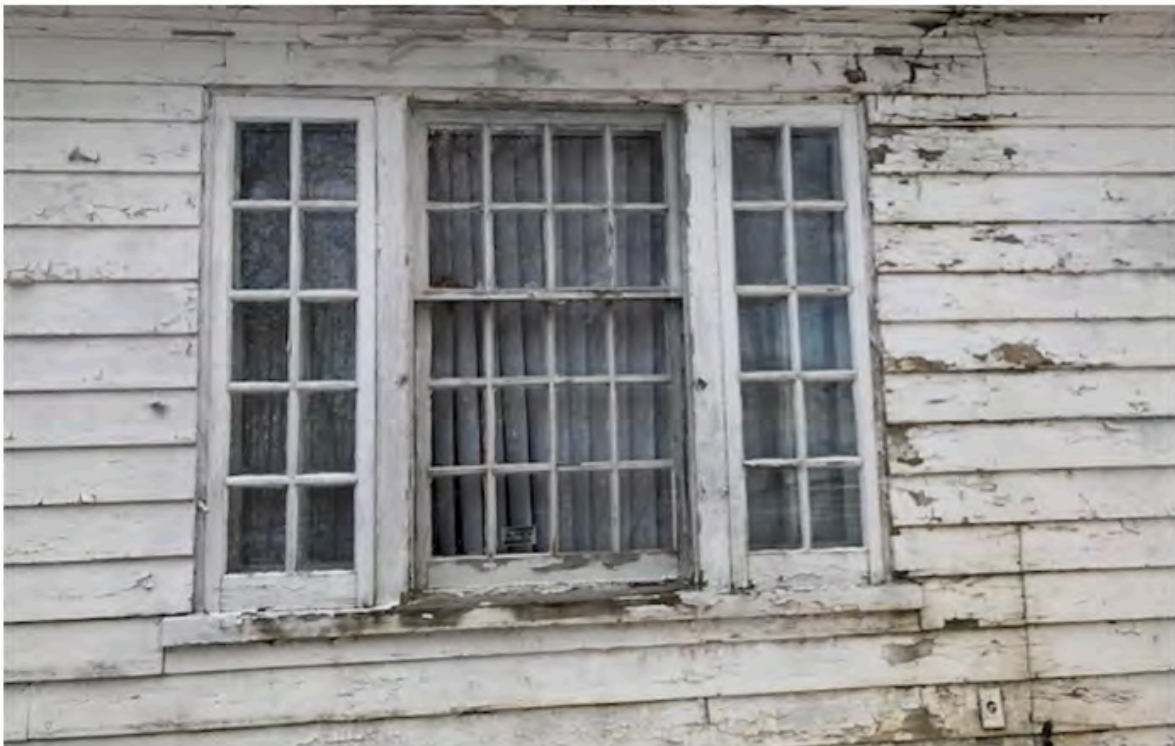
Typical window / siding details - south elevation

Loose or peeling paint at the window frame, window, storm window and window sill surfaces will be removed to solid material by scraping and sanding. Surfaces will be inspected and determine if the material requires replacement or could be primed or painted.

All replacement material will match the profiles of the existing and be primed and painted using the same material as reused elements. The surfaces of the existing storm windows and window frames will be filled with a wood filler, sanded, primed and painted to match the colour of the existing window frames and storm windows.

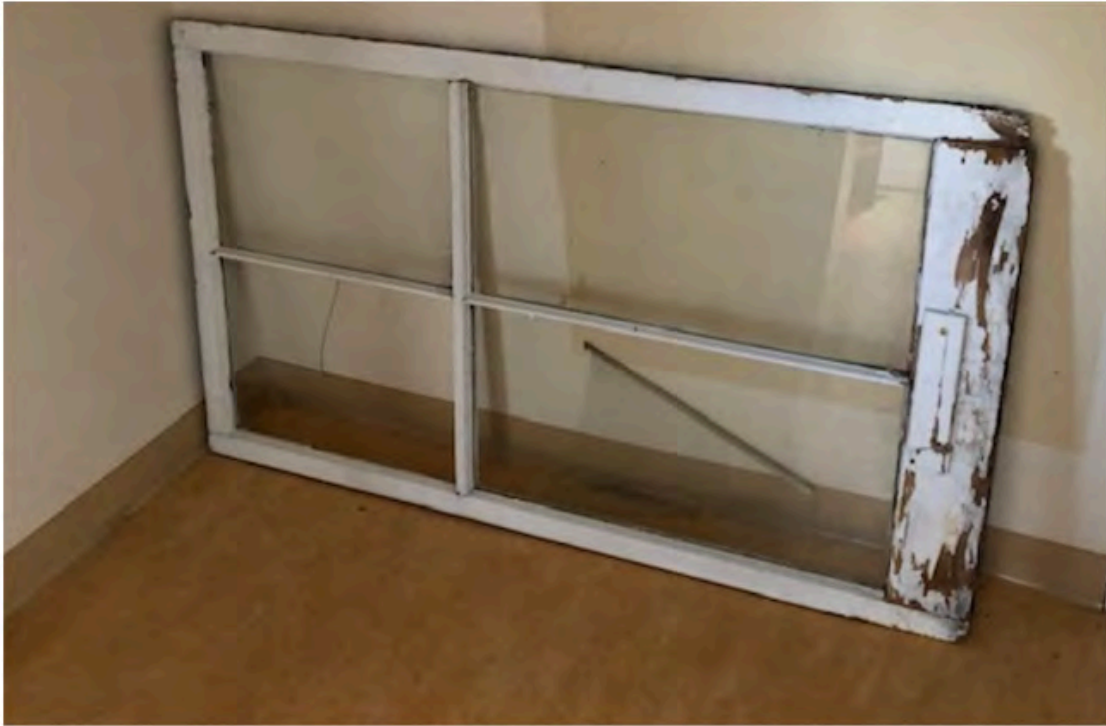
Storm window - Deteriorated bottom rail - south elevation
