Heritage Conservation Management Plan  
Adamson Estate Barn, 875 Enola Avenue, Mississauga

**Heritage Conservation Management Plan – Roof assembly, Second Floor Exterior Wall and Ground Floor Exterior Wall repairs at the Adamson Estate Barn located at 875 Enola Avenue, Mississauga Ontario**

Building structural review

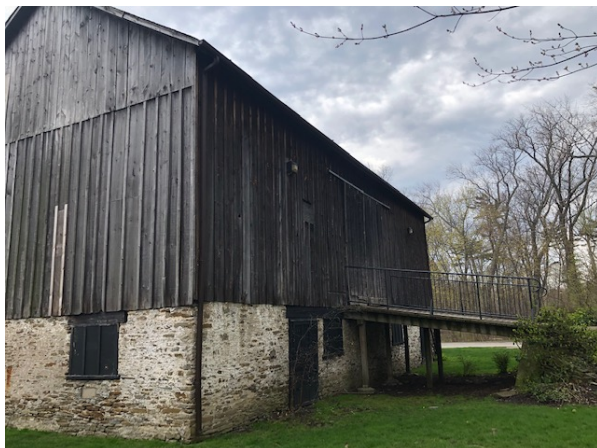
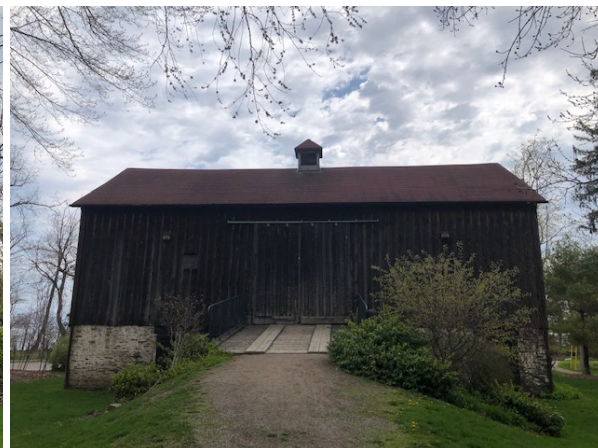
Images of southeast & east elevation – previously replaced boards and battens at south elevation

Wall siding has deteriorated beyond repairs at the east, north and west elevations. We propose to replace the deteriorated wood boards and battens with new to match south elevation boards and battens previously replaced.

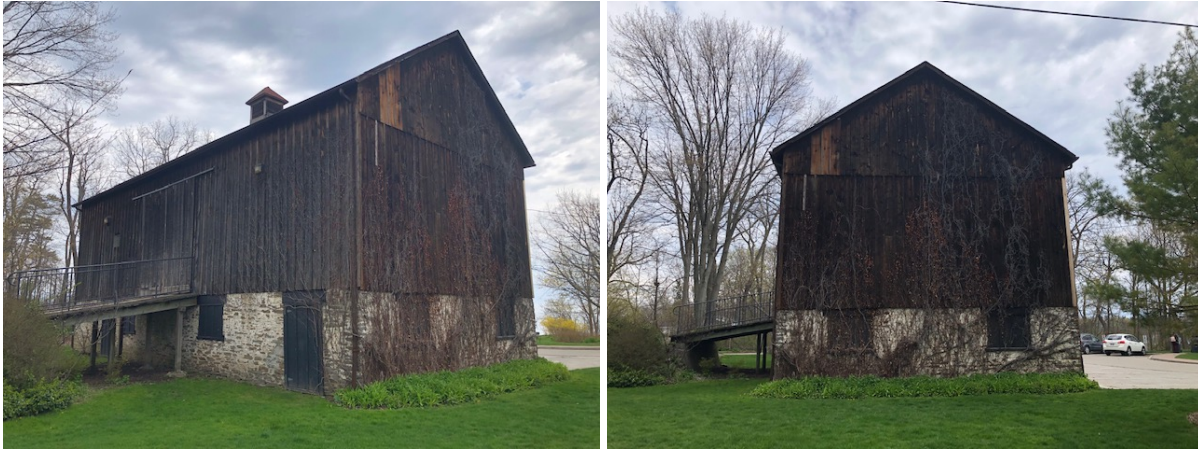
Images of northeast & north elevation

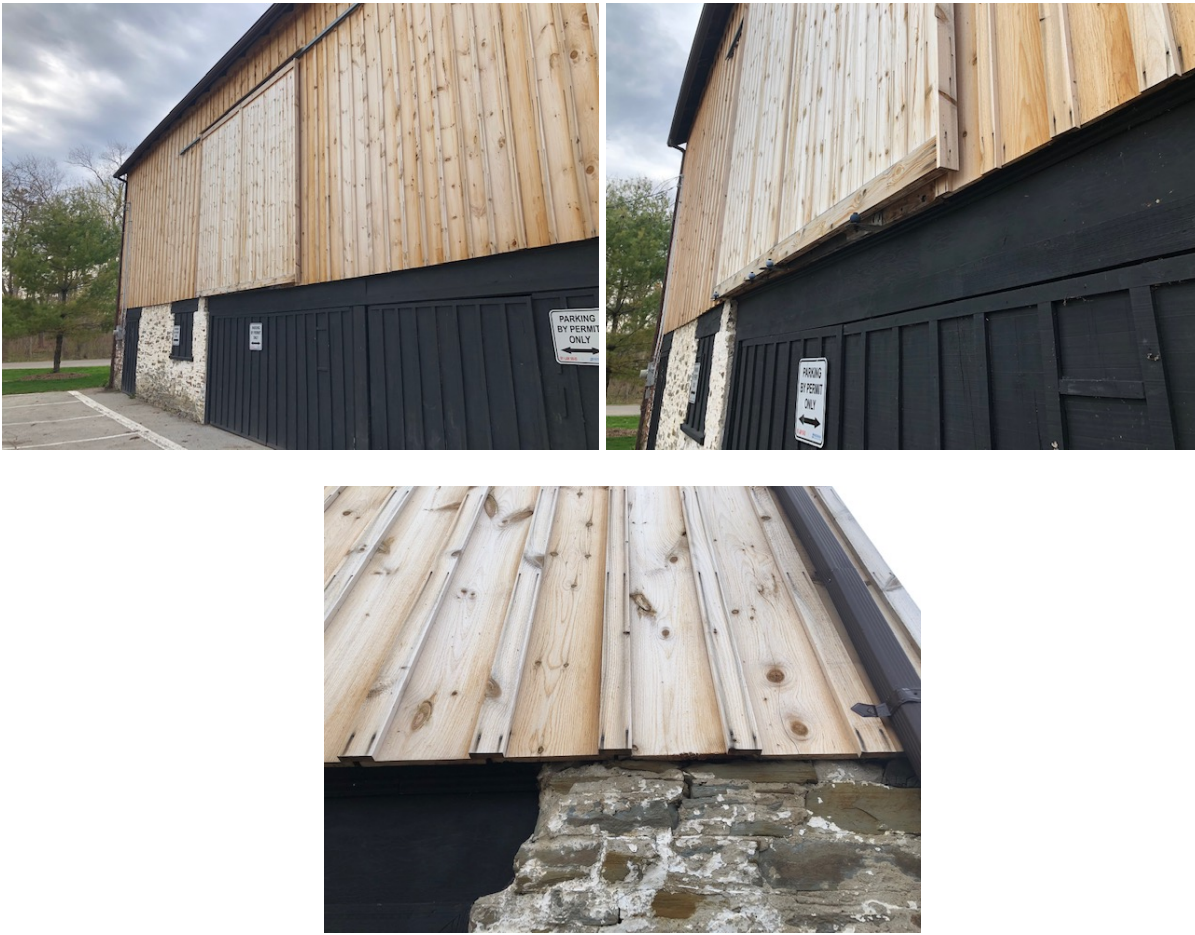
Images of typical board and batten deterioration found
