Heritage Property Application

Heritage Management Conservation Plan

Baird Sampson Neuert Architects (BSN) was engaged by the City of Mississauga to provide complete consulting and design services for Streetsville Kinsmen Hall, located at 327 Queen Street South, Mississauga, ON. The focus of BSN's services includes the conservation and repair of the deteriorated brick masonry on all building elevations, wood soffit refurbishment and repair, refurbishment of wood windows and doors, replacement of deteriorated hollow metal doors, asphalt roof replacement, removal of visible conduits and mechanical penetrations on the façades. Other work includes the replacement of a canopy and deteriorated ramp/stair system, all related to the rear entry (facing the parking lot), and the provision/upgrade of exterior lighting.

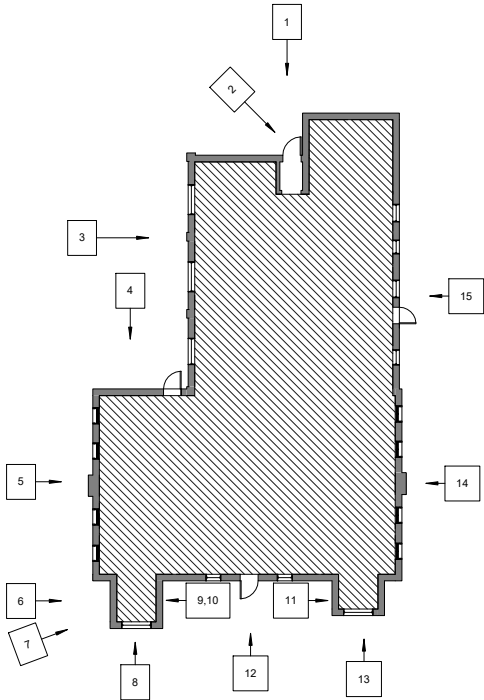
② PHOTO 2
1:25

Photo # 2: Overview of the south elevation of the building.

PREPARE SURFACES AND REPAINT FASCIAS AND SOFFIT

LOCALLY RAKE OUT AND REPOINT DETERIORATED MASONRY MORTAR JOINTS

WHOLESALE BRICK REPLACEMENT. BRICK REPLACEMENT MOCK-UP TO BE REVIEWED ON SITE TO ENSURE NEW BRICK MATCHES EXISTING HERITAGE BRICK

REFER TO DEMOLITION DRAWINGS FOR EXTENT OF CANOPY, RAMP, STAIR, HANDRAIL AND DOOR REMOVALS

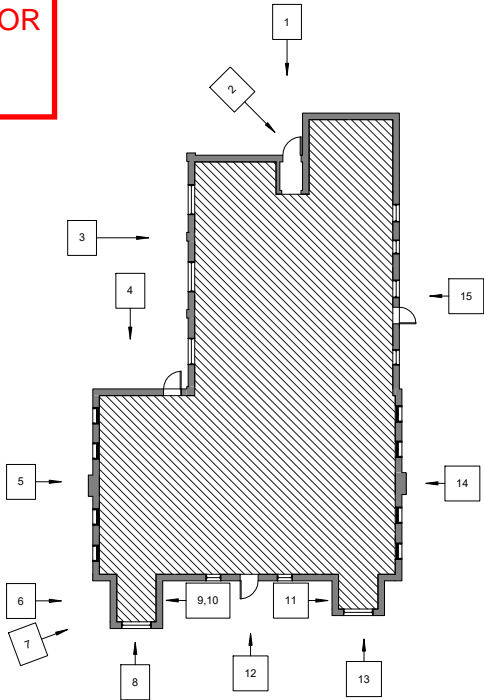
1 PHOTO 3
1:25

Photo # 3: Overview of the east elevation of the building.

REMOVE AND DISPOSE OF EXISTING ASPHALT ROOFING SYSTEM. SUPPLY AND INSTALL NEW ASPHALT SHINGLE ROOFING. TYPICAL ON ALL SLOPED ROOFS

LOCALLY RAKE OUT AND REPOINT DETERIORATED MASONRY MORTAR JOINTS

WHOLESALE BRICK REPLACEMENT. BRICK REPLACEMENT MOCK-UP TO BE REVIEWED ON SITE TO ENSURE NEW BRICK MATCHES EXISTING HERITAGE BRICK

REFER TO DEMOLITION DRAWINGS FOR EXTENT OF CANOPY, RAMP, STAIR, HANDRAIL AND DOOR REMOVALS

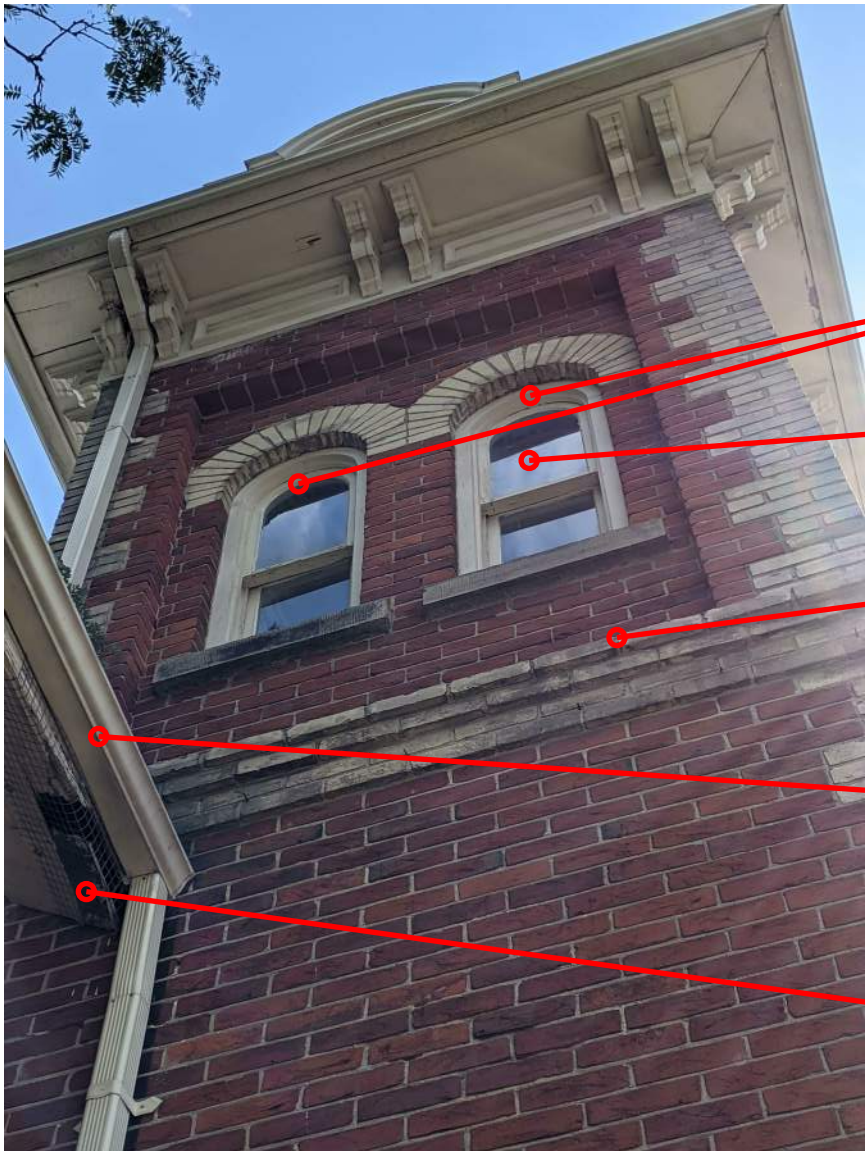
3 PHOTO 7
1:25

Photo # 7: Overview of spalling brick and efflorescence at the north elevation (original building, facing west).

EXISTING HERITAGE WINDOWS TO BE REFURBISHED AND REPAINTED

REMOVE AND REPLACE BROKEN WINDOW LITE TO MATCH EXISTING

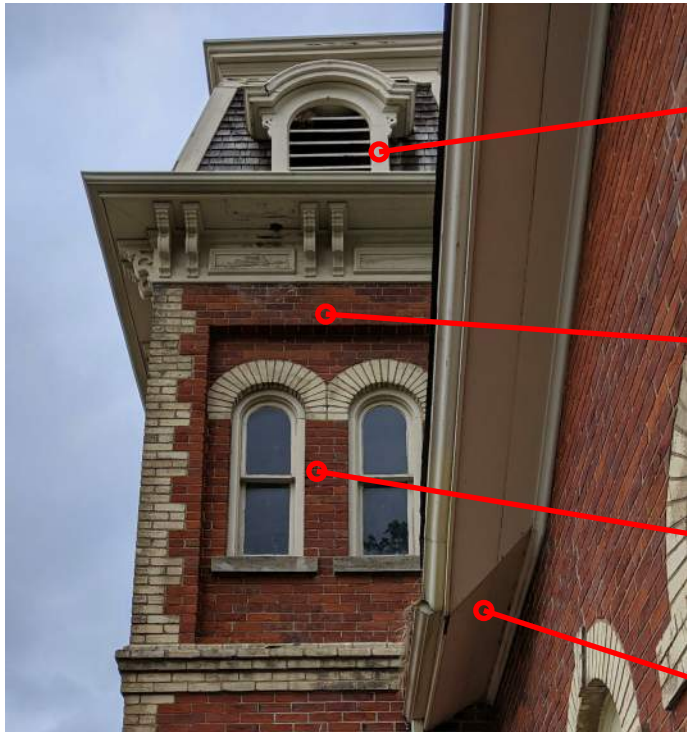
③ PHOTO 10
1 : 25

- .3 Brick and moisture deterioration as well as white staining (efflorescence) was observed to be concentrated approximately 12 inches above grade level at the north and east elevations (*Refer to Photo 10 in Appendix A*).

Photo # 10: White staining (efflorescence) was observed to be concentrated approximately 12 inches above grade level at the north and east elevations (original building).

PREPARE SURFACES AND PAINT
ALL EXISTING WOOD SURFACES

LOCALLY RAKE OUT AND REPOINT
DETERIORATED MASONRY
MORTAR JOINTS AS DIRECTED BY
CONSULTANT

LOCALLY REMOVE AND REPLACE
DETERIORATED MASONRY UNIT
AS DIRECTED BY THE
CONSULTANT

PREPARE SURFACES AND
REPAINT FASCIAS AND SOFFIT

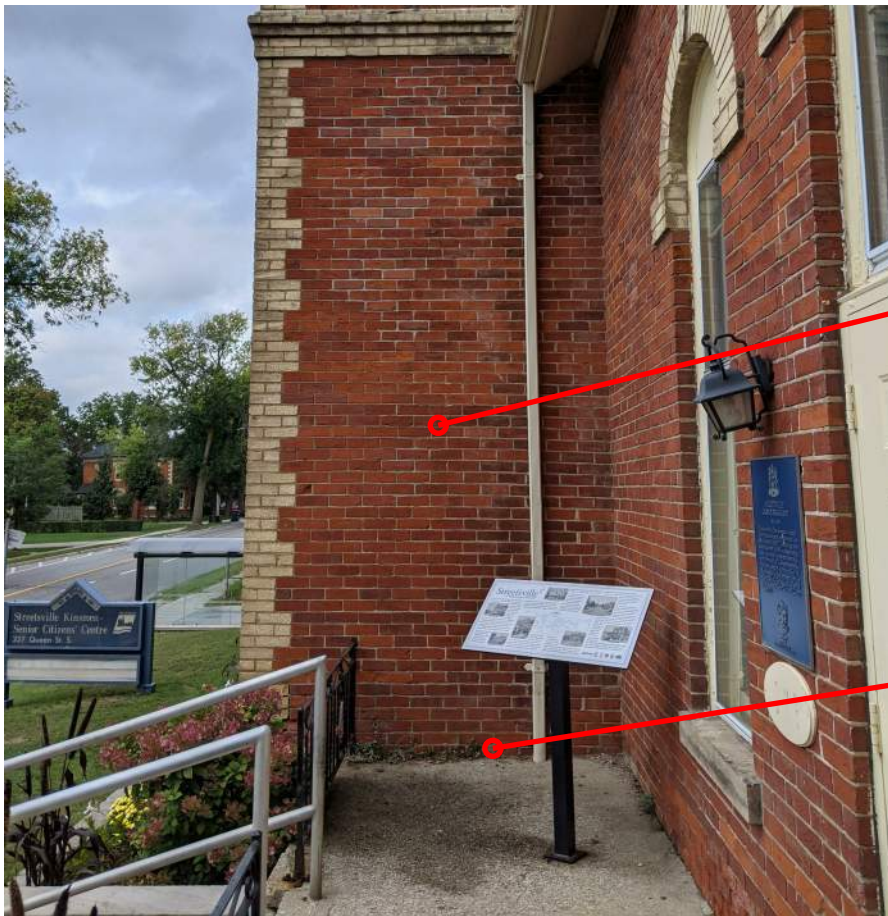
② PHOTO 9
1 : 25

Photo # 9: View of mortar deterioration at the grade level of the west elevation (west addition).

LOCALLY REMOVE AND REPLACE
DETERIORATED MASONRY UNIT AS
DIRECTED BY CONSULTANT

LOCALLY RAKE OUT AND REPOINT
DETERIORATED MASONRY
MORTAR JOINTS AS DIRECTED BY
CONSULTANT

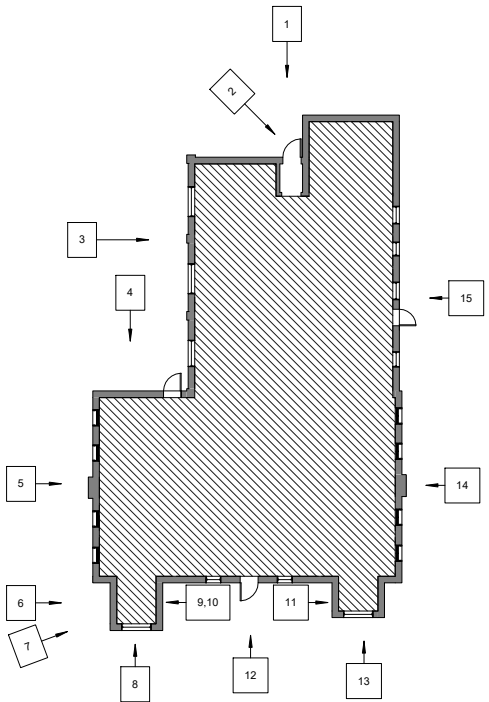
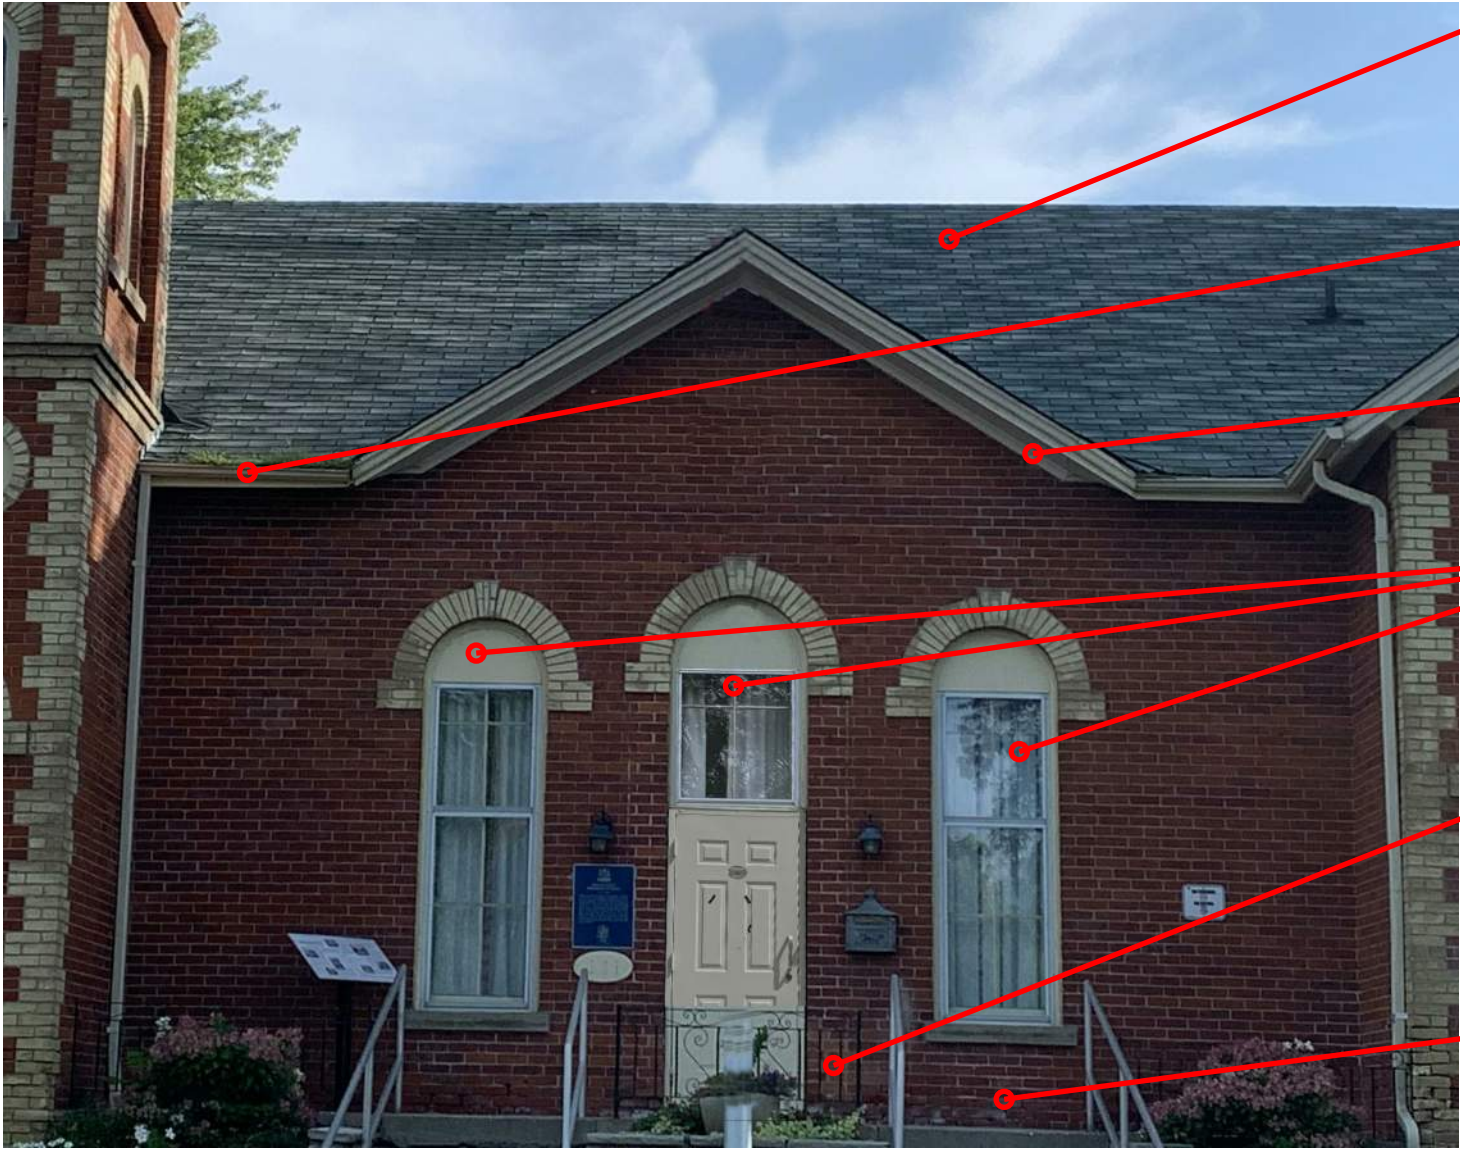
1 PHOTO 12
1:25

and signs of water washing deterioration in the area of the pilaster (*Refer to Photos 12 and 13 in Appendix A and Figures 3 and 4 in Appendix B*).

Photo # 12: View of step crack in the northeast corner pilaster at the east elevation (original building).

REMOVE AND DISPOSE OF EXISTING ASPHALT SHINGLE ROOFING SYSTEM. SUPPLY AND INSTALL NEW ASPHALT SHINGLE ROOFING TO MATCH

REMOVE AND DISPOSE OF EXISTING GUTTERS AND DOWNPIPES. SUPPLY AND INSTALL NEW

LOCALLY REMOVE AND REPLACE DETERIORATED MASONRY UNIT AS DIRECTED BY CONSULTANT

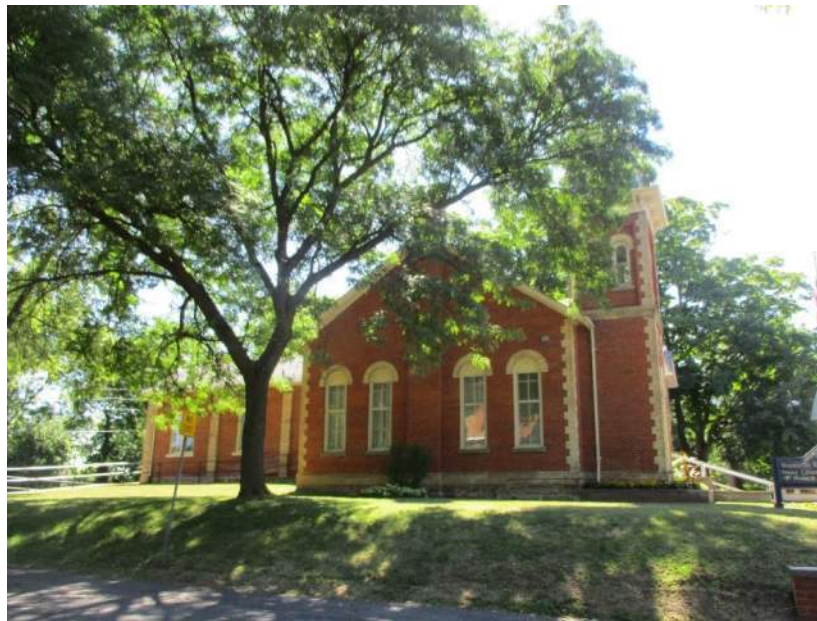
Photo # 4: Overview of the north elevation of the building.

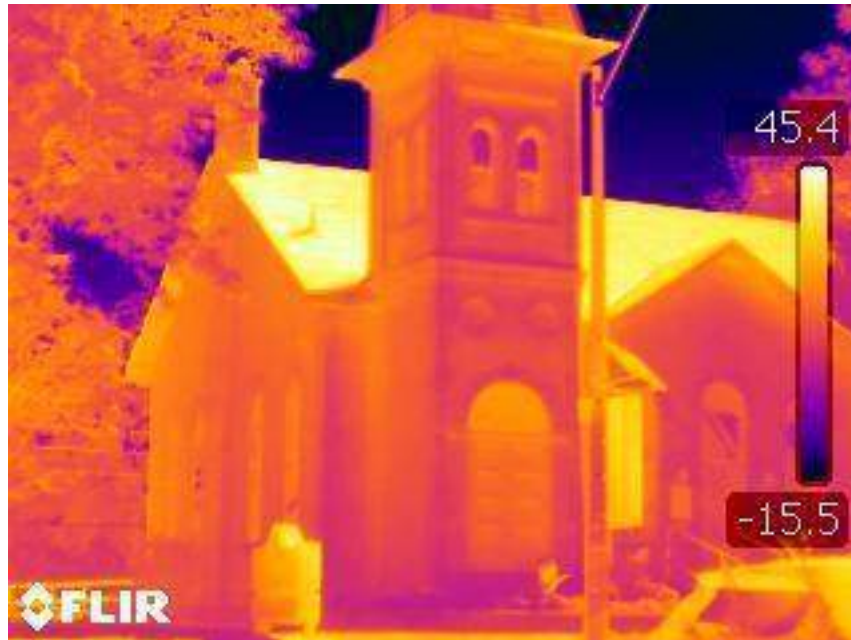
Photo # 29: Overview of northwest elevation. No thermal anomalies identified.

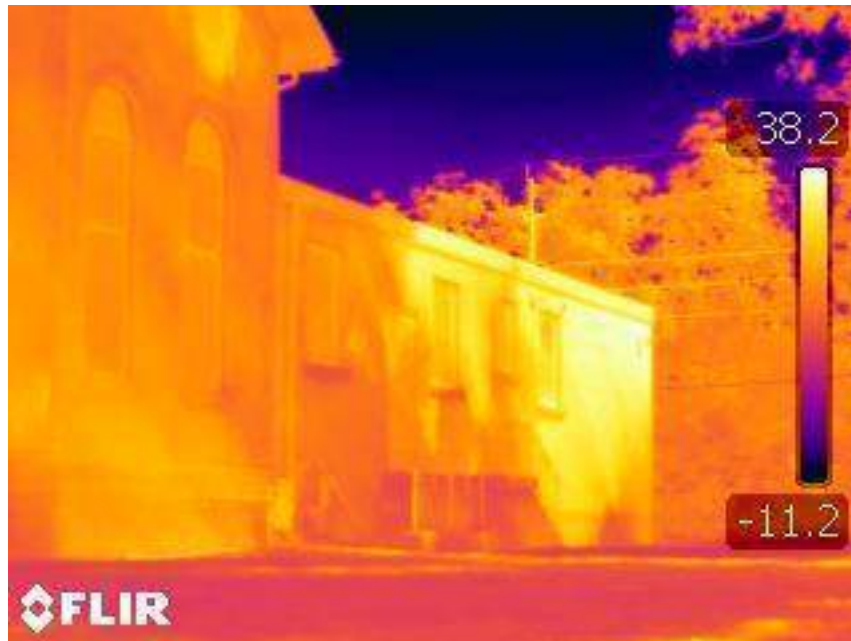
Photo # 30: Overview of south elevation of southeast addition

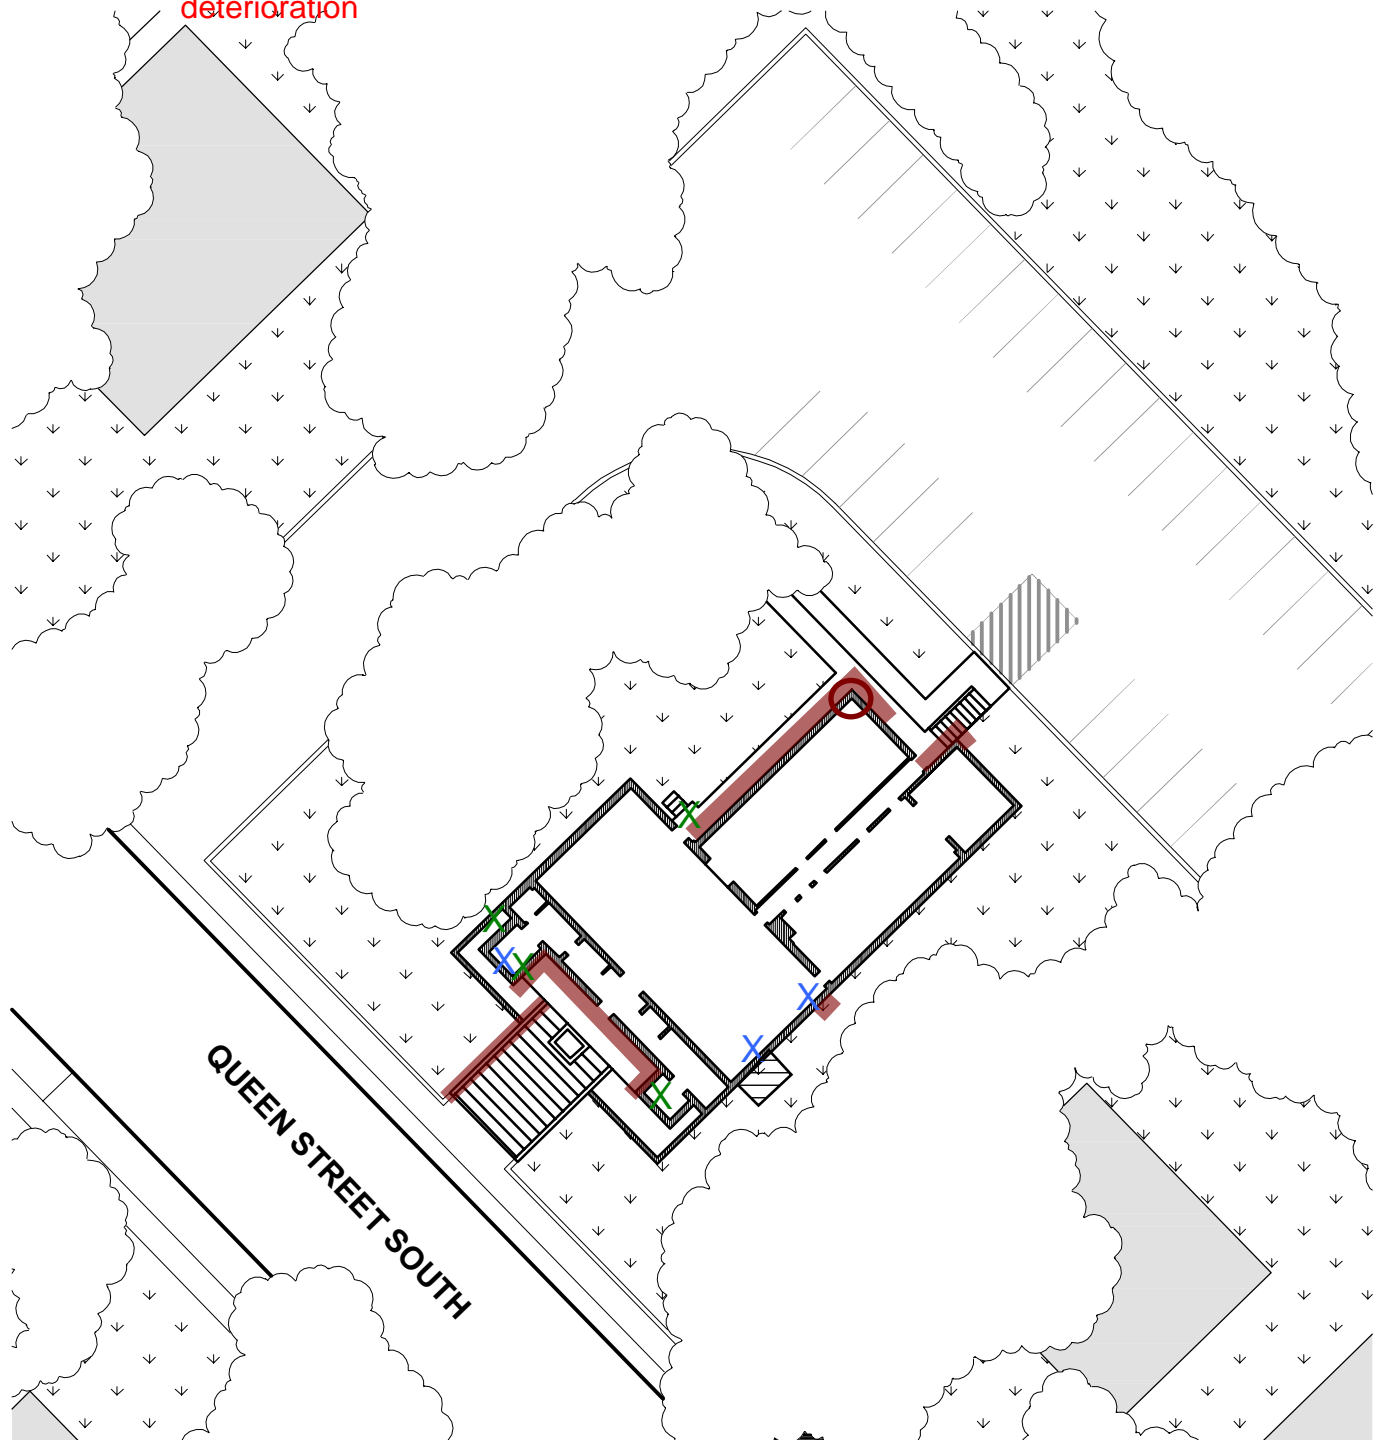
Figure 2.0 - Key observations - Ground floor

- Masonry deterioration
- Negative Drainage
- X Cracked Glass
- X Soffit deterioration
- Northeast pilaster deterioration

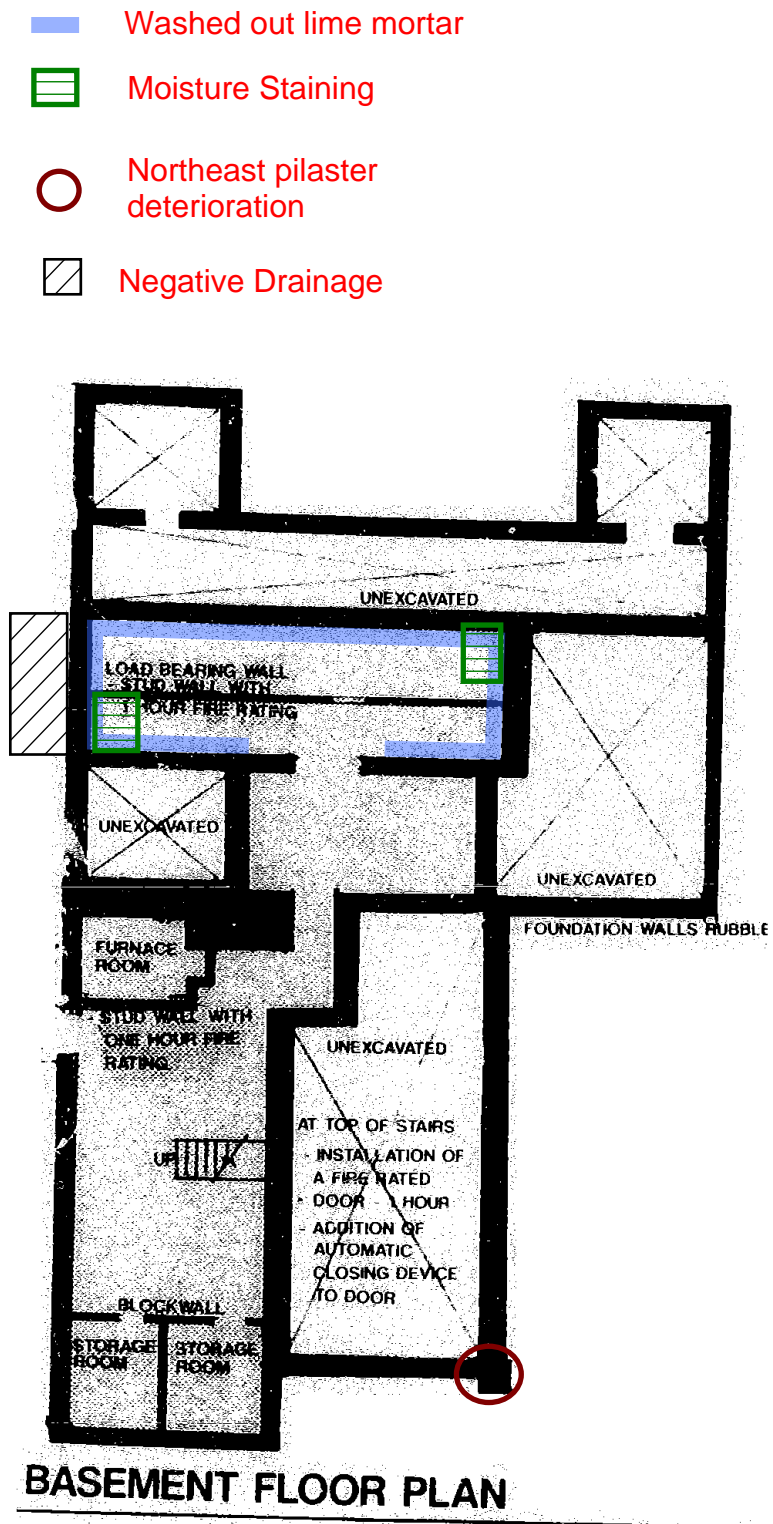
Figure 3.0 - Key observations - Below grade

- .2 The rubble foundation walls at the northern end of the building (*Refer to Figure 3 in Appendix B*) were observed to be exhibiting signs of deterioration in the forms of washed out lime based mortar and moisture staining at the floor level (*Refer to Photo 27 in Appendix A*).
