Heritage Property Application

1- Introduction

Baird Sampson Neuert Architects (BSN) was engaged by the City of Mississauga to provide complete consulting and design services for Streetsville Kinsmen Hall, located at 327 Queen Street South, Mississauga, ON. The focus of BSN's services includes the conservation and repair of the deteriorated brick masonry on all building elevations, wood soffit refurbishment and repair, refurbishment of wood windows and doors, replacement of deteriorated hollow metal doors, asphalt roof replacement, removal of visible conduits and mechanical penetrations on the façades. Other work includes the replacement of a canopy and deteriorated ramp/stair system, all related to the rear entry (facing the parking lot), and the provision/upgrade of exterior lighting.

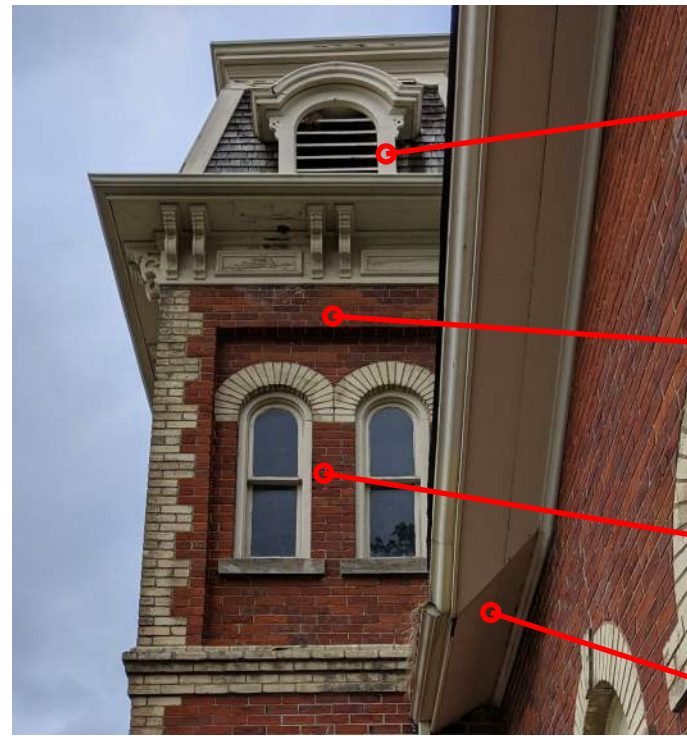
③ PHOTO 10
1 : 25

- .3 Brick and moisture deterioration as well as white staining (efflorescence) was observed to be concentrated approximately 12 inches above grade level at the north and east elevations (*Refer to Photo 10 in Appendix A*).

Photo # 10: White staining (efflorescence) was observed to be concentrated approximately 12 inches above grade level at the north and east elevations (original building).

PREPARE SURFACES AND PAINT
ALL EXISTING WOOD SURFACES

LOCALLY RAKE OUT AND REPOINT
DETERIORATED MASONRY
MORTAR JOINTS AS DIRECTED BY
CONSULTANT

LOCALLY REMOVE AND REPLACE
DETERIORATED MASONRY UNIT
AS DIRECTED BY THE
CONSULTANT

PREPARE SURFACES AND
REPAINT FASCIAS AND SOFFIT

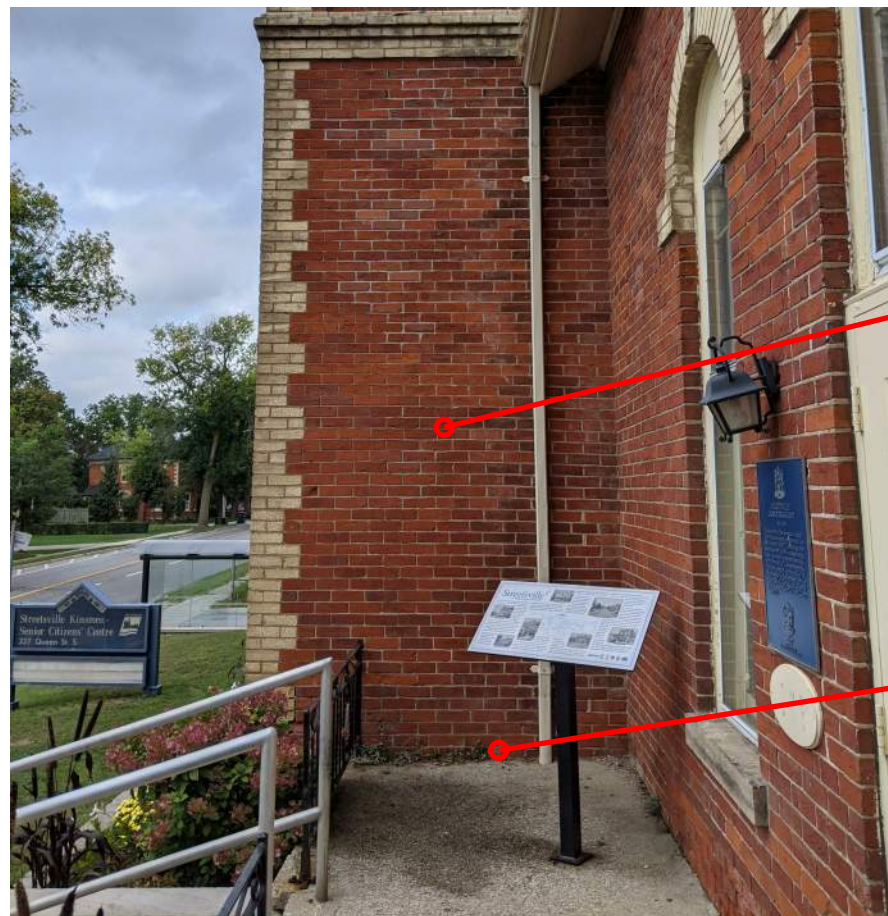
② PHOTO 9
1 : 25

Photo # 9: View of mortar deterioration at the grade level of the west elevation (west addition).

LOCALLY REMOVE AND REPLACE
DETERIORATED MASONRY UNIT AS
DIRECTED BY CONSULTANT

LOCALLY RAKE OUT AND REPOINT
DETERIORATED MASONRY
MORTAR JOINTS AS DIRECTED BY
CONSULTANT

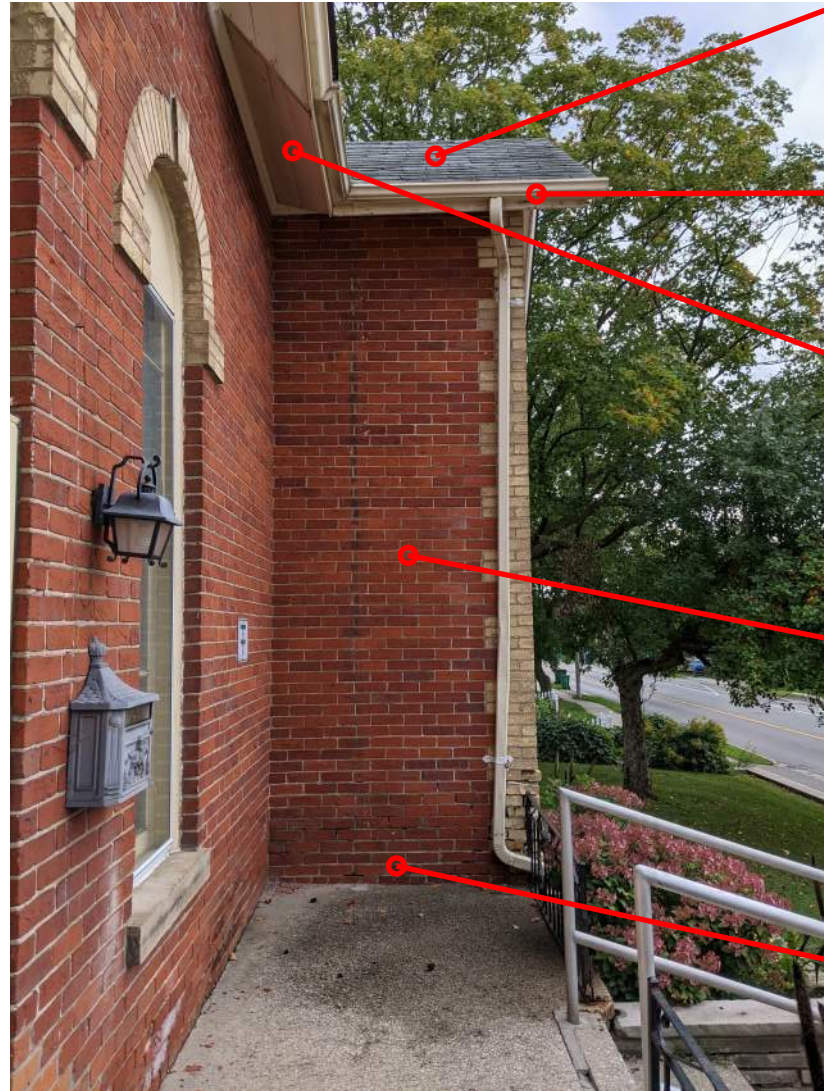
4 PHOTO 11
1 / 25

- .4 The exterior face of the brick masonry at the north and east elevation was observed to have a rough texture that appeared to be the result of a previous sandblasting program, that has weakened the brick masonry (*Refer to Photo 11 in Appendix A*).

Photo # 11: View of the brick masonry at the east elevation. The masonry was observed to have a rough texture that appeared to be the result of sandblasting (original building).

REMOVE AND DISPOSE OF EXISTING ASPHALT SHINGLE ROOFING SYSTEM. SUPPLY AND INSTALL NEW ASPHALT SHINGLE ROOFING TO MATCH

REMOVE AND DISPOSE OF EXISTING GUTTERS AND DOWNPIPES. SUPPLY AND INSTALL NEW

LOCALLY REMOVE AND REPLACE DETERIORATED MASONRY UNIT AS DIRECTED BY CONSULTANT

LOCALLY RAKE OUT AND REPOINT DETERIORATED MASONRY MORTAR JOINTS AS DIRECTED BY CONSULTANT

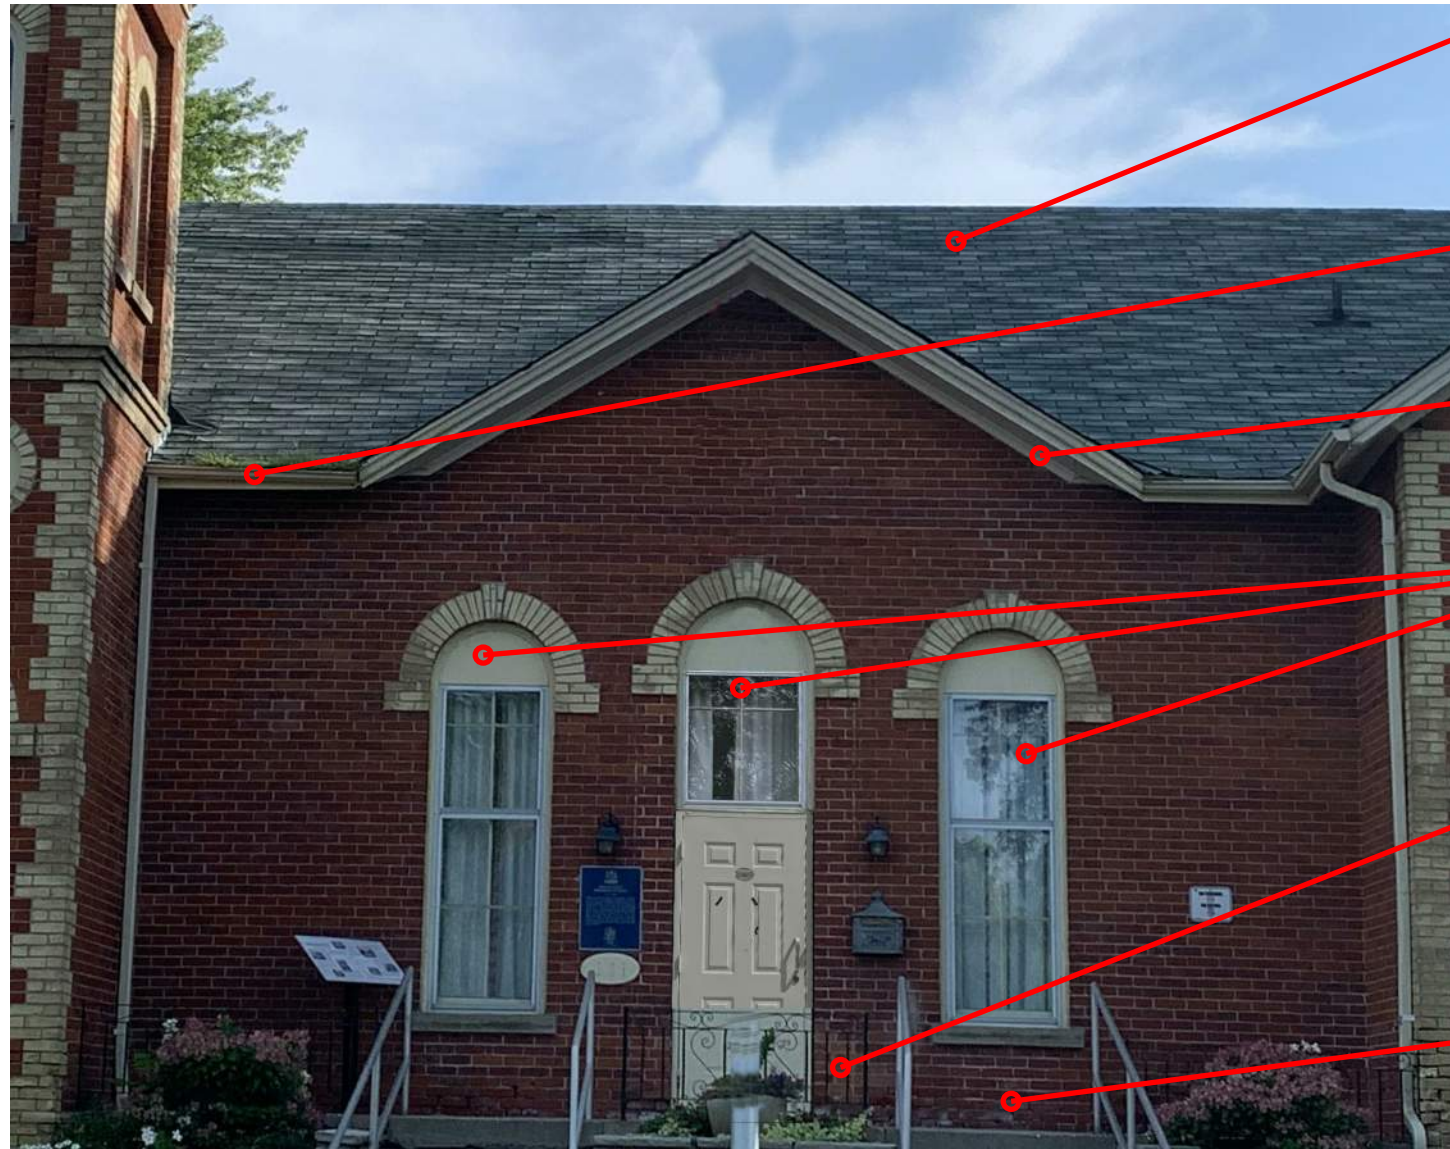
1 PHOTO 12
1:25

Photo # 12: View of step crack in the northeast corner pilaster at the east elevation (original building).

REMOVE AND DISPOSE OF EXISTING ASPHALT SHINGLE ROOFING SYSTEM. SUPPLY AND INSTALL NEW ASPHALT SHINGLE ROOFING TO MATCH

REMOVE AND DISPOSE OF EXISTING GUTTERS AND DOWNPIPES. SUPPLY AND INSTALL NEW

LOCALLY RAKE OUT AND REPOINT DETERIORATED MASONRY MORTAR JOINTS AS DIRECTED BY CONSULTANT

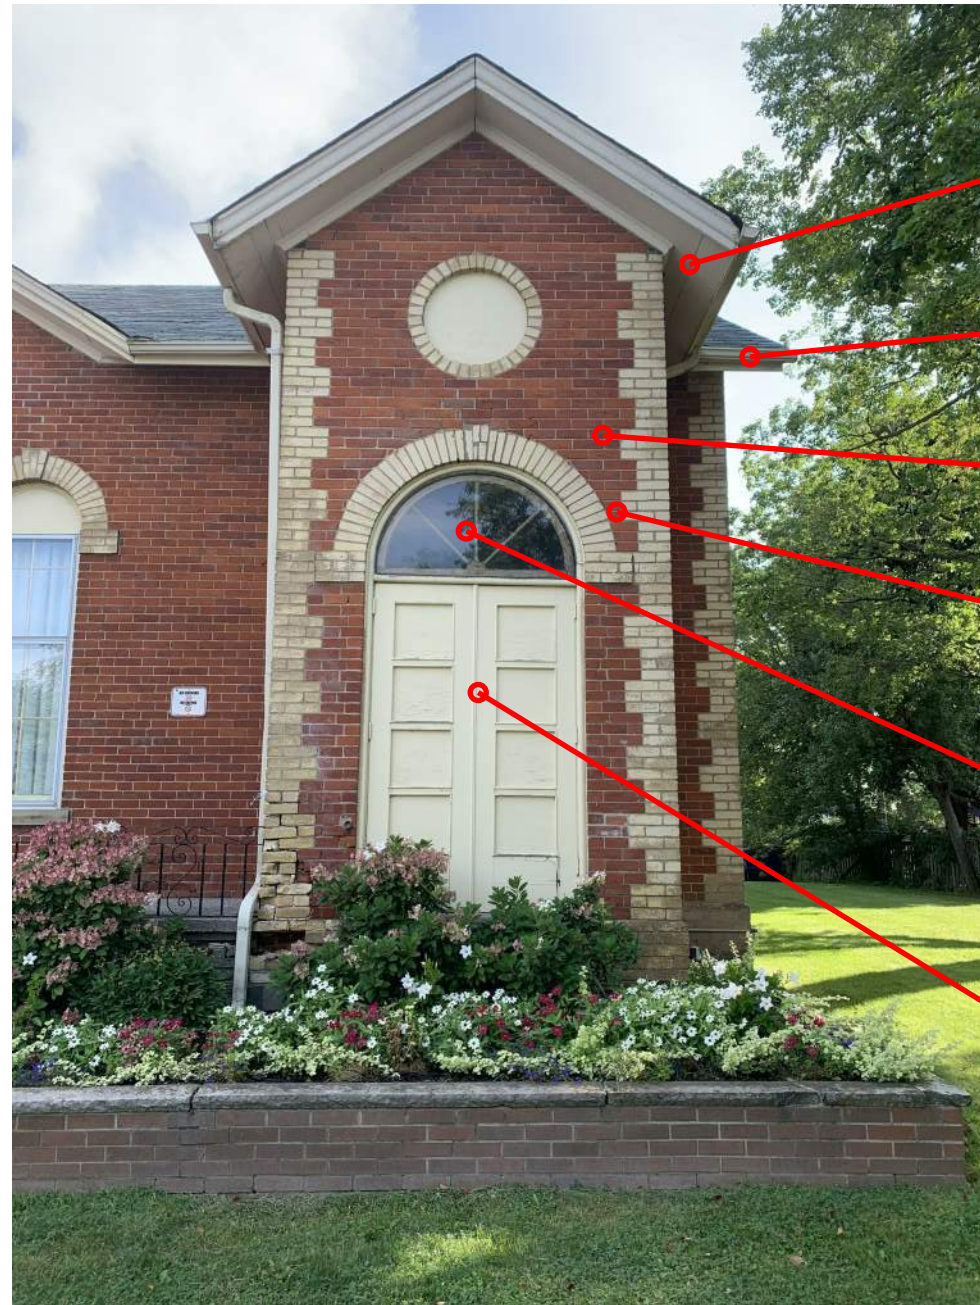
② PHOTO 13
1 : 25

Photo # 13: View of step crack continuing through masonry brick at east elevation and mortar deterioration.

PREPARE SURFACES AND
REPAINT FASCIAS AND SOFFIT

REMOVE AND DISPOSE OF
EXISTING GUTTERS AND
DOWNPIPES. SUPPLY AND
INSTALL NEW

REMOVE AND DISPOSE OF
EXISTING WOODEN DOOR. NEW
WOOD DOOR TO MATCH PROFILE
AND COLOR OF ORIGINAL DOORS
DOCUMENTED IN HISTORIC
PHOTOS

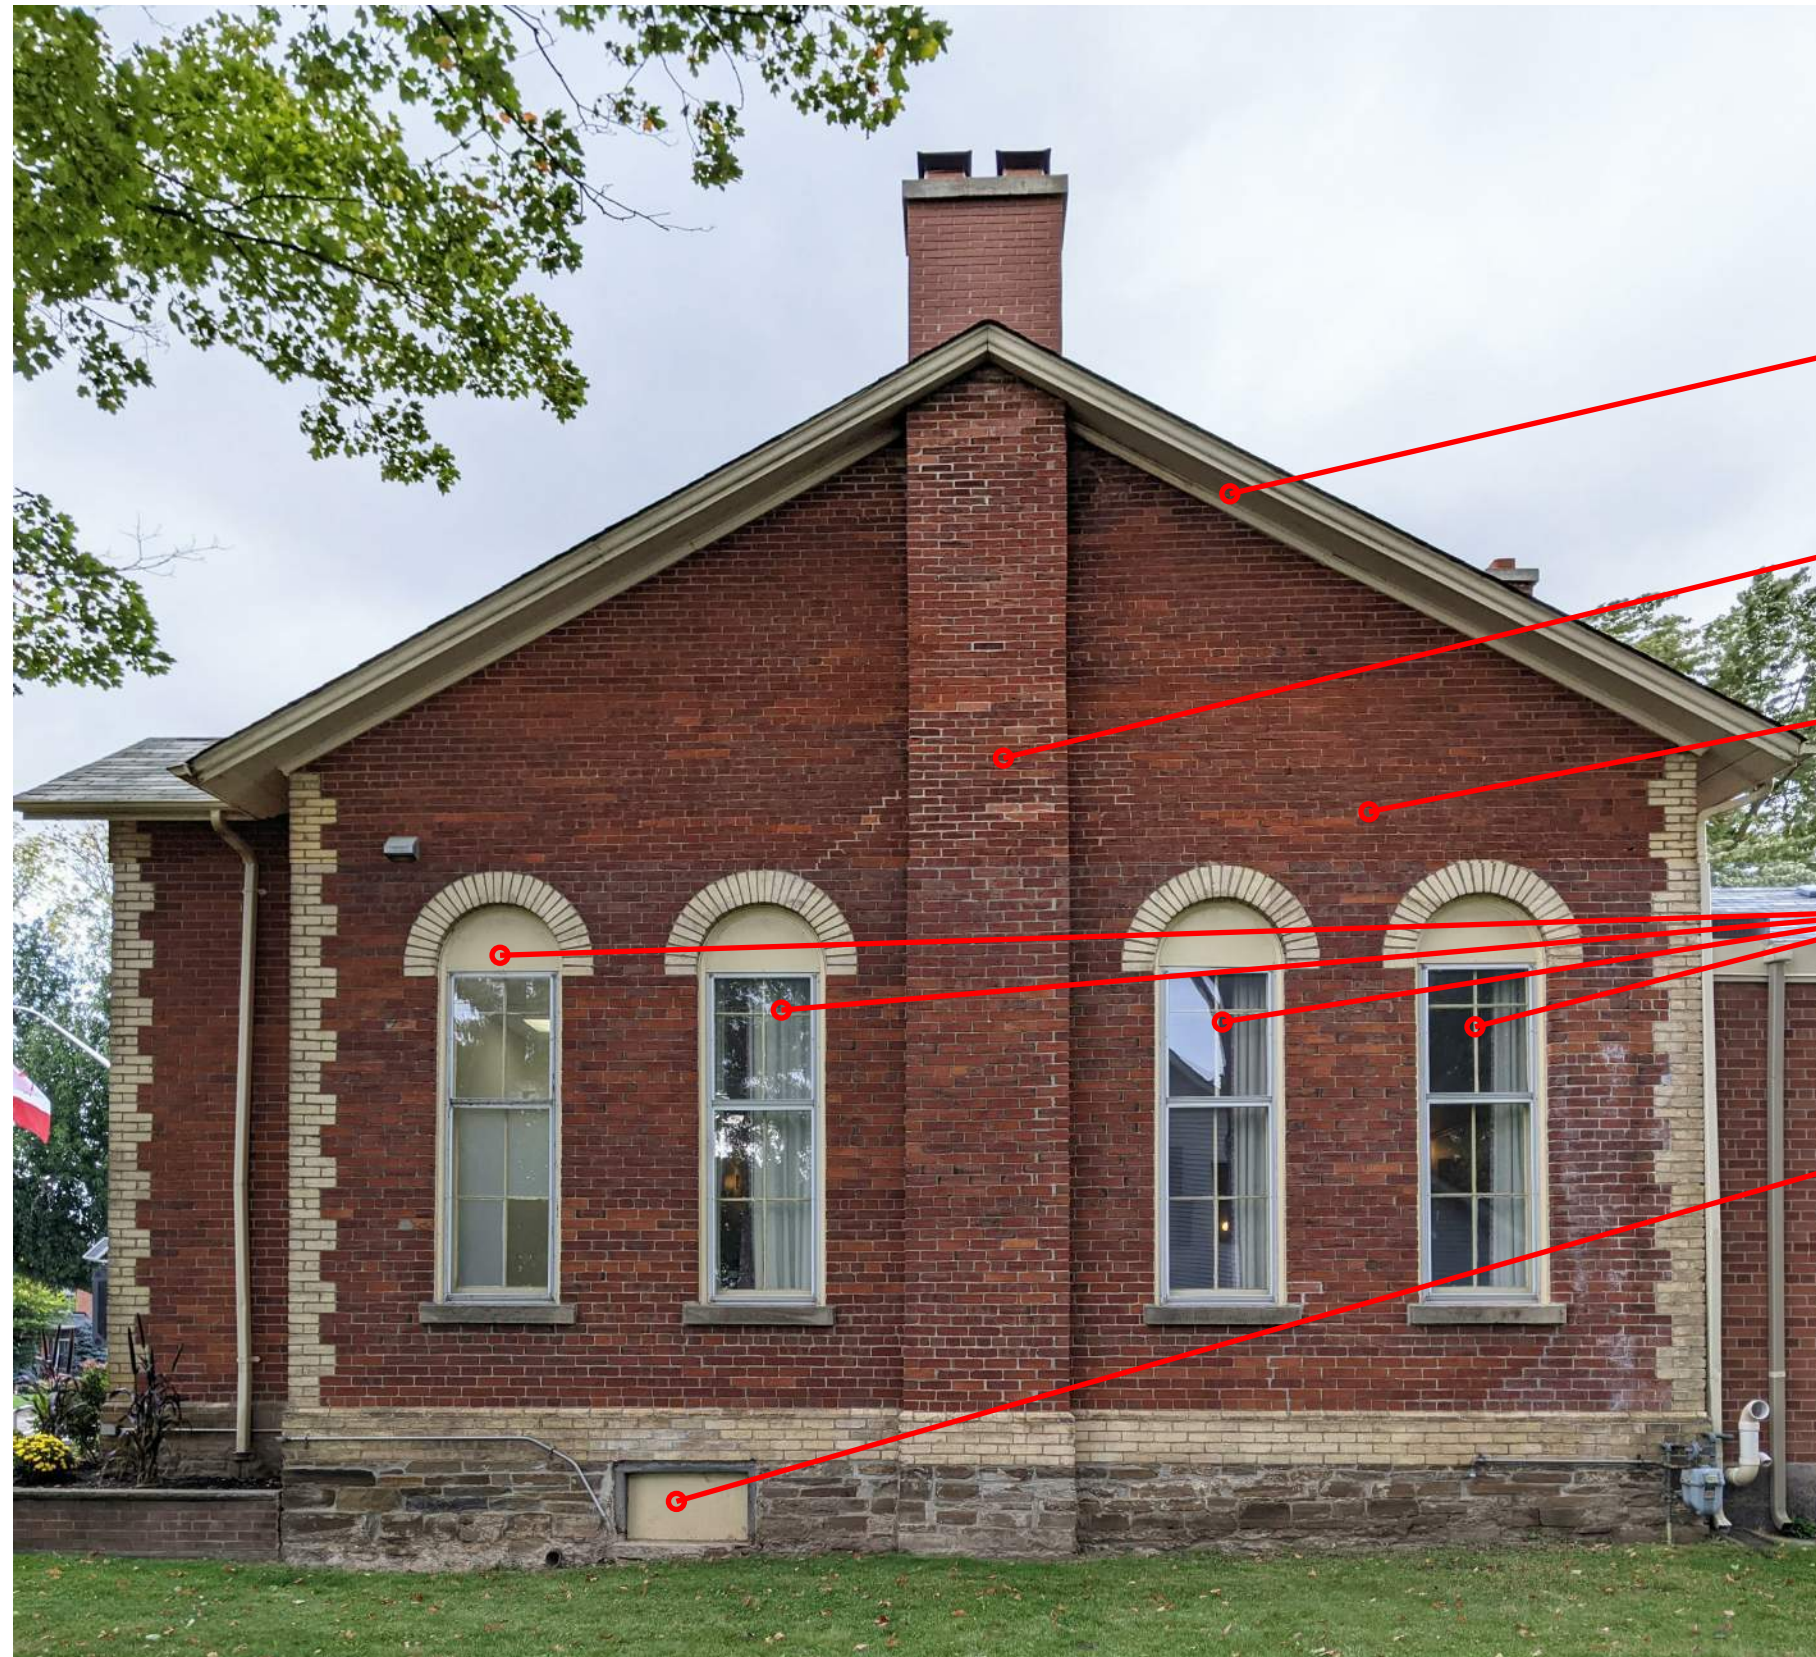
① PHOTO 14
1:25

- .7 A rain water leader was observed to be present next to the north-east corner pilaster at the north elevation and appeared to feed into and underneath the access ramp and drains onto the grass (not connected to the sewer system) (*Refer to Photo 14 in Appendix A*).

Photo # 14: A rain water leader was observed to be present next to the north-east corner pilaster at the north elevation and appeared to run underneath the access ramp.

PREPARE SURFACES AND
REPAINT FASCIAS AND SOFFIT

LOCALLY REMOVE AND REPLACE
DETERIORATED MASONRY UNIT AS
DIRECTED BY CONSULTANT

EXISTING HERITAGE WINDOWS TO
BE REFURBISHED AND
REPAINTED. EXISTING STORM
WINDOWS AND PERIMETER
SEALANTS TO REMAIN.

REMOVE AND DISPOSE OF
EXISTING WINDOW FRAME. FILL IN
ROUGH OPENING WITH MASONRY
TO MATCH

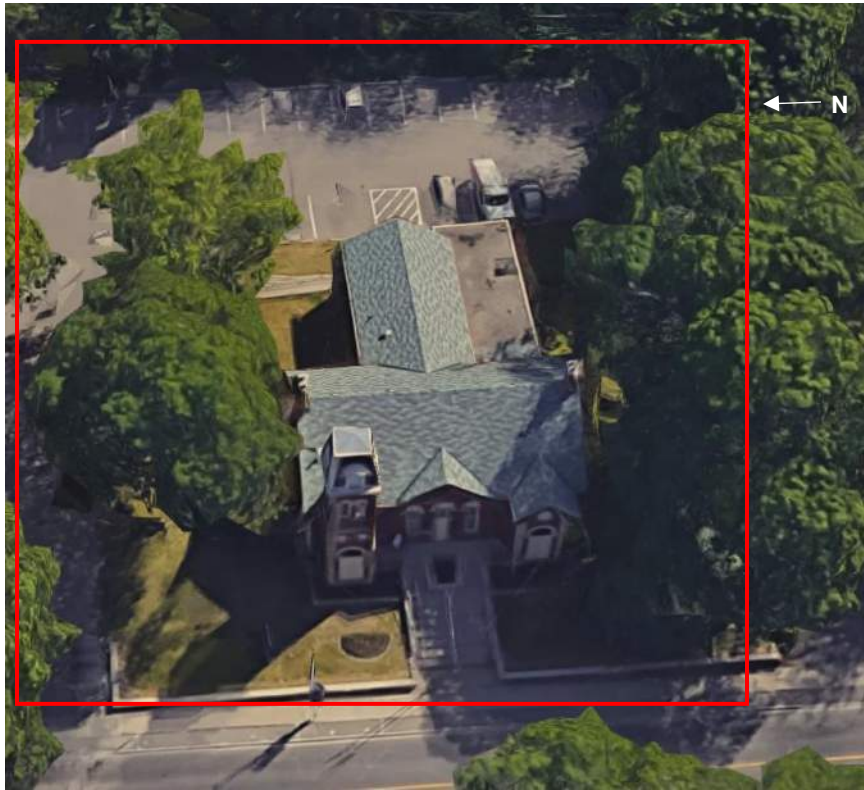
Photo # 1: Overview of site at 321 Queen Street South , Mississauga, ON (red line).

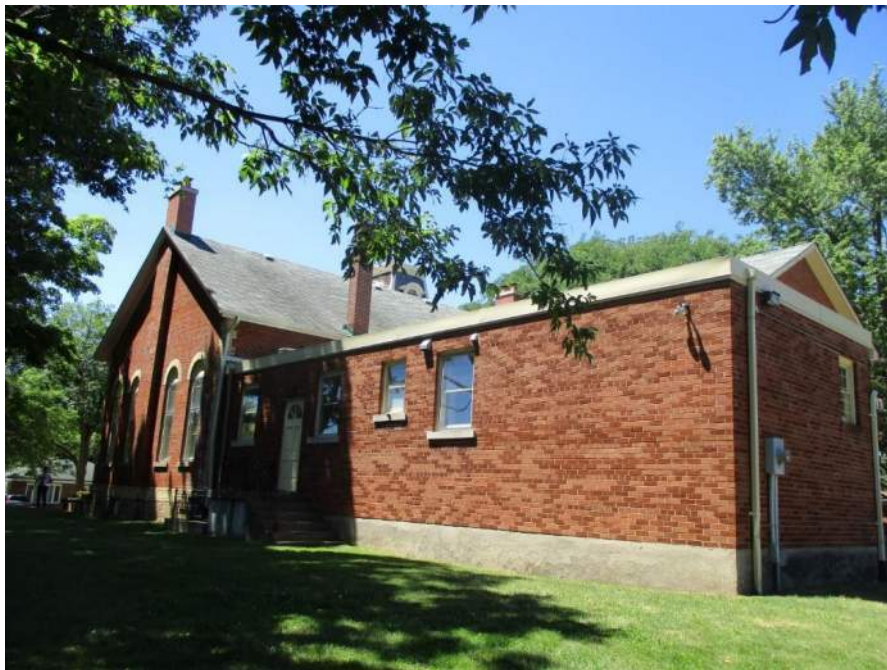
Photo # 2: Overview of the south elevation of the building.

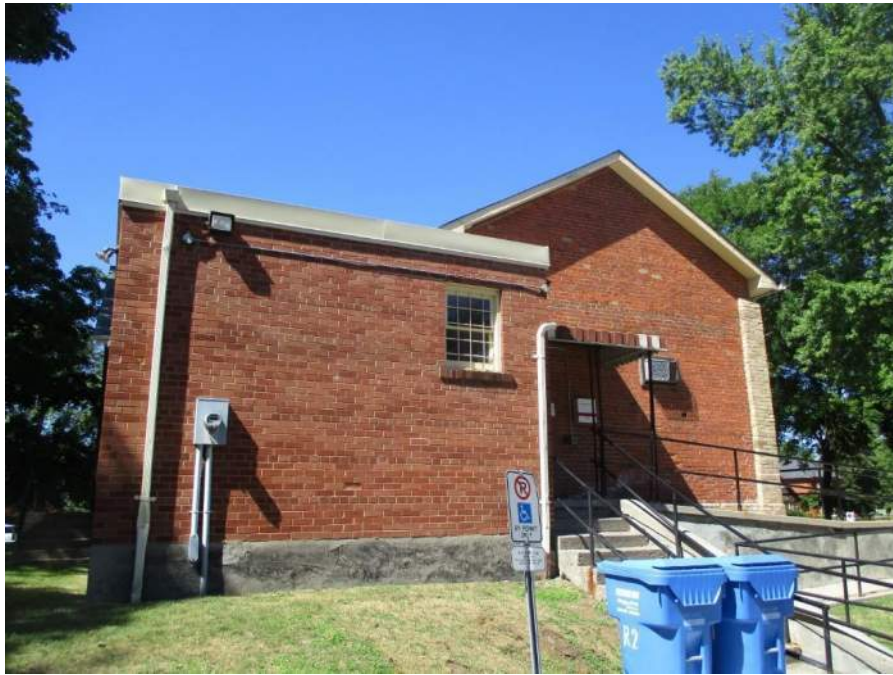
Photo # 3: Overview of the east elevation of the building.

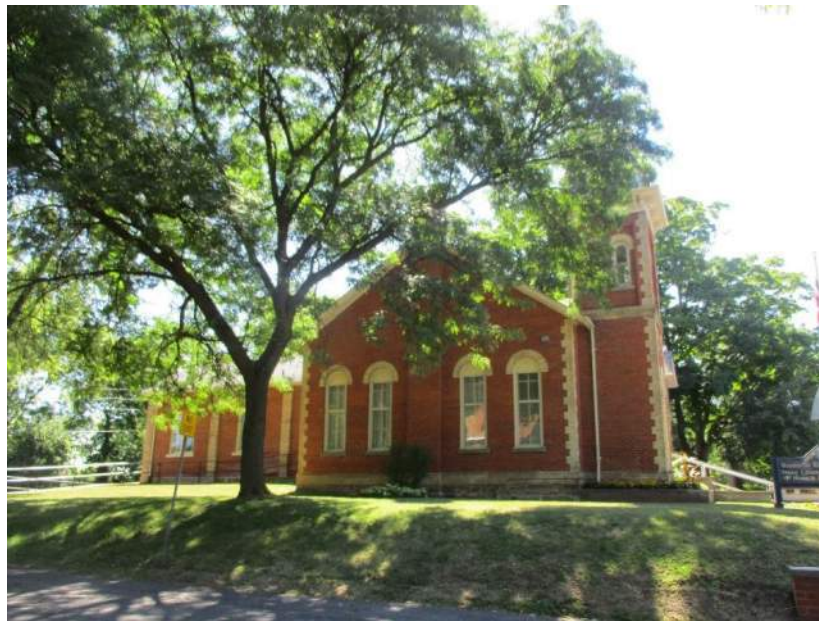
Photo # 4: Overview of the north elevation of the building.

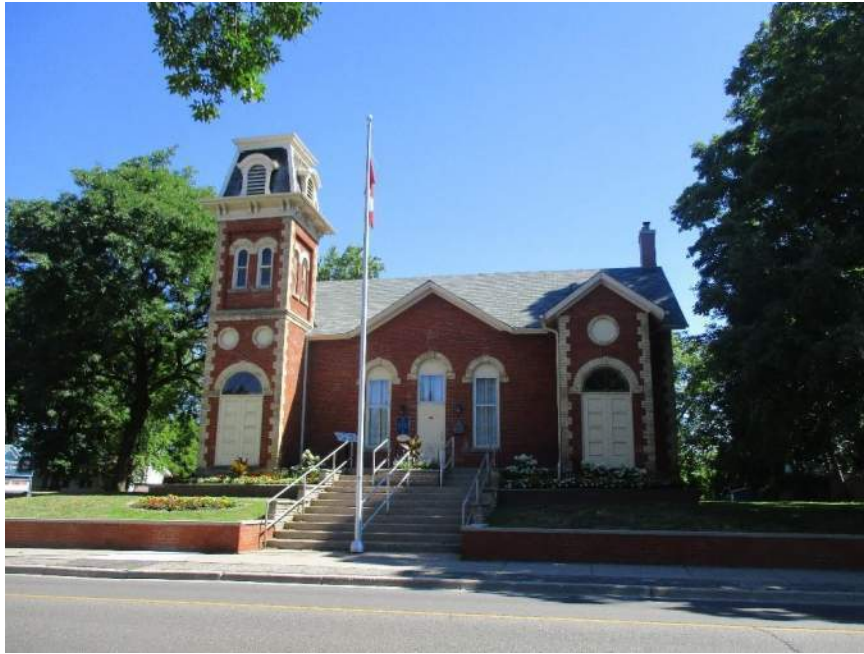
Photo # 5: Overview of the west elevation of the building.

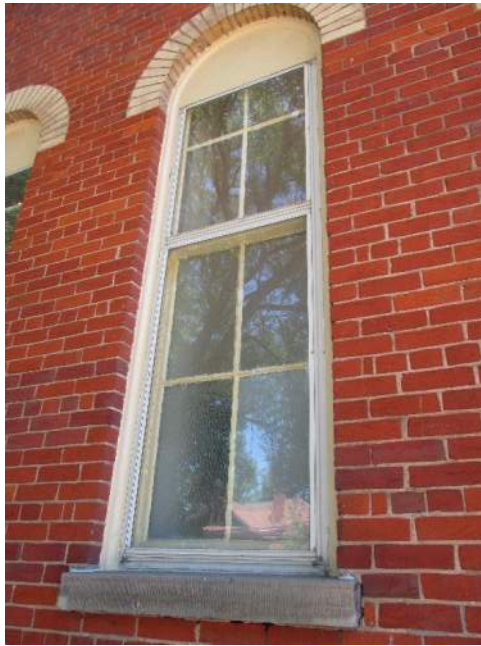
- .13 The glazing at the building was observed to be single pane single hung windows in wood frames, and appeared to be of the original building construction. Arches were observed at the window head at the western building construction (west addition). Exterior storm windows in aluminum frames are present at the majority of the windows. The operables did not appear to be functioning and the windows were observed to be sealed shut and painted over. The windows appeared to be in fair condition and were observed to have mild paint peeling and deterioration consistent with their age and exposure (*Refer to Photo 19 in Appendix A*).

Photo # 19: View of typical single hung wood framed window with masonry arches and exterior aluminum framed storm windows at the exterior (south elevation of west addition).

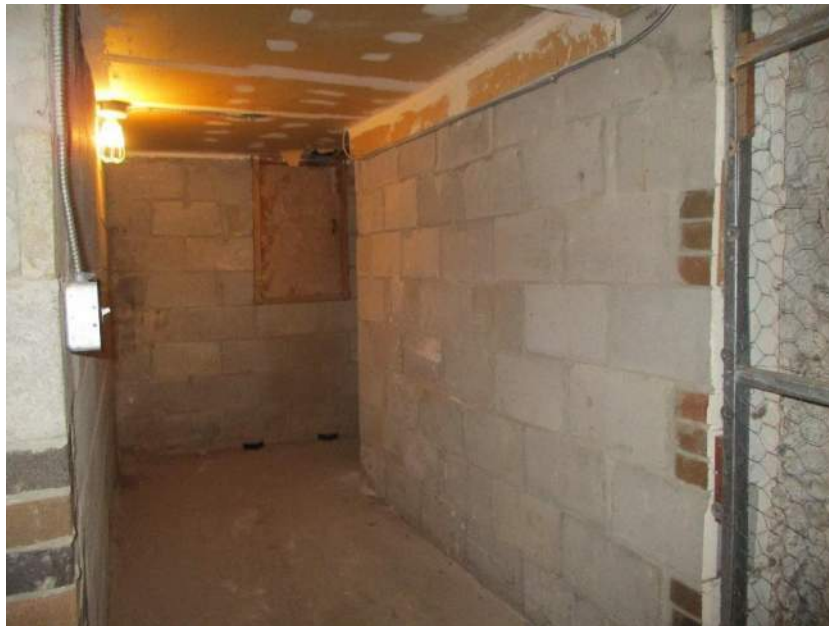
- .1 The foundation walls were visually reviewed from the interior. The west and north building constructions were observed to have rubble foundation walls and the newer addition at the south east elevation was observed to have concrete masonry unit foundation walls. Some areas have full height basement while others are unexcavated and have a dirt floor crawl space (*Refer to figure 2 in Appendix B*). As such, some walls were visible for review while others were not (*Refer to Photo 25 and 26 in Appendix A*).

Photo # 26: View of typical concrete masonry unit foundation in the newer addition to the building (interior hallway, south addition).

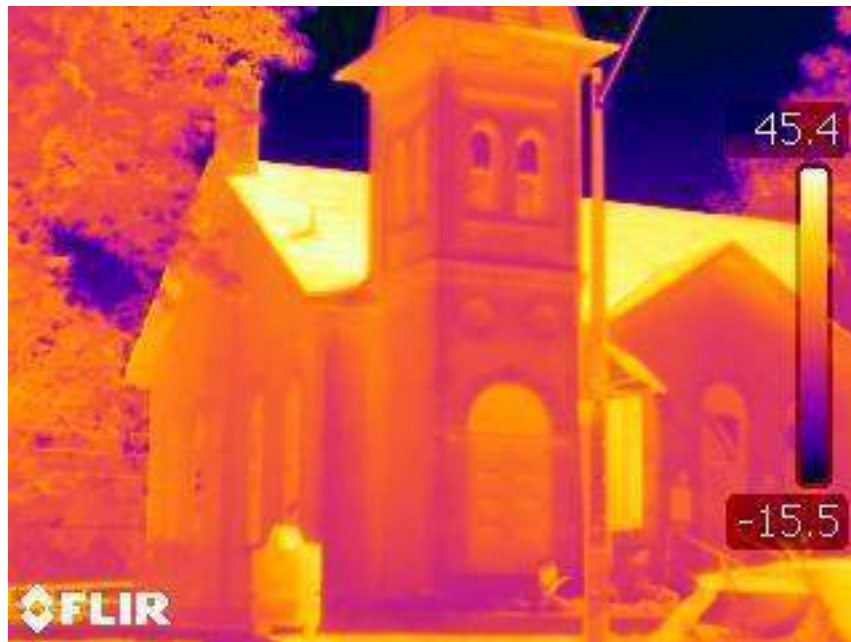
Photo # 29: Overview of northwest elevation. No thermal anomalies identified.

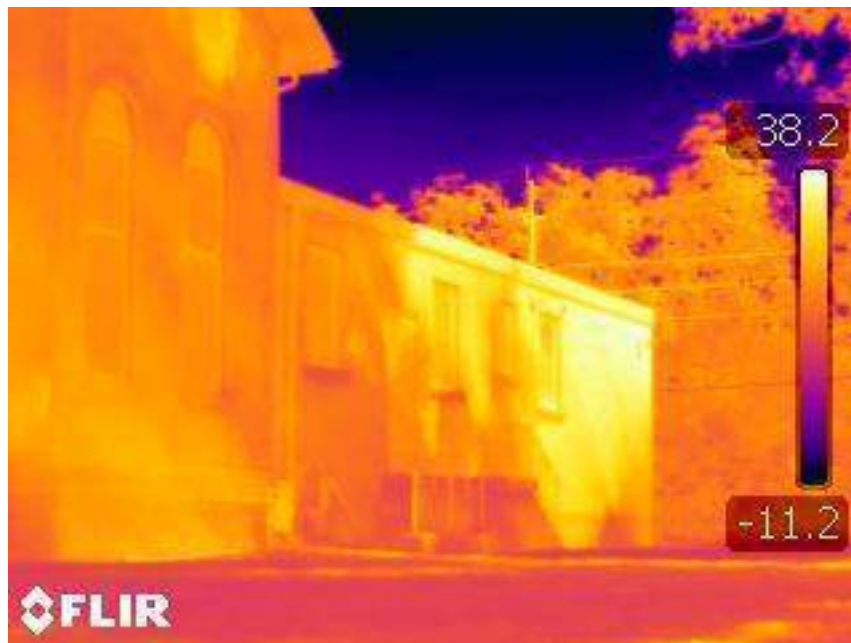
Photo # 30: Overview of south elevation of southeast addition

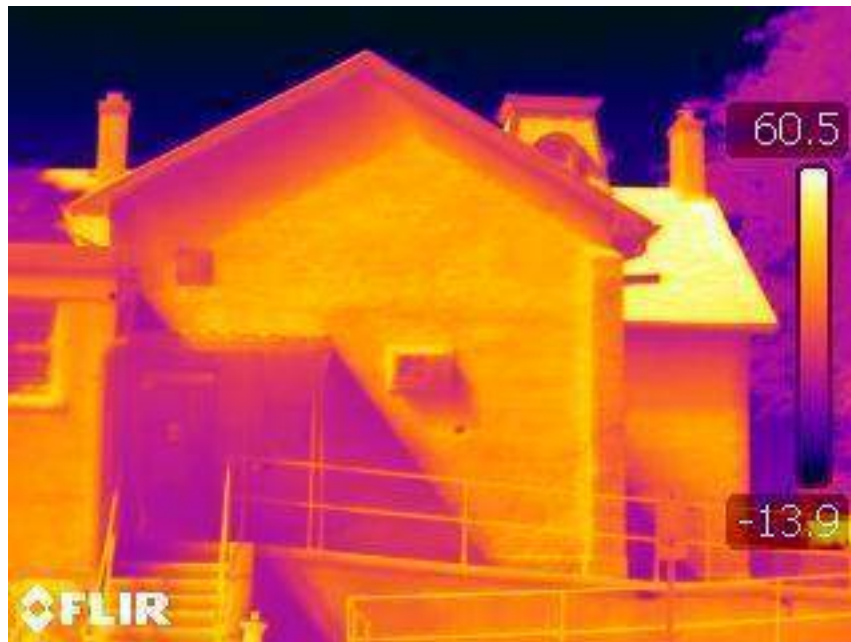
Photo # 31: View east elevation

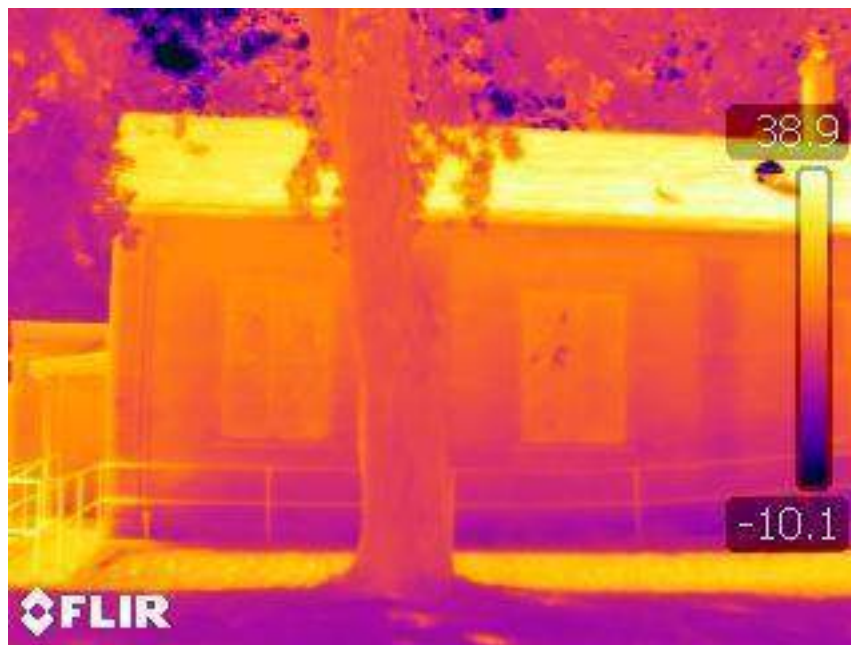
Photo # 32: View of north elevation of original building

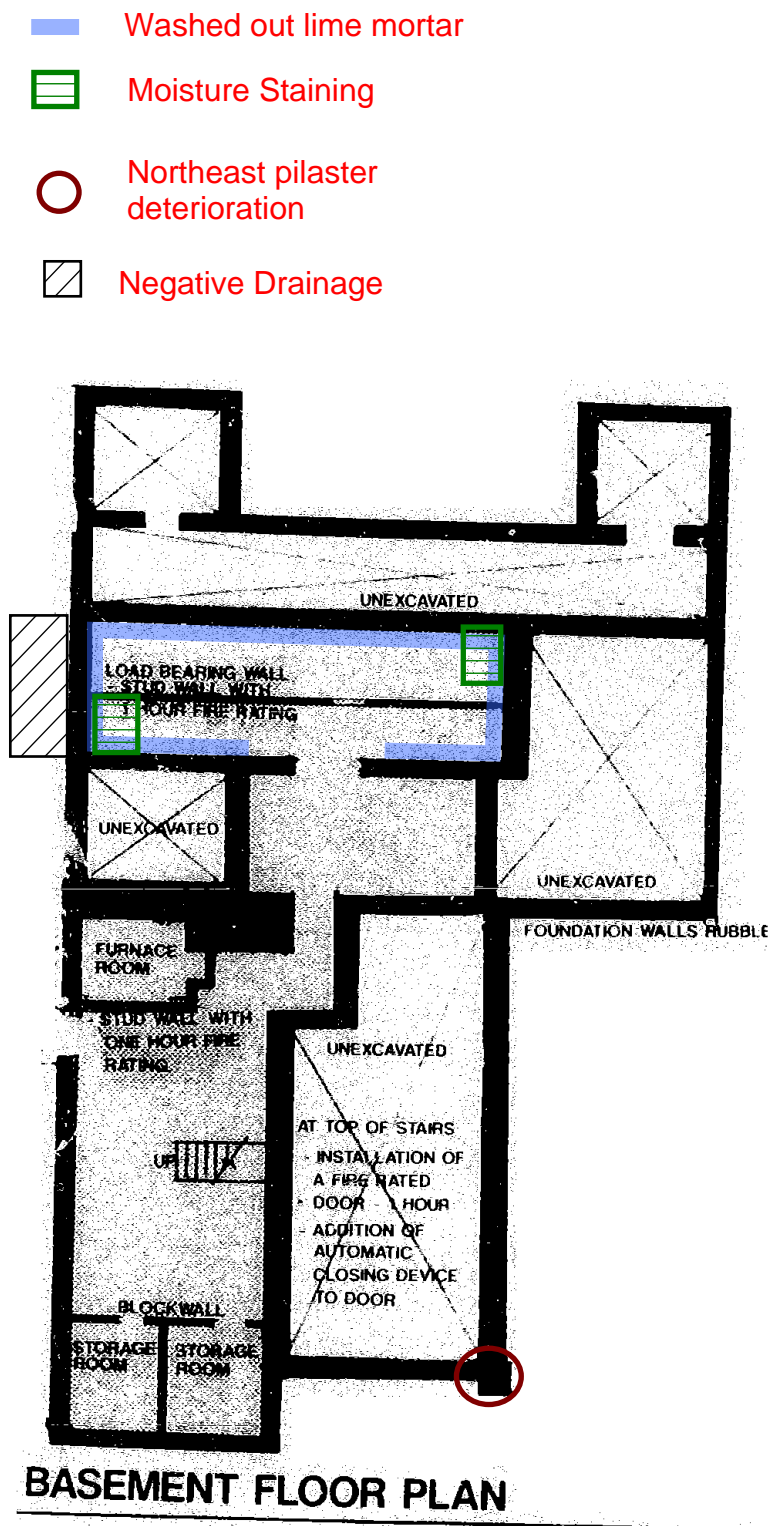
Figure 3.0 - Key observations - Below grade

- .2 The rubble foundation walls at the northern end of the building (*Refer to Figure 3 in Appendix B*) were observed to be exhibiting signs of deterioration in the forms of washed out lime based mortar and moisture staining at the floor level (*Refer to Photo 27 in Appendix A*).
