VIMY PARK ENHANCEMENT | CITY OF MISSISSAUGA

EXISTING CONDITIONS REPORT AND SCHEMATIC DESIGN BRIEF

Cenotaph Condition Report

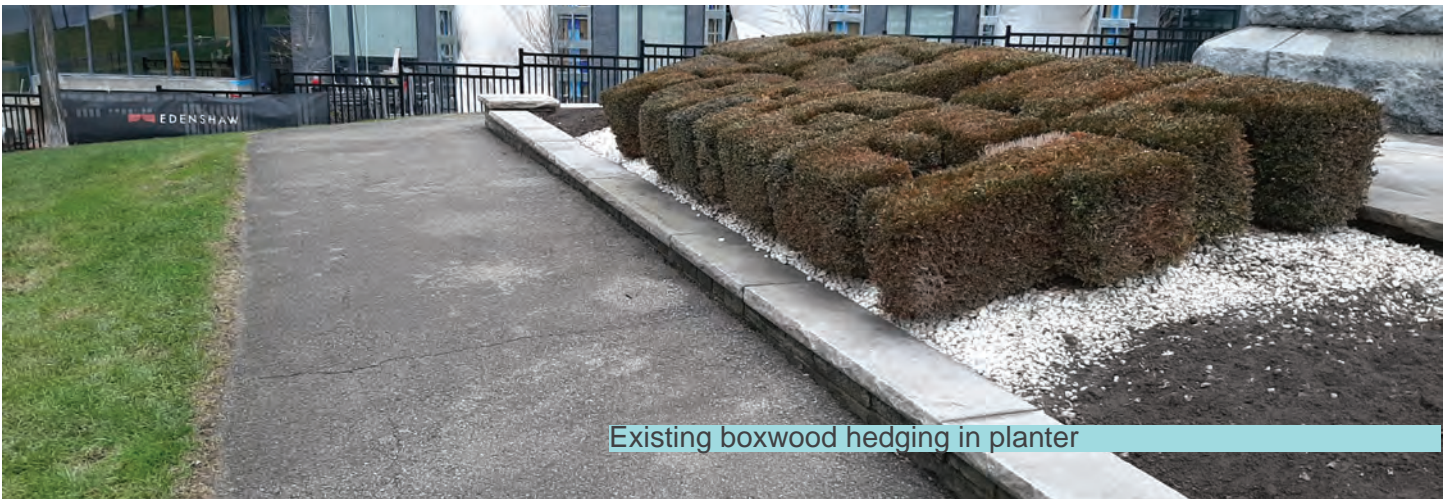
An ornamental planting bed is located in a raised planter around the Cenotaph Terrace. The bed is primarily dedicated to annual planting schemes which change seasonally. The west side of the planter contains boxwood (*Buxus sp.*) hedges that have been pruned into lettering which states "Lest We Forget".

Existing boxwood hedging in planter

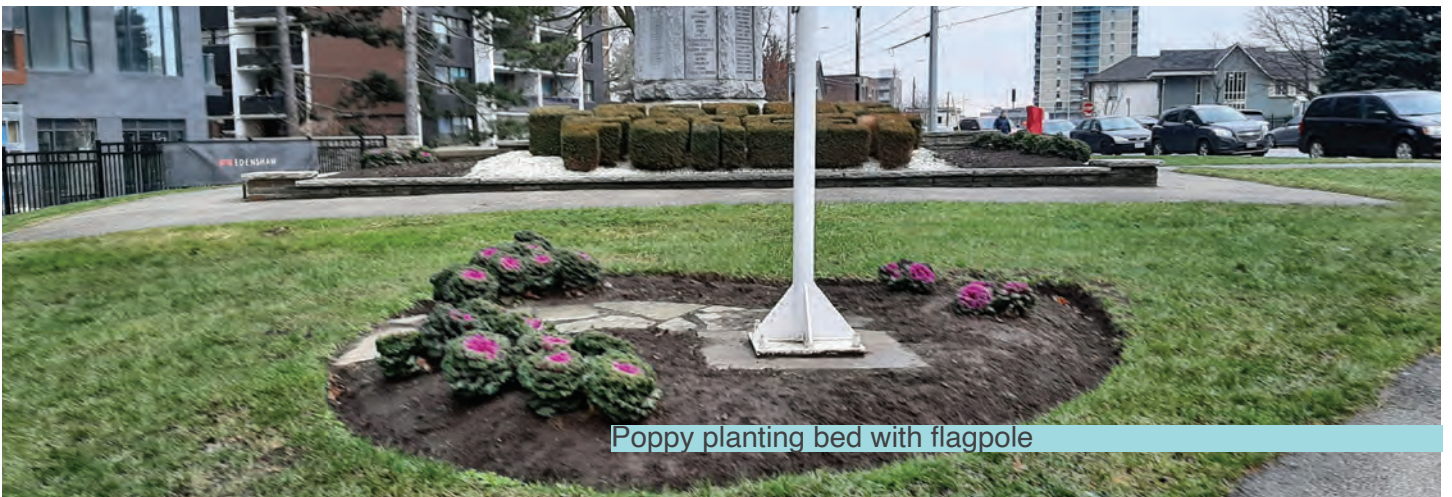
A small, at-grade planting bed, consisting of both perennial poppies (*Papaver sp.*) and seasonal annuals, is located just west of the monument.

Poppy planting bed with flagpole

- Re-surface and re-grade the park where necessary.
- Buffer the backside of the park with plant material along new development.
- Restore surrounding landscape.
- Identify areas for proposed trees and naturalizing landscape.
- Improve existing poppy planting bed with formalized edge treatment.
- Retain existing trees and/or identify for relocation.

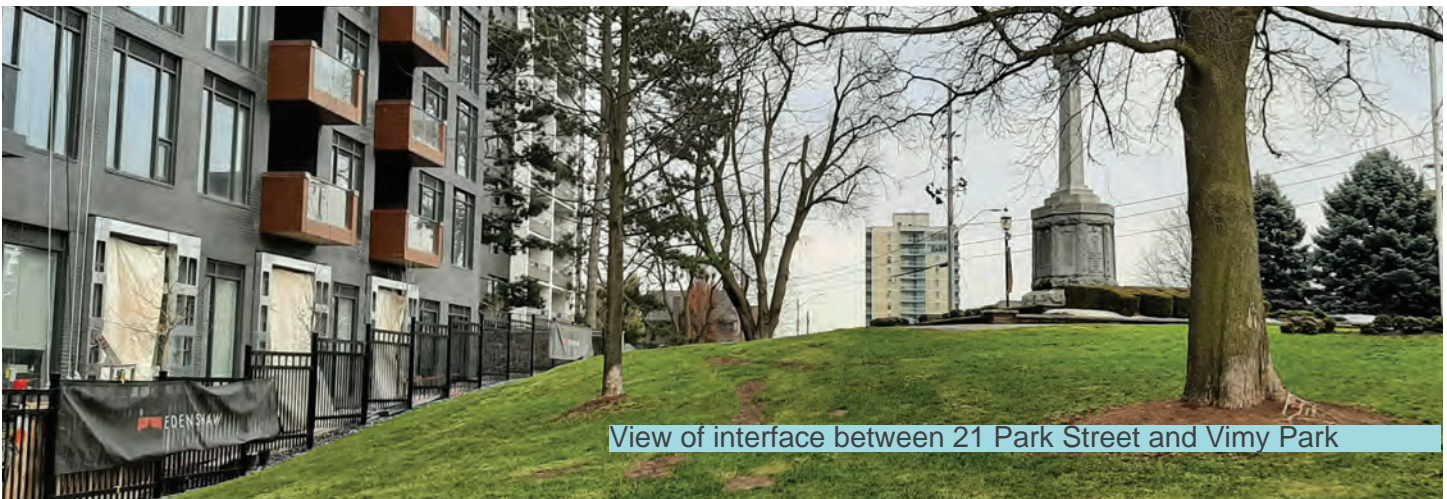
View of interface between 21 Park Street and Vimy Park

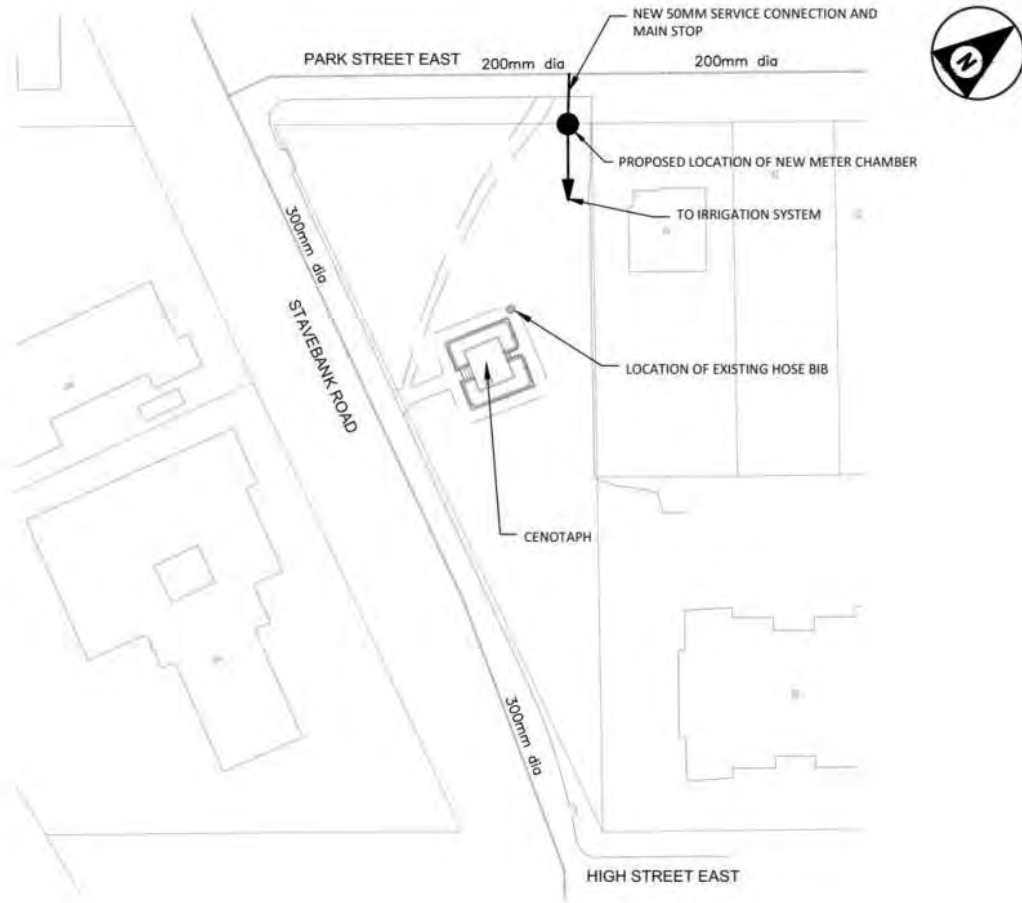
Figure 2: Preliminary Layout

There is limited information related to the water servicing for the existing hose bib; however, it is assumed that the existing service is either a 19mm or 25mm service. It is proposed to decommission the existing service and provide a new 50mm water service for irrigation purposes from the watermain on Park Street East at the north end of the Site. The new meter chamber for the irrigation system will be placed at the property line, adjacent to the new condominium development.

Based on the need for an irrigation system at the Vimy Park site, the existing water service is proposed to be decommissioned and a new 50mm water service and metering chamber are proposed. As this is essentially a replacement and upsizing of the existing service, and is limited to intermittent, seasonal summer use, we do not anticipate any negative impact to the water distribution system as a result of this undertaking.
