HERITAGE IMPACT ASSESSMENT

**36 BAY STREET**  
MISSISSAUGA, ONTARIO

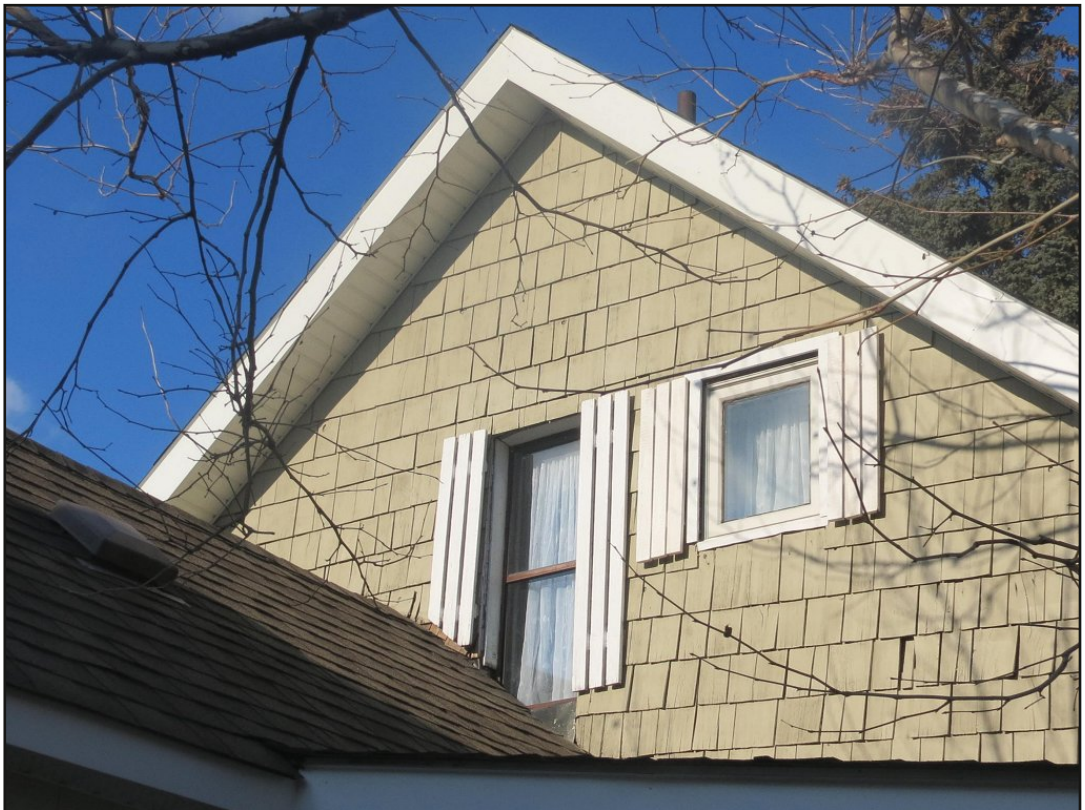
**2.3.2h: first generation windows and shutters**

Some of the additions have compromised the heritage character of the ~1890 portion of the home. Referring to image 2.3.2h, the centre line of the gable roof of the westward addition was offset from the centre line of the gable roof of the ~1890 section, resulting in an awkward confrontation of angles, with part of the rear, second-floor window (overlooking the second addition) obscured, and the the bottom corner of the decorative left shutter cut off to make room for the addition's roof. Skylights have been added which are inconsistent with the late 19th century character of the home (see image 2.3.2g), and the second-floor addition features modern windows that are inconsistent in style with the original part of the residence (See images 2.3.2e and 2.3.2f). Additions to the back of the house are uncharacteristic of the overall style of the residence, but these cannot be seen from the public realm.

As noted in Section 3.1.1, the general proportions of the current home have been compromised by four additions of varying heights and masses, which include an uncharacteristically-positioned porch and a westward addition that required truncating the lower portion of the shutters of the ~1890 home (See image 2.3.2h). The intent of the proposed addition is to essentially start from scratch; replacing the various contrasting additions with one addition of a more harmonious design, with a porch located, in a traditional manner, in the resulting John Street-facing alcove. This basic design is characteristic of other homes from the same era in the Port Credit Heritage Conservation District. (See images 3.1.3b to 3.1.3e.)

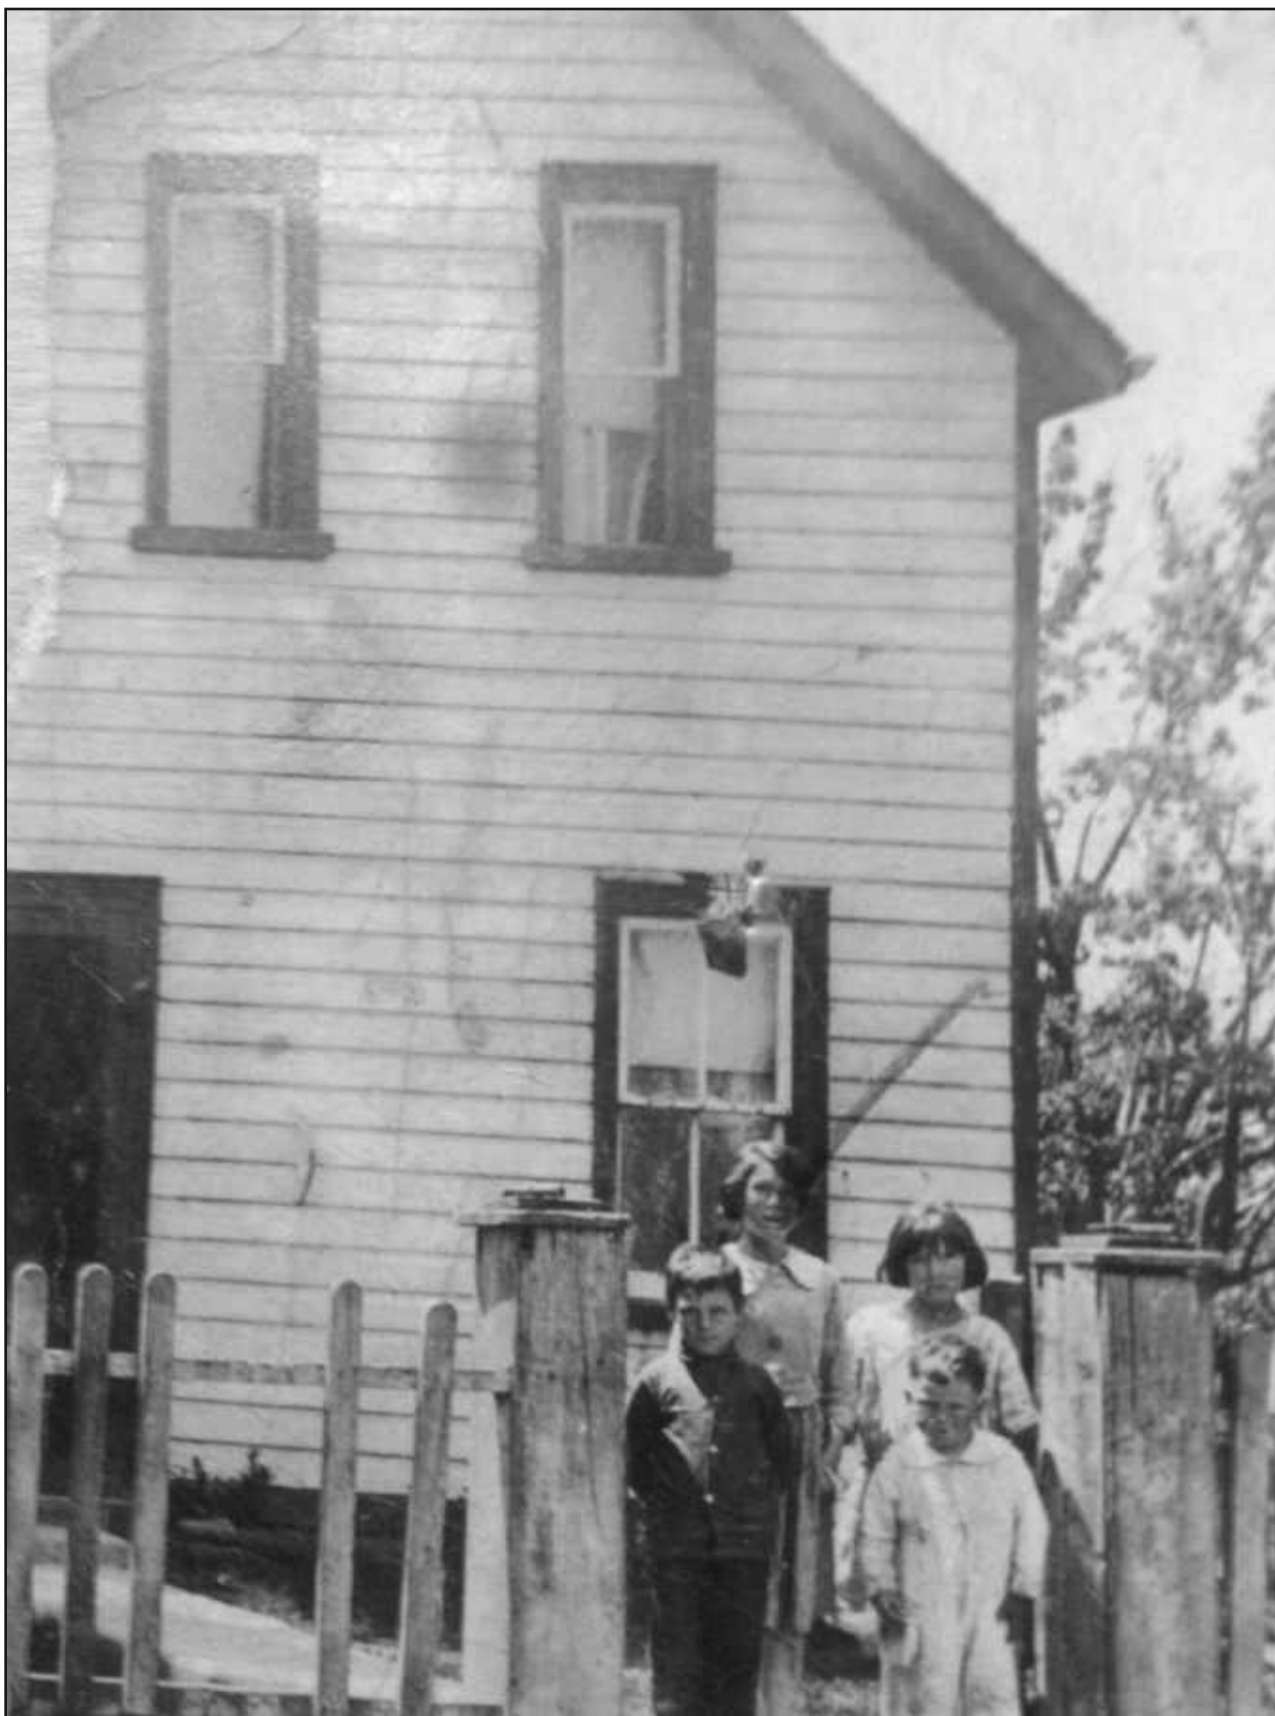
2.3.6c: front of 36 Bay Street, about 1915 (based on age of oldest daughter Sadie, born 1903)

Only one photograph of the ~1890 section of William Harrison's home has been found during research on the property. (See image 2.3.6c.) This has been used by the architect in designing the current home in a simple, vernacular style. Victorian
