Scoped Heritage Impact Assessment for the Reroofing of Cherry Hill House
Unit 18 – 680 Silver Creek Boulevard, Mississauga, Ontario

by Francine Antoniou Architect
and Paul Dilse, Heritage Planning Consultant

for the Property Owner and the City of Mississauga

on March 28, 2023

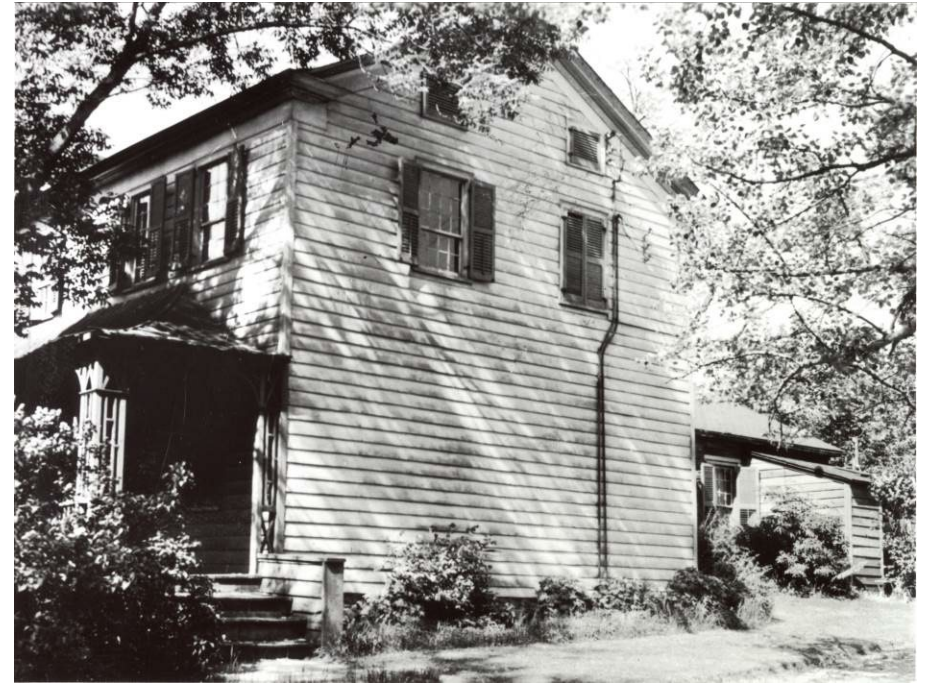
Fig. 7 Arthur Malcolm Mushlian, "Cherry Hill House, Dixie," c. 1930, Mississauga Library System, I.D. MC0005. The corner view of the front elevation and one side elevation shows the verandah's bent board-and-batten roof, then perhaps eight decades old.

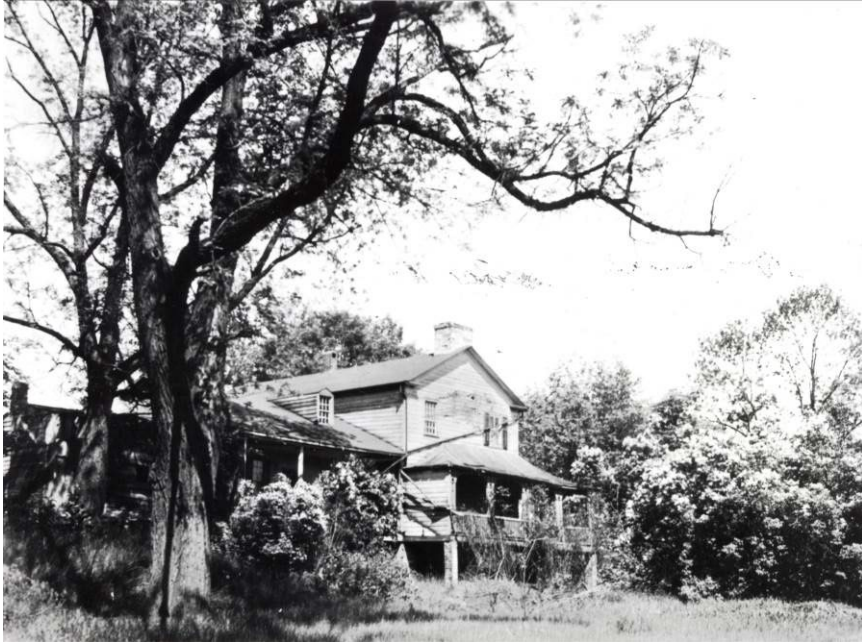
Fig. 8 Arthur Malcolm Mushlian, "Cherry Hill House, Dixie," c. 1930, Mississauga Library System, I.D. MC0002. A side view of the house shows the bent board-and-batten roof surmounting the verandah and asphalt shingle covering the roofs over both the front part and back wing.

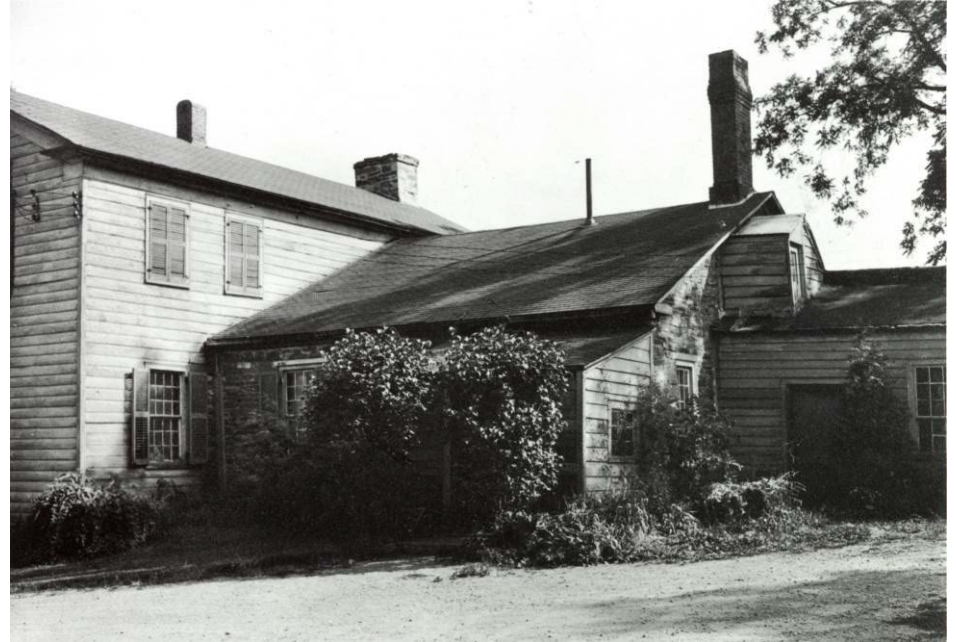
Fig. 9 Arthur Malcolm Mushlian, "Cherry Hill House, Dixie," c. 1930, Mississauga Library System, I.D. MC0003. The rear view shows asphalt shingle on the house's front part and back wings.

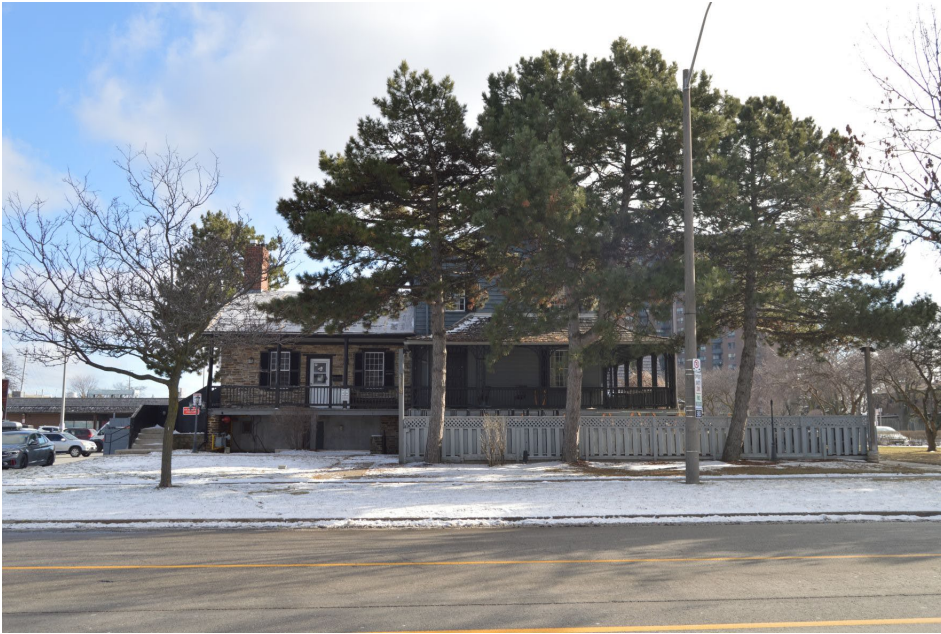
Fig. 20 North elevation facing Silver Creek Boulevard, hidden by Austrian pines and a contemporary wood patio screen enclosure

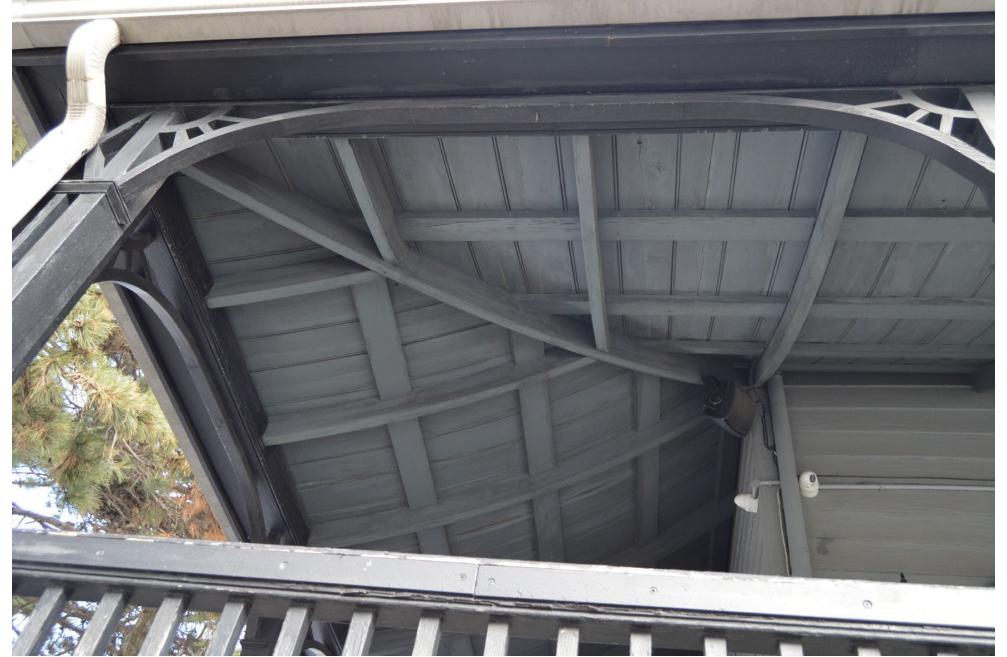
Fig. 27 A close-up view of the underside of the verandah roof

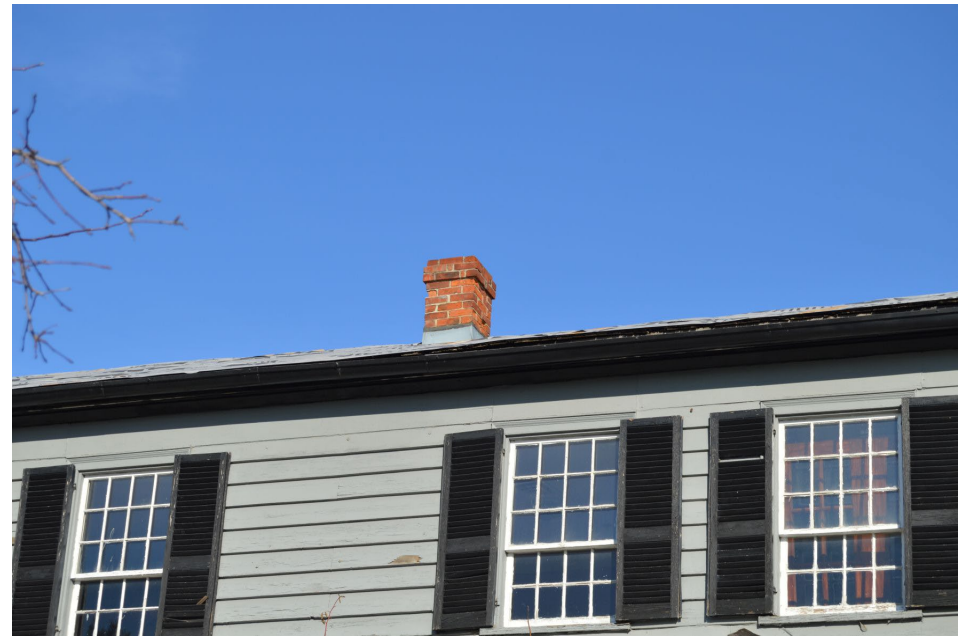
Fig. 29 Small red brick chimney on the ridge of the gable roof surmounting the house's front part

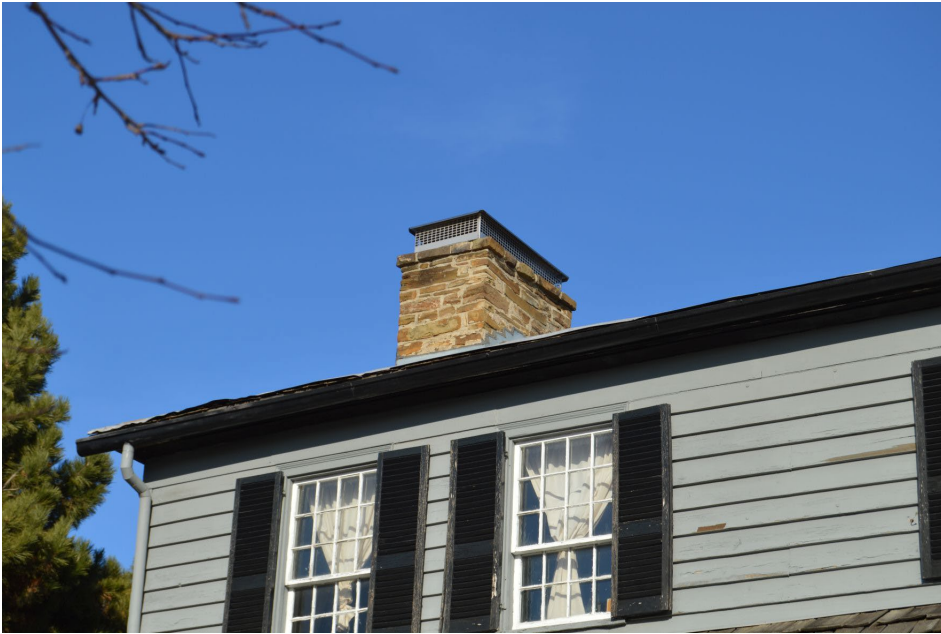
Fig. 30 Rebuilt stone chimney at the house's north gable end

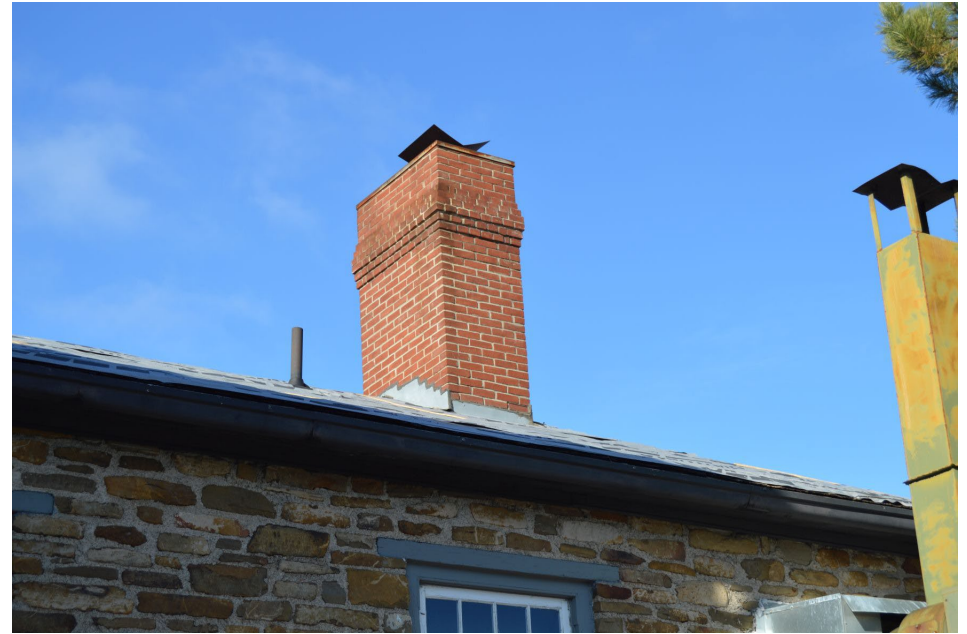
Fig. 31 Rebuilt red brick chimney on the back wing

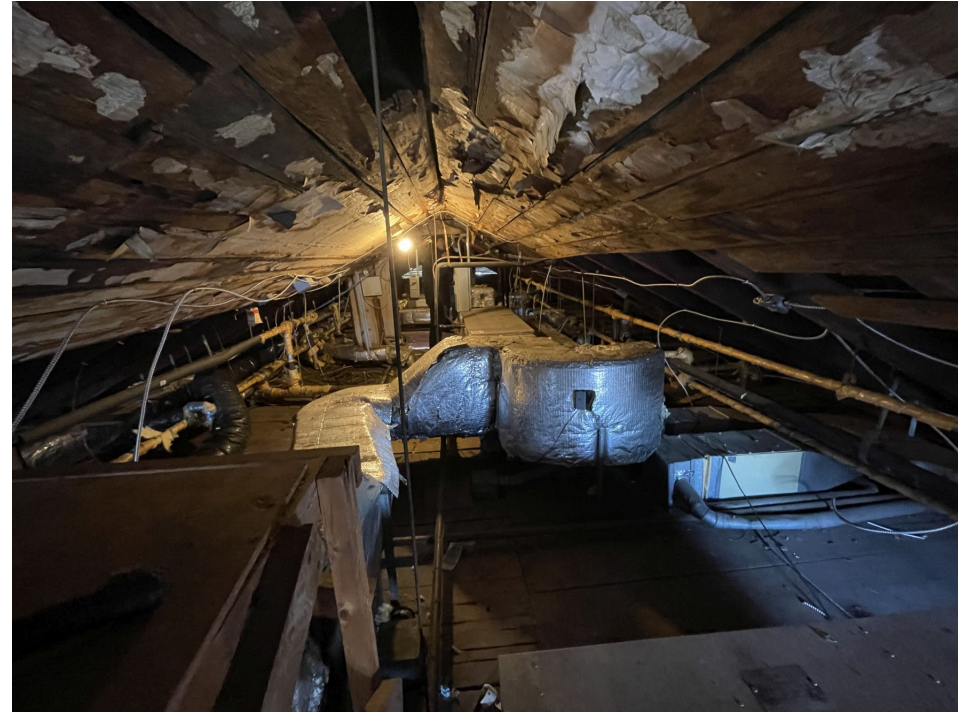
Inside the house, the verandah roof clad in weathered silvery-grey wood shingle can be better seen (Fig. 32). A hole in the upper floor's ceiling located near the building's west-facing front facade has likely been caused by raccoons (Fig. 33 and 34). The reconstructed A-frame attic over the house's front part is full of duct work (Fig. 35 to 38). The asbestos sheet specified in the engineers' drawings from the 1970s shows between boards in the attic ceiling (Fig. 39). Some of the asbestos is intact, and some is damaged (Fig. 40). Loose asbestos is also evident around what appears to be the stove pipe hole for the small brick chimney (Fig. 41). Like the front part's attic, the back wing's attic dates from the 1970s (Fig. 42).

Fig. 35 View of the attic over the building's frame front part, looking south

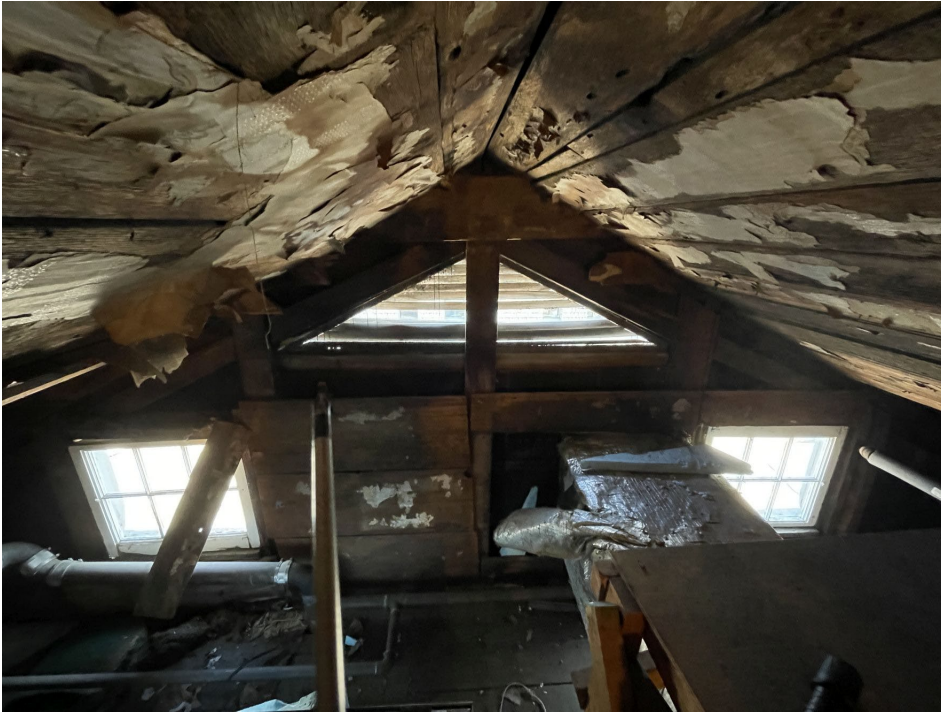
Fig. 36 South end of the same attic

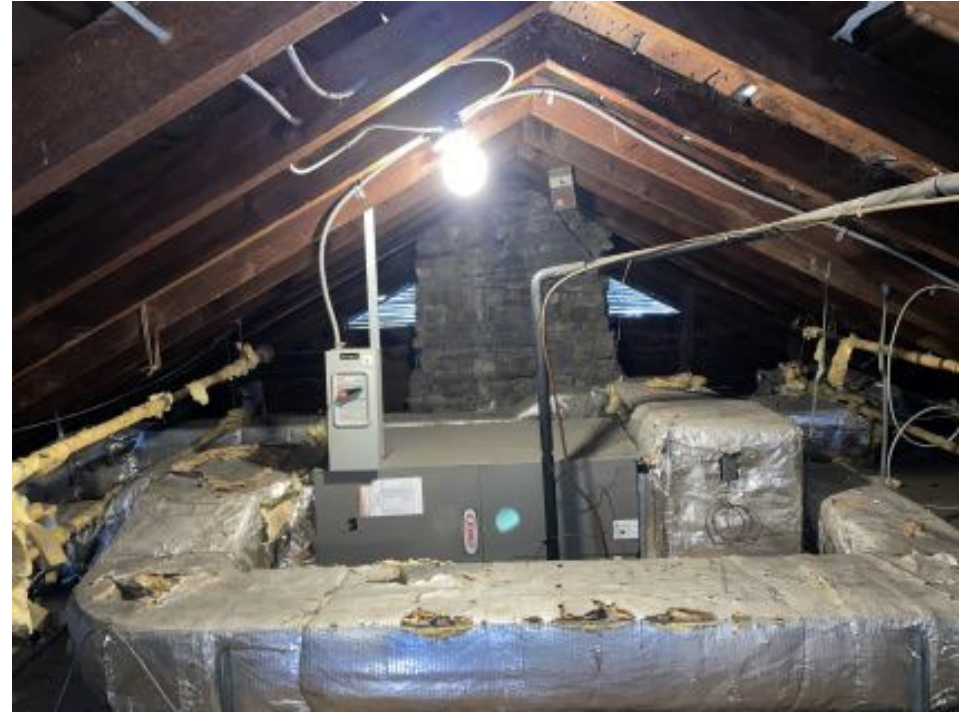
Fig. 37 View of the same attic, looking north to the stone chimney

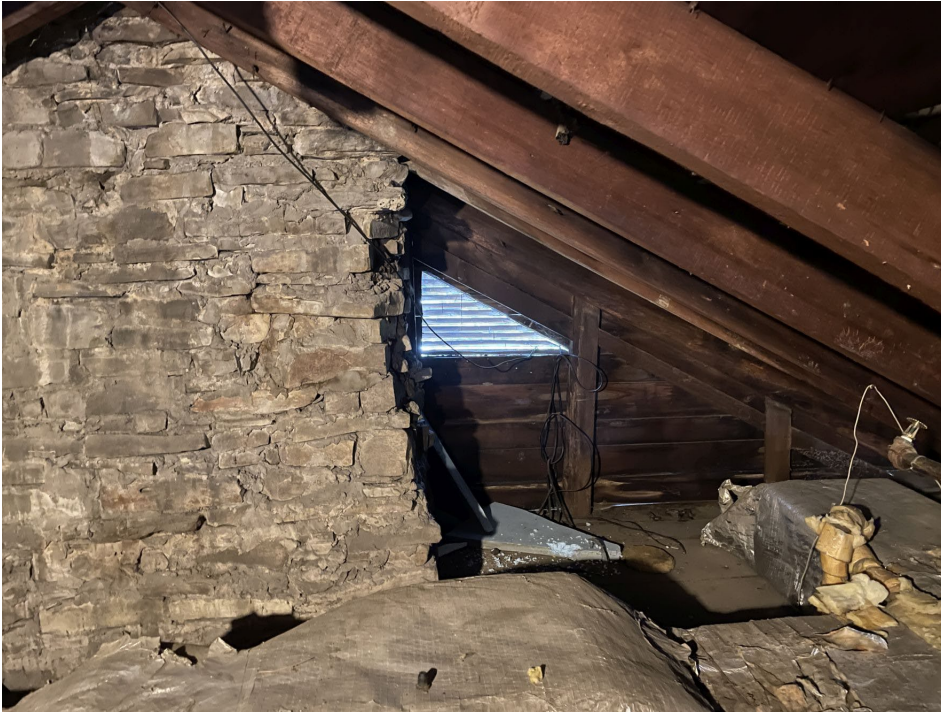
Fig. 38 North end of the same attic

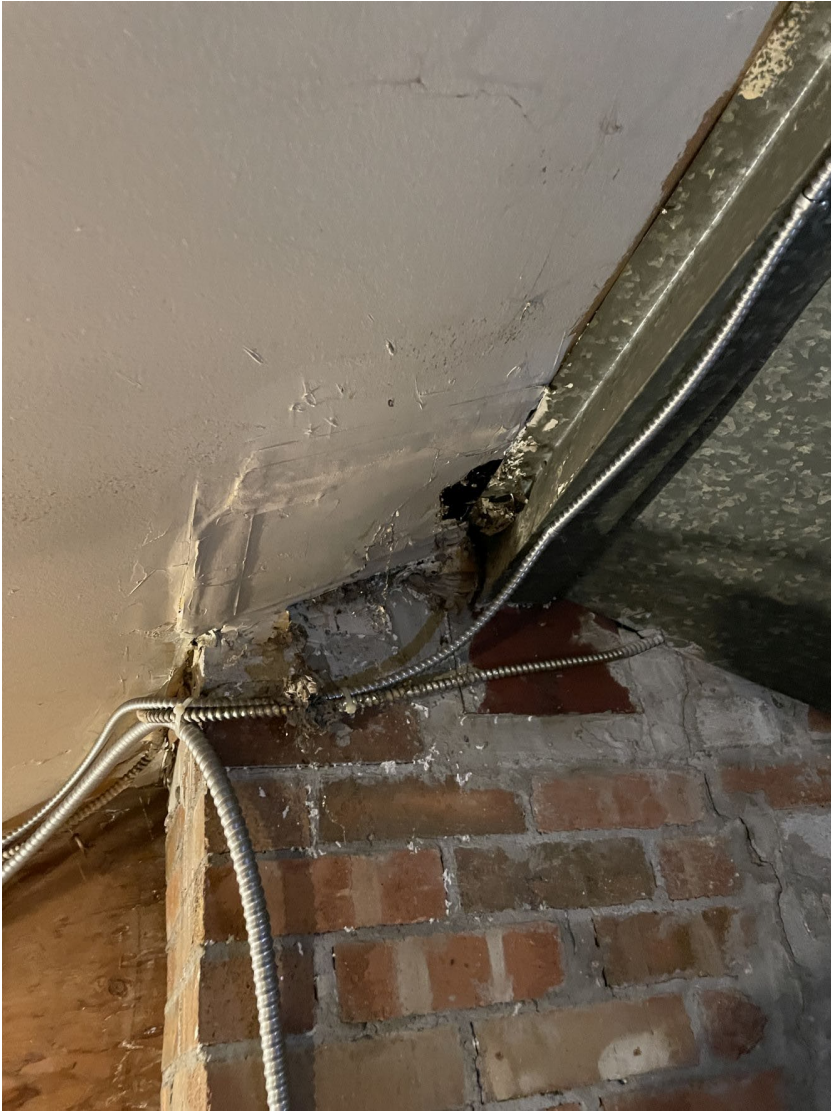
Fig. 42 View of the back wing's ceiling round its big brick chimney.
Note the concrete block wall – the structure for the exterior stone veneer.
