HIA ADDENDUM

1141 CLARKSON ROAD NORTH
City of Mississauga

30 APRIL 2024

**RE: 1141 Clarkson Rd N, Mississauga
 Structural Condition Assessment & Moving Feasibility Study**

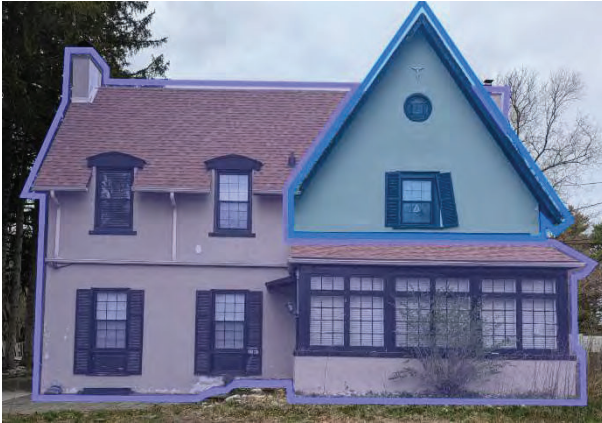
Photo #1: West Elevation, facing Clarkson Rd N [JCAL 2024]

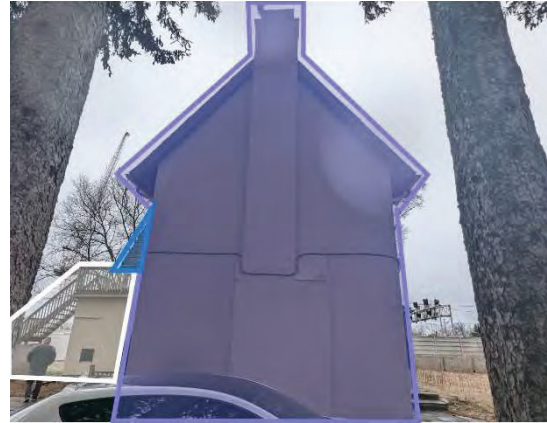
Photo #2: North Elevation, facing the driveway [JCAL 2024]

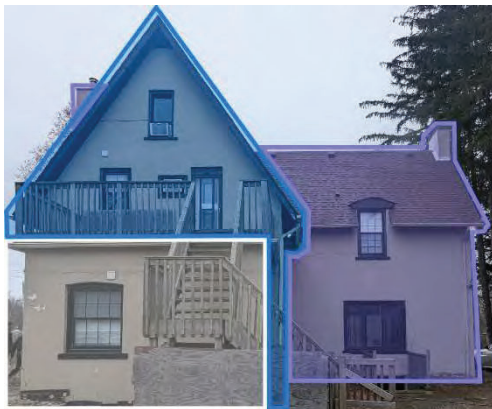
Photo #3: East Elevation, facing the backyard [JCAL 2024]

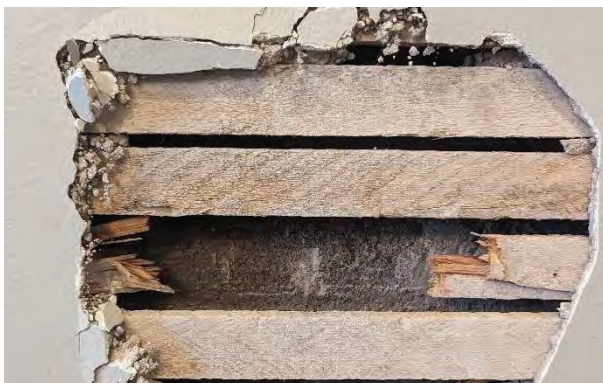
Photo #7: Horizontal wood lath, typical at interior face of walls [JCAL 2024]

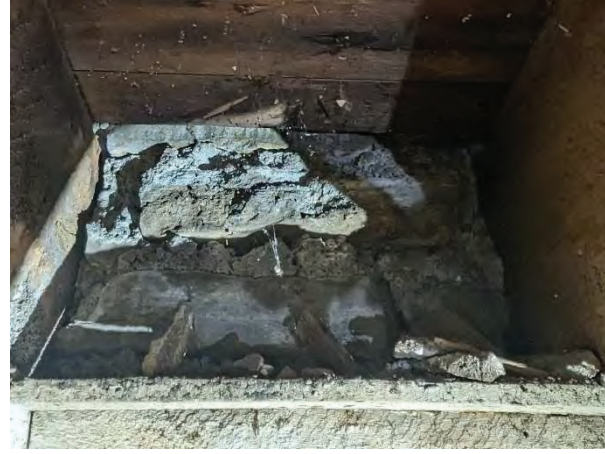
Photo #10: Stones laid in courses where the second-floor joists are embedded in the exterior wall [JCAL 2024]

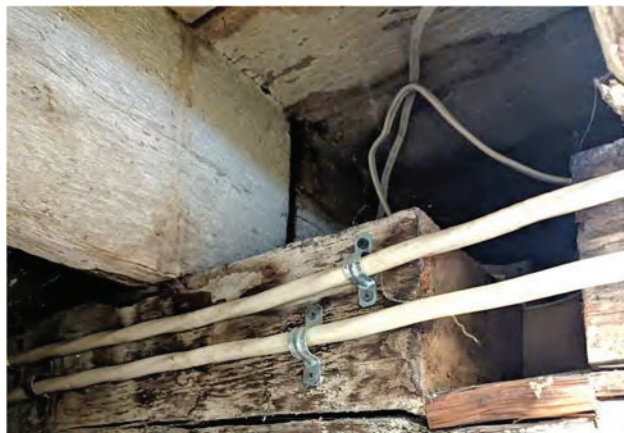
Photo #16: Butt joint at the first-floor framing joists centered above the supporting beam [JCAL 2024]

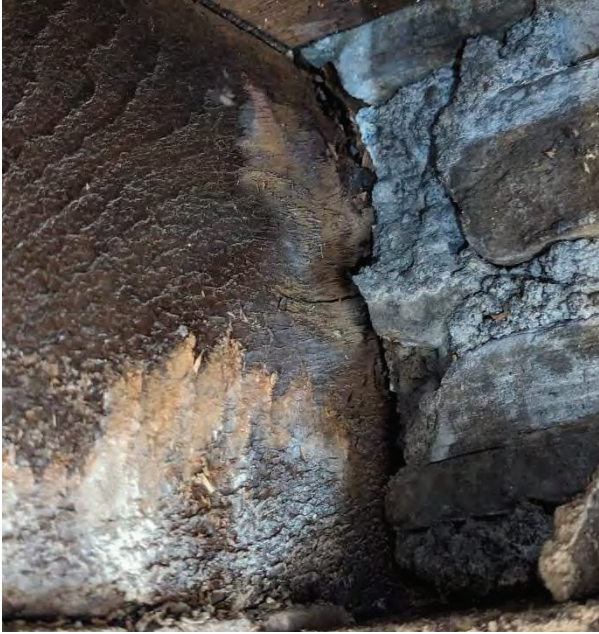
- The second-floor framing is comprised of $\pm 2\text{-}\frac{2}{3}$ " x $\pm 7\text{-}\frac{3}{4}$ " wood joists running in the east-west direction, spaced at approximately 16 inches on center, and supported by 2x4 partition walls at one end and the exterior walls at the other end where the joist ends are embedded into the walls. Some dry rot of an embedded joist end was observed at one of the exploratory openings (see Photo #17), however, the joists appeared to be generally sound beyond the inner face of the wall. We anticipate that similar conditions may exist at other joist/beam ends embedded into the exterior walls.

Photo #17: Rotted joist end at a second-floor joist embedded into the exterior wall [JCAL 2024]

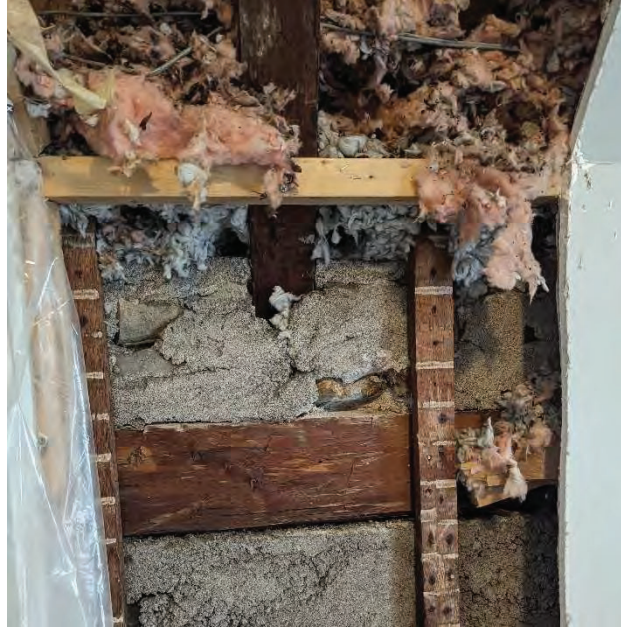
- The roof framing is comprised of ± 3 " wide by ± 5.5 " deep rafters running in the north-south direction, spaced at approximately 24 inches on center, and bearing on and extending through the exterior walls. A ± 5.75 " deep wood top plate of unknown width is embedded into the exterior walls below the rafter penetration point (see Photo #18). As observed from the exterior, the rafters do not appear to be notched to bear on the wall or sill plate, but rather, are cut to approximately half their depth once the rafters extend diagonally out of the wall (see Photo #19). The asphalt shingles on the roof were also observed to be nailed directly to the wood sheathing and rafters without a membrane, and some of the rafters showed signs of water damage (see Photo #20).

Photo #18: Exterior wall at the intersection with the roof framing showing a wood rafter extending through the wall and beyond the embedded wood top plate [JCAL 2024]
