Bradley House

1620 Orr Rd  
Mississauga, ON

Sheet Title:  
Elevations

A001.0

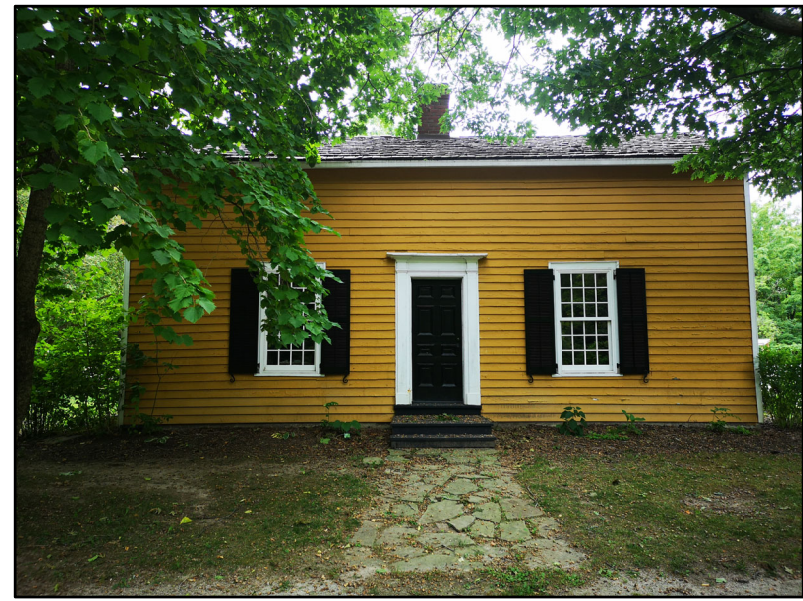
EXISTING NORTH ELEVATION

NOTE DETERIORATED WINDOW TRIM. INSPECT ALL TRIMS FOR DAMAGE OR DETERIORATION. CUT OUT AFFECTED AREAS. REPAIR SMALL AREAS (UNDER 2" THICK) WITH WOOD FILLER. REPAIR LARGER AREAS WITH NEW WOOD CUT AND TIGHTLY FITTED TO SUIT.

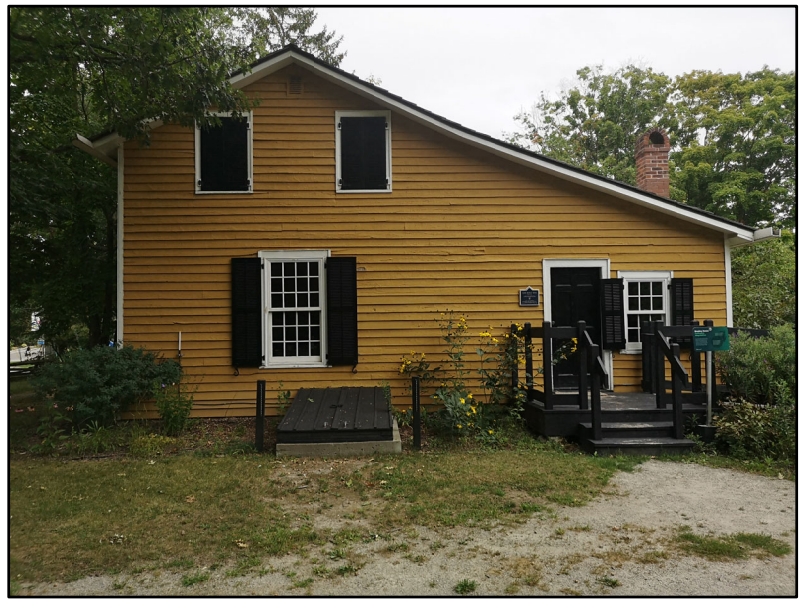
EXISTING WEST ELEVATION

DAMAGED/ROTTED AREAS FROM PREVIOUS NON-PROFESSIONAL INSTALLATION OF NEW SHUTTERS. INSPECT ALL WINDOWS FOR DAMAGE. CUT OUT AFFECTED AREAS. REPAIR SMALL AREAS (UNDER 2" THICK) WITH WOOD FILLER. REPAIR LARGER AREAS WITH NEW WOOD CUT AND TIGHTLY FITTED TO SUIT.

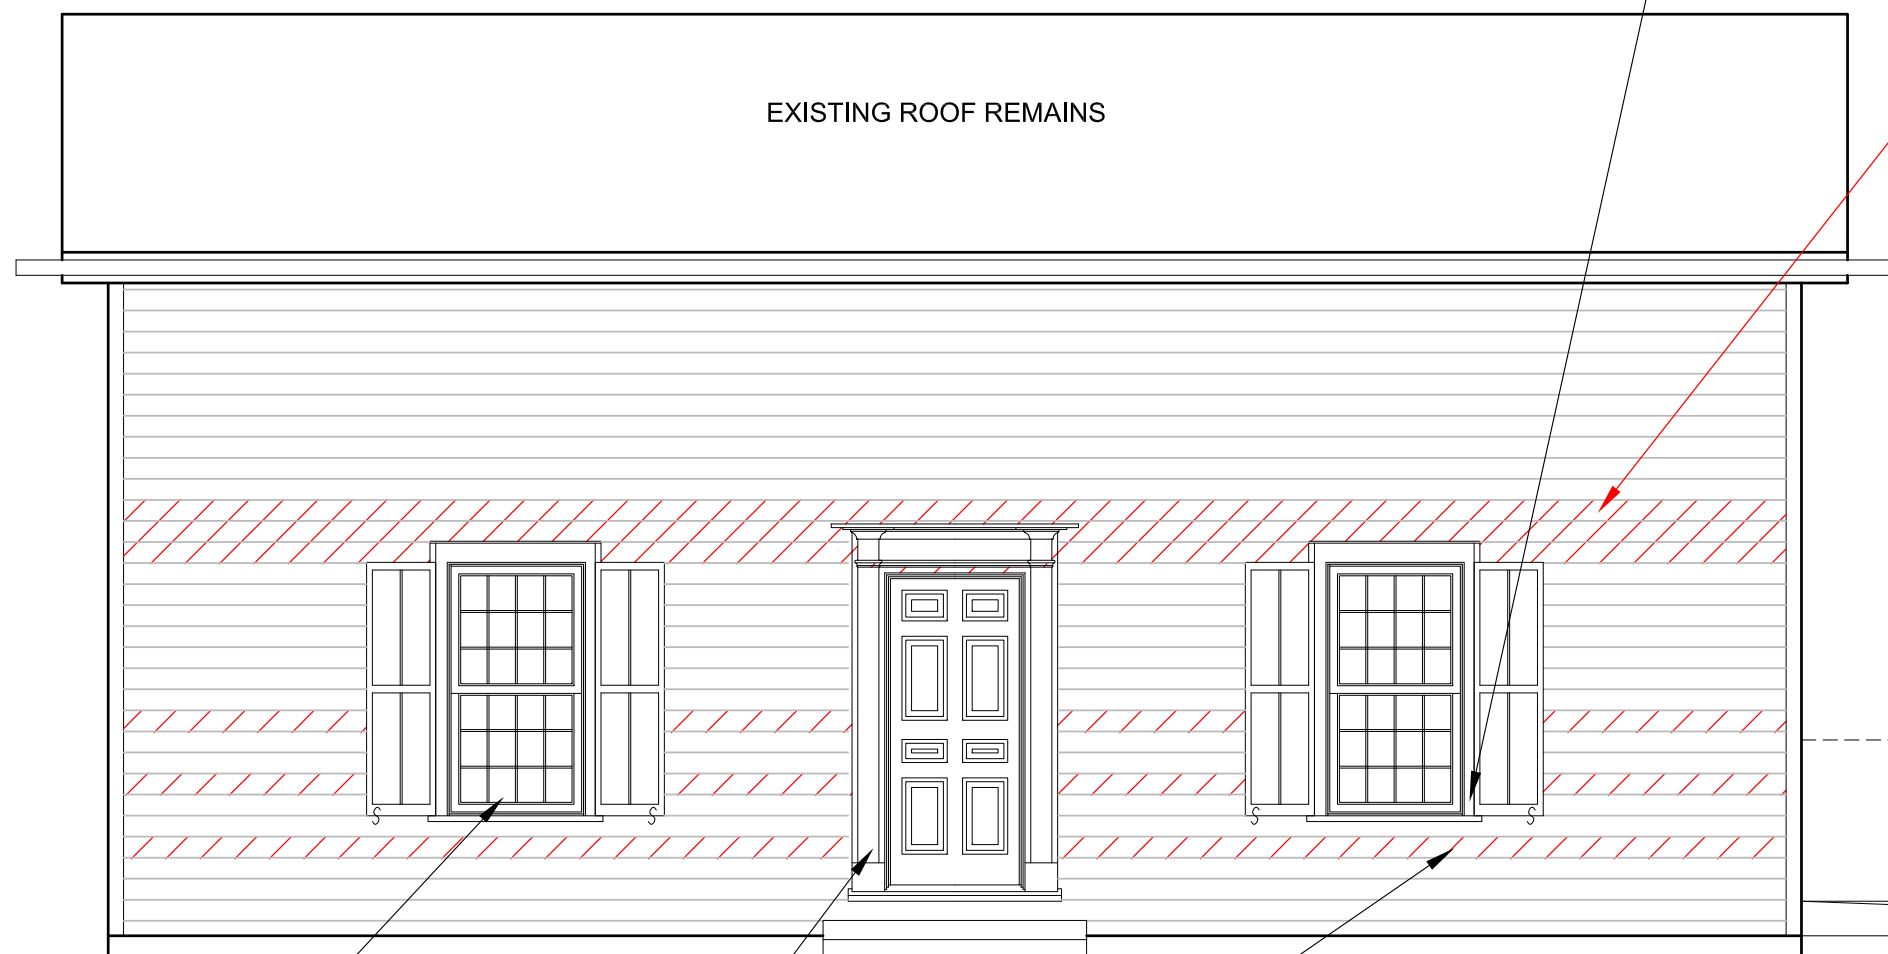
NORTH ELEVATION

TYPICAL PEELING PAINT, SIDING DETERIORATION

**Wood Siding:** the horizontal siding on all elevations shows signs of extensive peeling paint. Some siding boards are split, twisted or have pieces missing. Deteriorated areas of siding should be cut out for replacement. Do not cut out sections of board if the result would be to leave a remnant less than 0.9m long. The entire board should be removed in this case. The removed board material should be inspected and if serviceable portions (generally 1.2m long or longer) from these removed boards can be recovered they should be cut out and saved for potential re-use or repair elsewhere. See drawings for expectation of location and amount of siding to be replaced. Consultant and/or City representative on-site may direct additional removals and replacement. Actual quantity to be replaced may vary from assumed quantities. Assume overall that approx. 30% of the siding boards will require replacement.

**Siding repair:** Very small (less than 25mm) imperfections should be filled with epoxy filler. Larger imperfections and local deterioration should be cut out and replaced with new or salvaged material. Boards that have been removed due to deterioration should be replaced with new material. Existing boards should be checked for firm attachment and nailed as required.

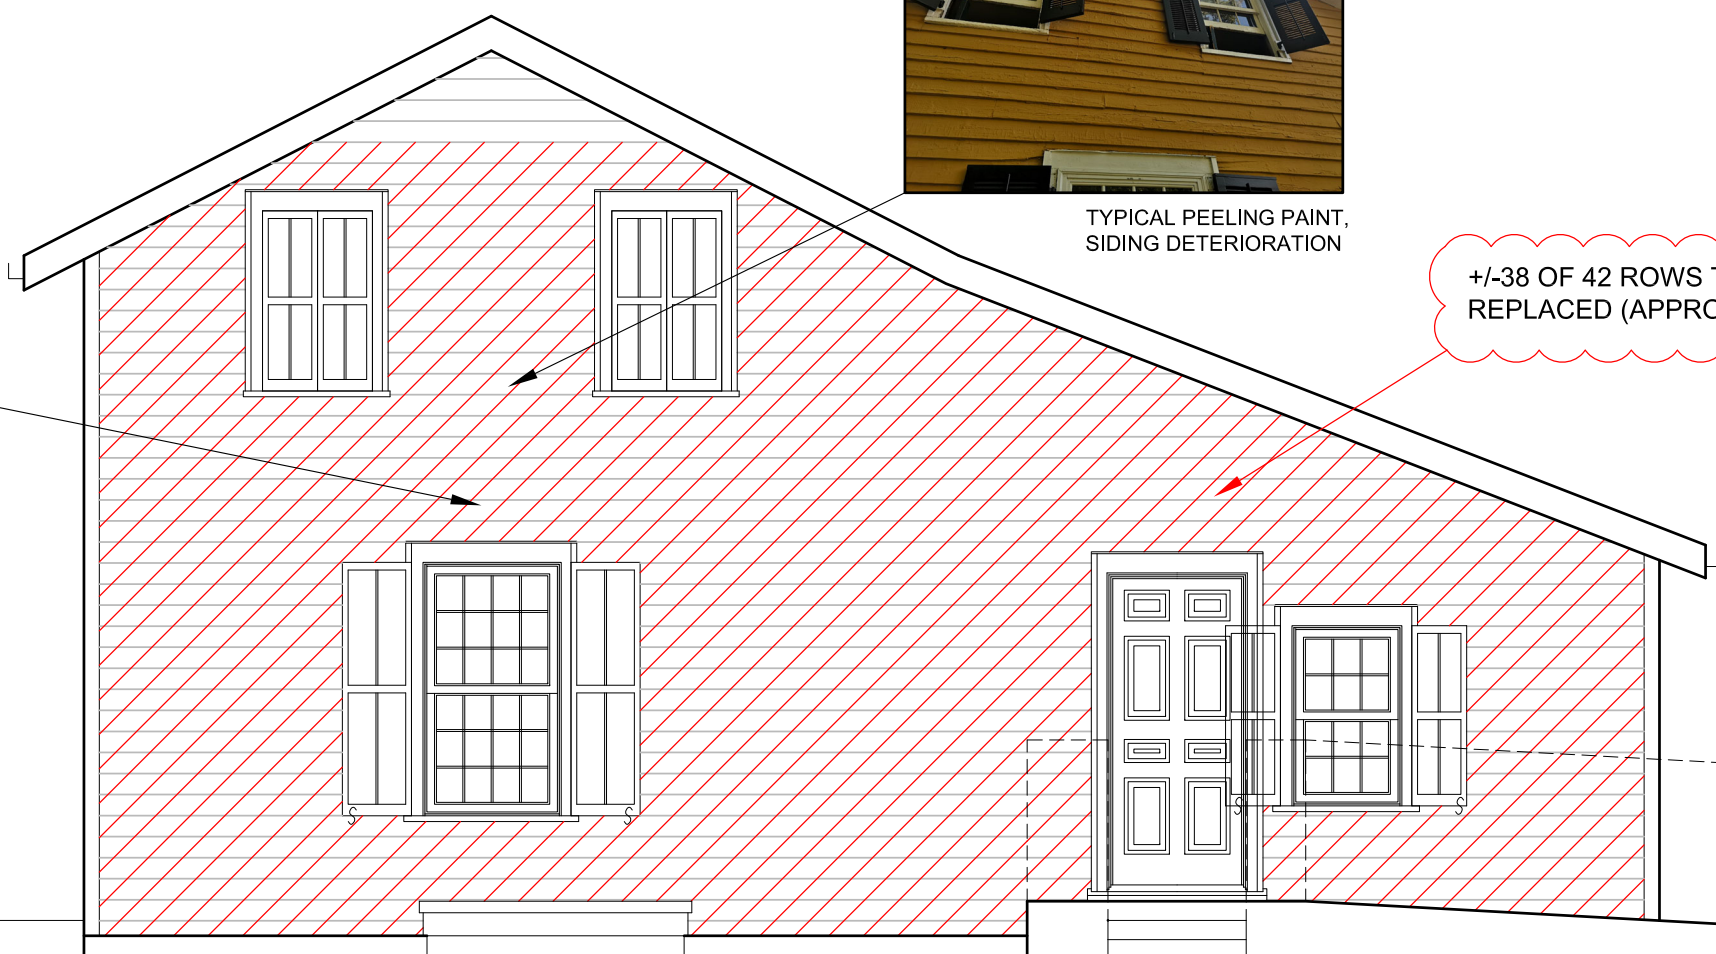
WEST ELEVATION

TYPICAL PEELING PAINT, SIDING DETERIORATION

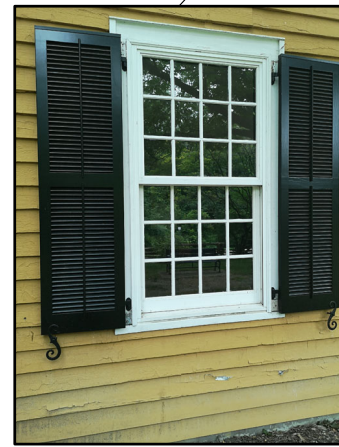
EXISTING WINDOW, SHUTTERS & TRIMS

**Windows:** extant windows are a mix of newer wood replacements (sash kits) in older wood frames & trims and older wood sash, frames & trims. All window sash, frames & trims must be inspected on all elevations. Generally they appear to be in good condition, however note damage caused to many window trims from previous non-professional installation of shutters. Report significant deterioration, if found, to consultant.

**Windows, Doors, Trims, Soffits, Fascia, Corner Boards, Misc. Wood Trims:** These must be hand scraped and sanded to a smooth finish. Rotted or badly damaged areas must be replaced. Smaller damage areas may be repaired with wood filler. Areas of bare wood must be treated with one coat primer. Complete removal of the existing paint finish is not anticipated. Loose boards must be re-attached. Nails holes must be filled.

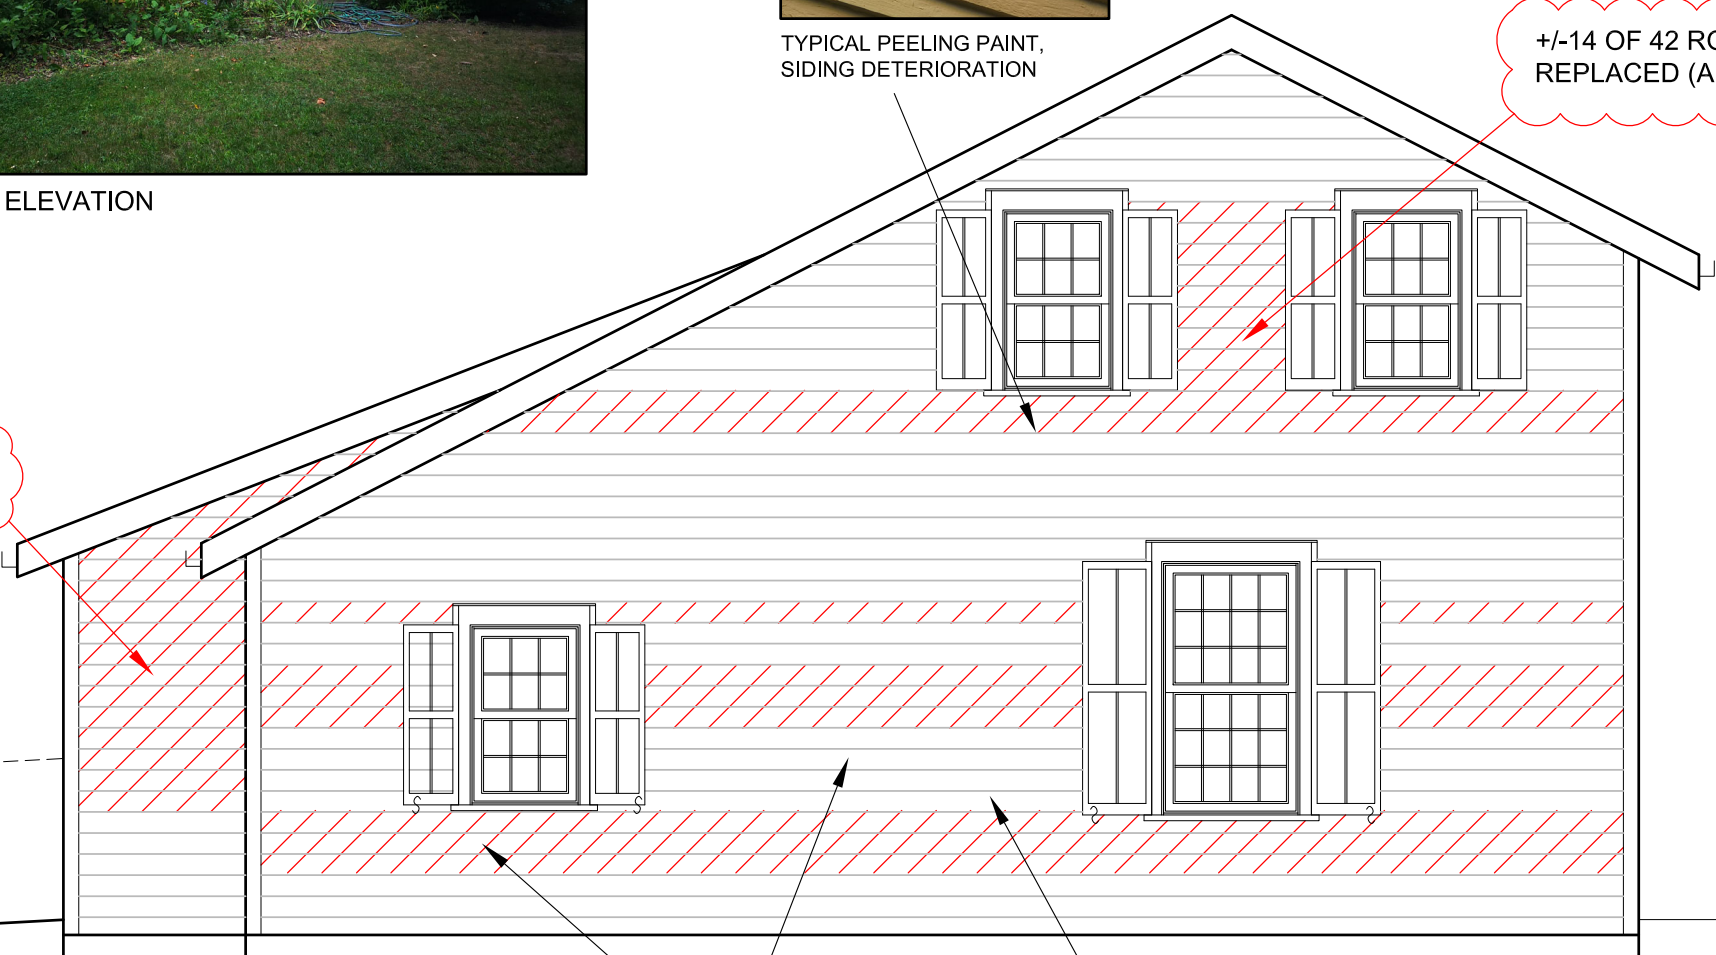
EAST ELEVATION

TYPICAL PEELING PAINT, SIDING DETERIORATION
