SUBJECT: Request to Replace a Structure on a Heritage Designated Property
Old Port Credit Village Heritage Conservation District
24 John Street South
(Ward 1)

HERITAGE IMPACT STATEMENT

A PHYSICAL, HISTORICAL AND CONTEXTUAL ASSESSMENT OF
24 JOHN STREET SOUTH
MISSISSAUGA, ONTARIO

Structural Assessment and Recommendations
for 24 John Street South, Port Credit, Mississauga

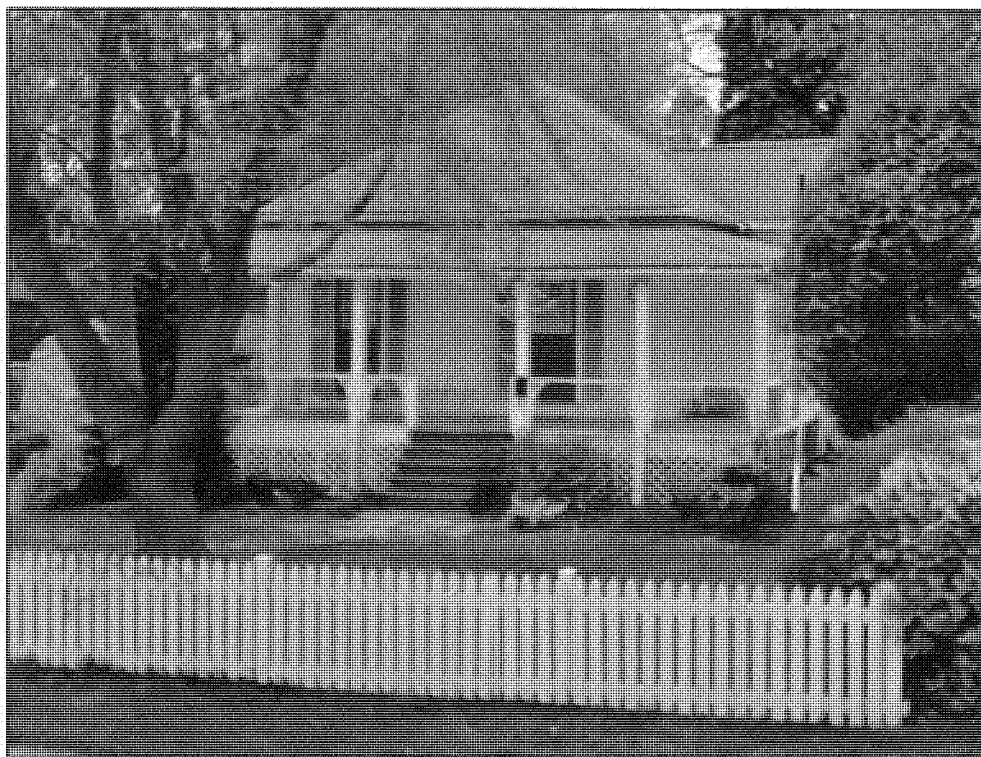
This porch is in urgent need of reconstruction. The structural integrity of the posts that sustain the porch is seriously compromised. The planks of wood on its flooring are cracked and decaying. The roofing is rotten and sagging. The railing was damaged years ago and removed."

"Wrap-around" front porch, typical of earlier homes on John Street South.
