The purpose of this memorandum is to request your approval to Rebuild Alectra's (Legacy Enersource's) existing hydro pole line along Mississauga Road South from Lake St. to High St. West along the east boulevard. This is to reinstate the current temporary condition of the poles along the east boulevard of Mississauga Road from Lake Street to Lake Shore Road West. The existing poles were trimmed due to condition of the assets and safety reasons. The customers had been temporarily accommodated from the existing pole line on the west boulevard of Mississauga Road, which is also of the same vintage.

# **Arborist Report**

Tree Inventory and Assessment

17 Mississauga Rd N to 53 Lake St Mississauga, ON

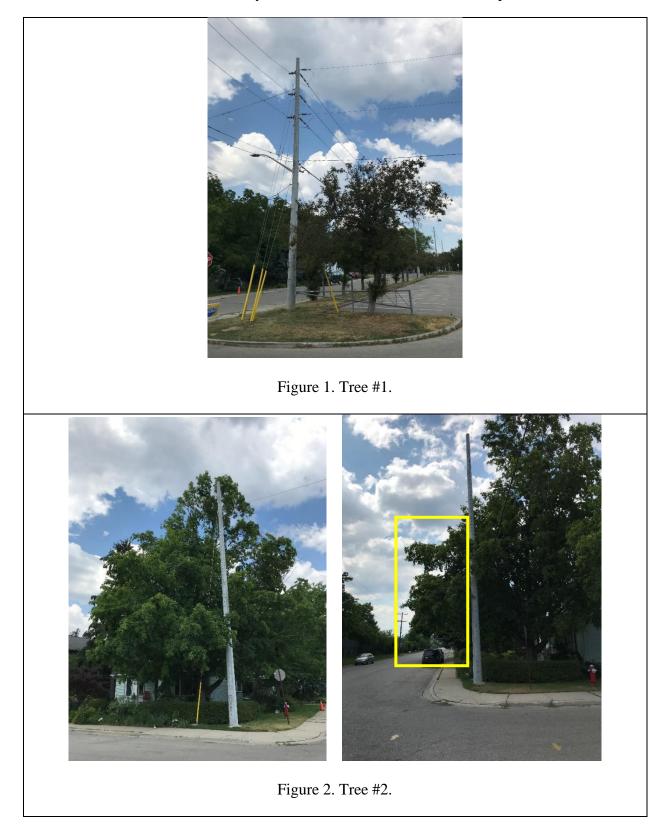
# Appendix 7 – Photographs

Branches within the yellow boxes are recommended to be pruned.

Trees #2, #3, #5-10, #12-15, #17, and #19-21 are recommended for utility clearance pruning and should be pruned in accordance with good arboricultural practices.
