**TO:** Laura Archila  
**FROM:** Brendan Quinn  
**SUBJECT:** City of Mississauga, Willow Lane Culvert HIA  
Guide Rail Treatment Alternatives  
**DATE:** April 30, 2021

#### **Alternative 1: Replace guide rail type**

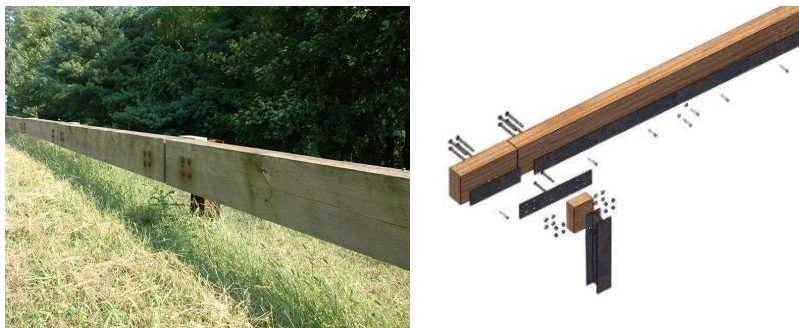
Figure 1. Merritt Parkway Guide Rail/Steel-Backed Timber Rail

One proposed alternative is to replace the current steel beam guide rail with a type of guide rail that has a heritage look more appropriate to the surrounding area and a minimal visual impact. In the current configuration, the culvert approaches are protected by steel beam guide rail that is in accordance with the Ontario Provincial Standards (OPS). These are approved products that have been tested to confirm they provide an affective level of safety. If the City wishes to remove this guide rail and replace it with an alternative style such as timber rails or masonry walls, the product would need to provide the same level of safety as the steel beam guide rail. The OPS does not include these alternative styles of barrier, however the American Association of State Highway and Transportation Officials (AASHTO) standards include a number of alternative barrier options that may better suit the cultural heritage character of the area and have been crash test approved to similar requirements as the OPS. Examples of these in the AASHTO Roadside Design Guide include Merritt Parkway or steel-backed timber rail (Figure 1) and stone masonry wall consisting of precast reinforced concrete faced with natural stone (Figure 2). Both options have been crash tested to meet NCHRP Report 350, TL-3 safety performance conditions.

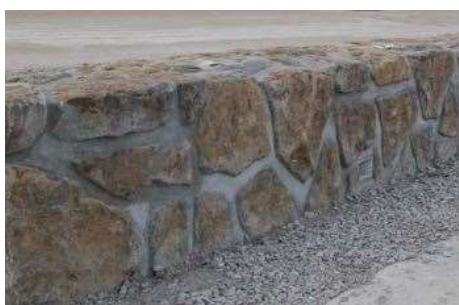
Figure 2. Stone Masonry Wall/Precast Masonry Wall
