Small Arms Inspection Building

South Building Roof Upgrade Design

Facility: Small Arms Inspection Building 1352 Lakeshore Rd E, Mississauga, ON L5E 1E9	Date: January 2024
--	------------------------------

Heritage Memo

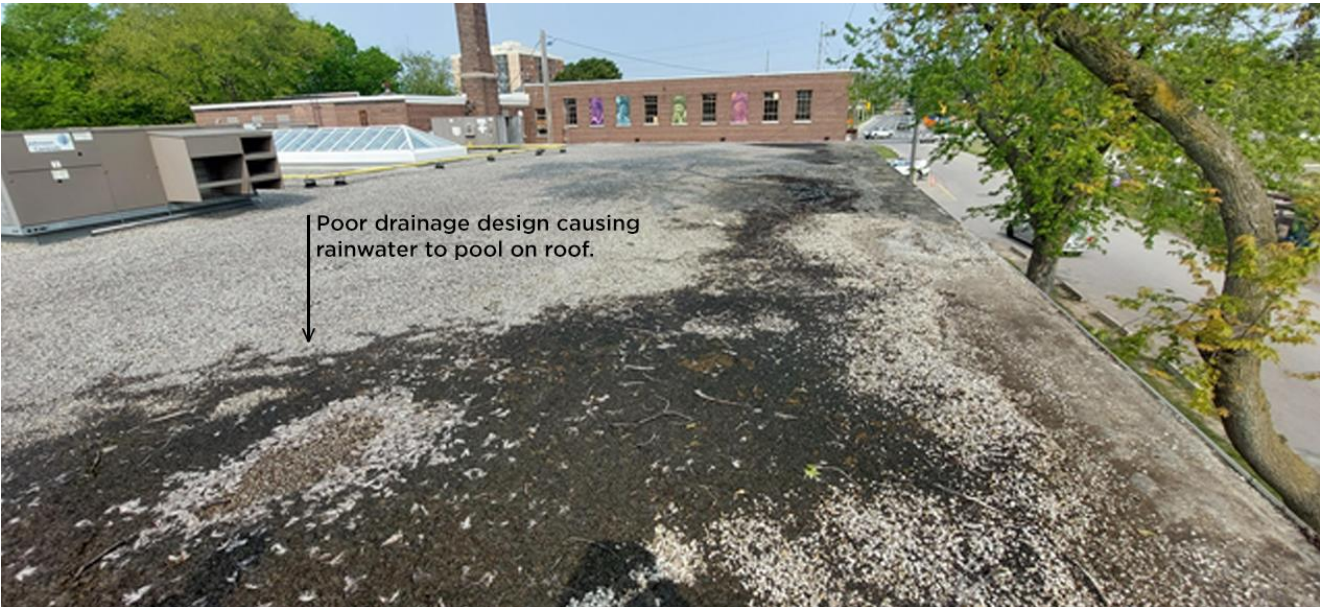
Figure 1. Existing roof condition. Dark areas indicate rainwater pooling as a result of inadequate drainage design.

The existing roof structure is a low slope flat roof that sheds water to the perimeter gutters. The shedding of rain water frequently overflows the roof and gutter system, causing leaks through the heritage windows. The poor drainage design of the current roof is causing rainwater to pool on the roof, and as a result, there are localized leaks in the wood ceiling. The drainage needs to be addressed in order to prevent further roof leaks and improve the performance and preservation of this heritage designated building.

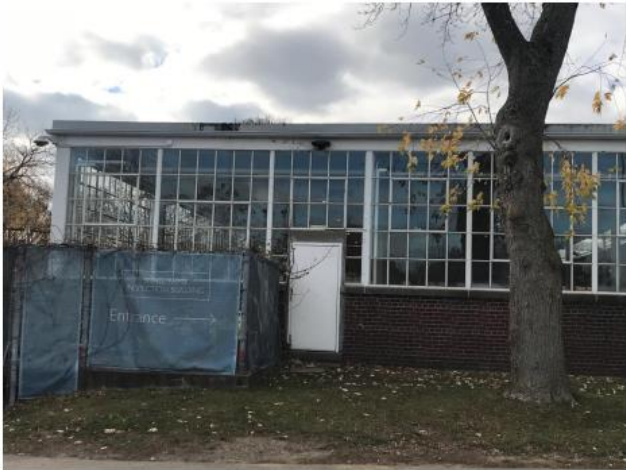
EXISTING ROOF EAVE CONDITION

PROPOSED ROOF EAVE DESIGN WITH NEW 6" CURB

Figure 3. Proposed Roof Curb Design. The render on the right illustrates that the setback 6" curb is hidden from view when standing in the same viewpoint as the image on the left. Additionally, raising the gutter to the top of the roof edge will improve the drainage system and prevent water from spilling over the edge and through the windows.

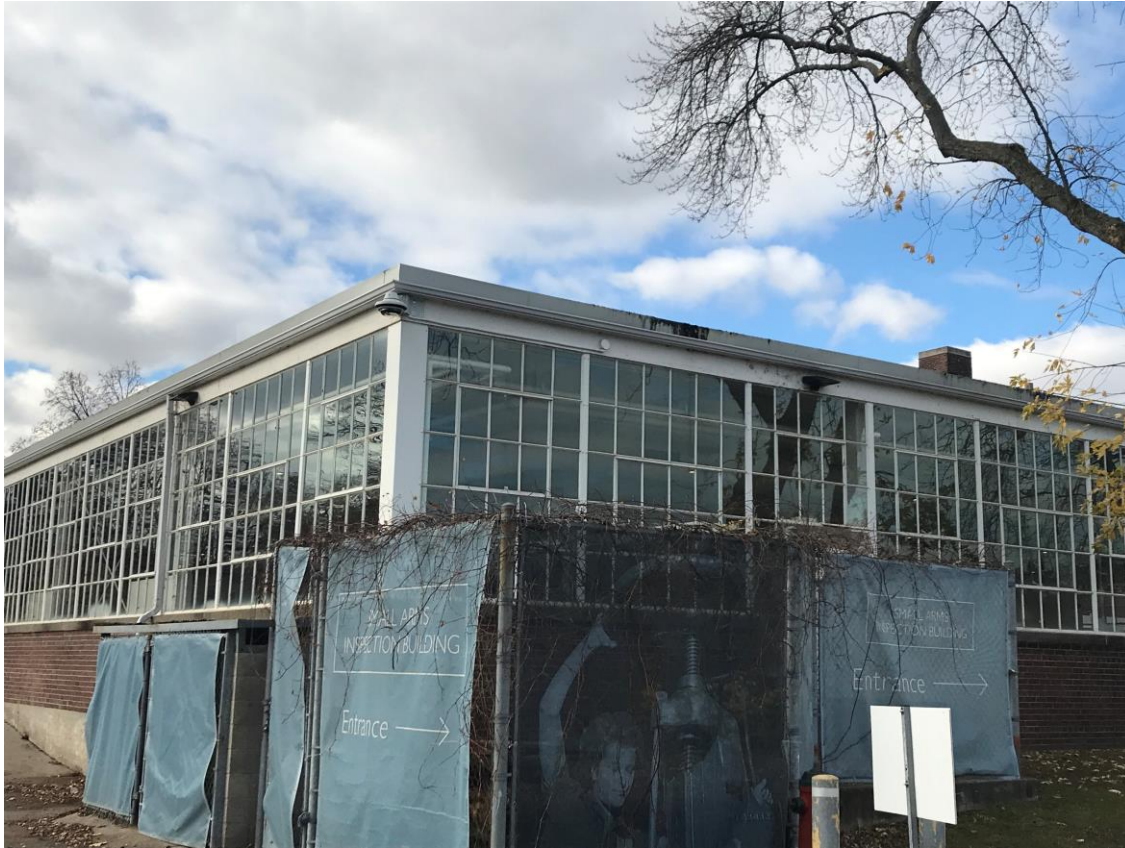
EXISTING ROOF EAVE CONDITIONS

SOUTHEAST CORNER OF THE BUILDING

PROPOSED ROOF EAVE DESIGN

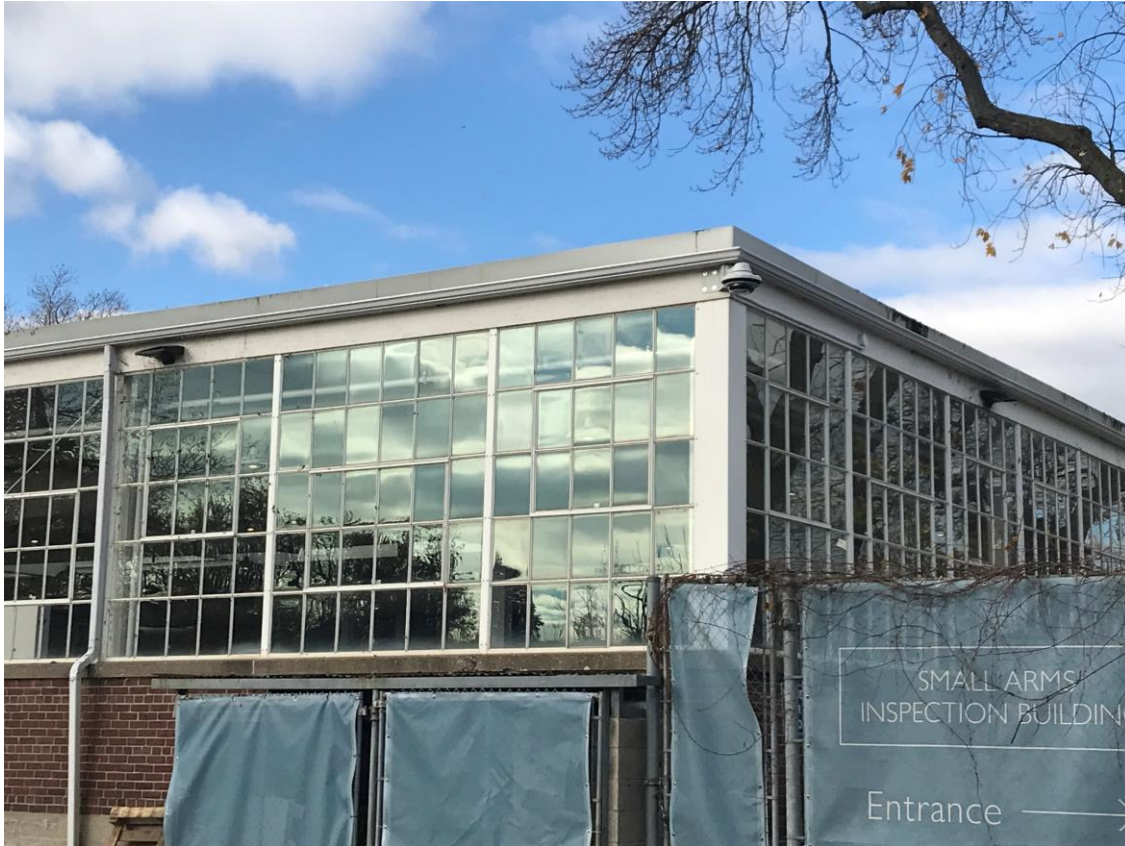
EXISTING ROOF EAVE CONDITIONS

SOUTHEAST CORNER OF THE BUILDING

PROPOSED ROOF EAVE DESIGN

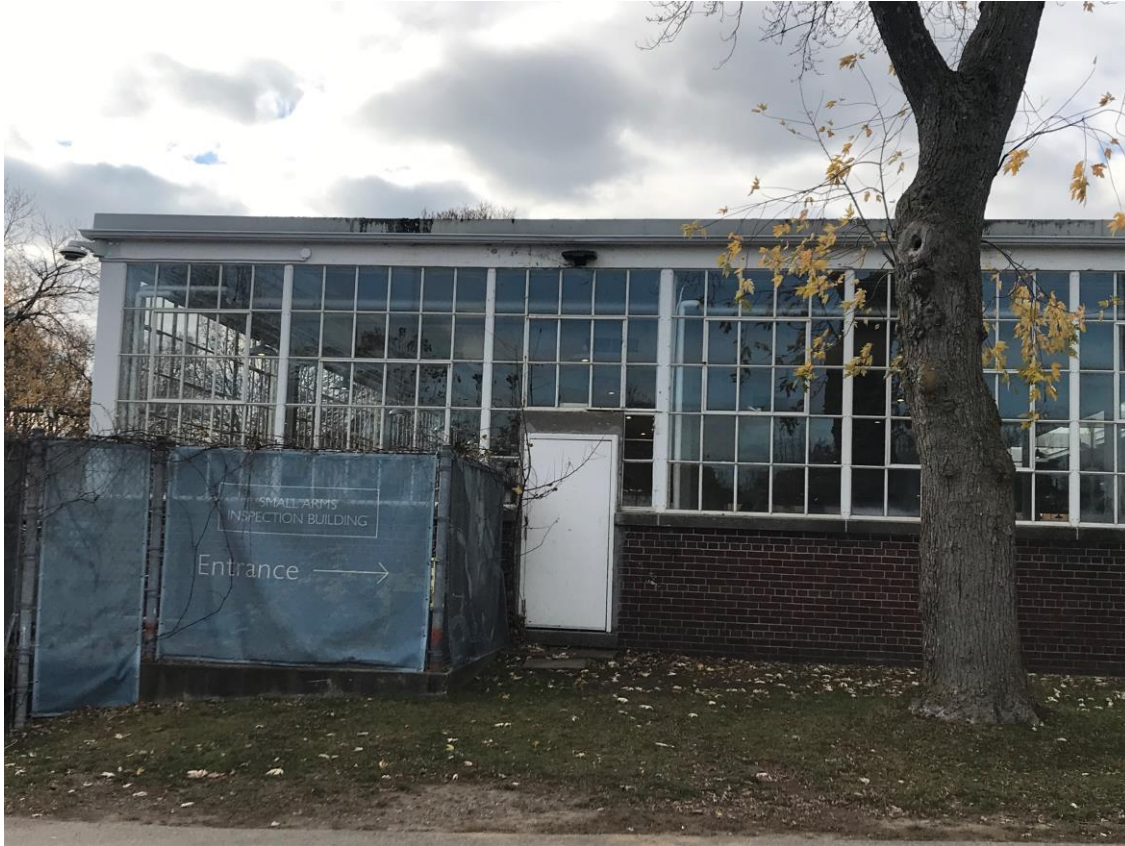
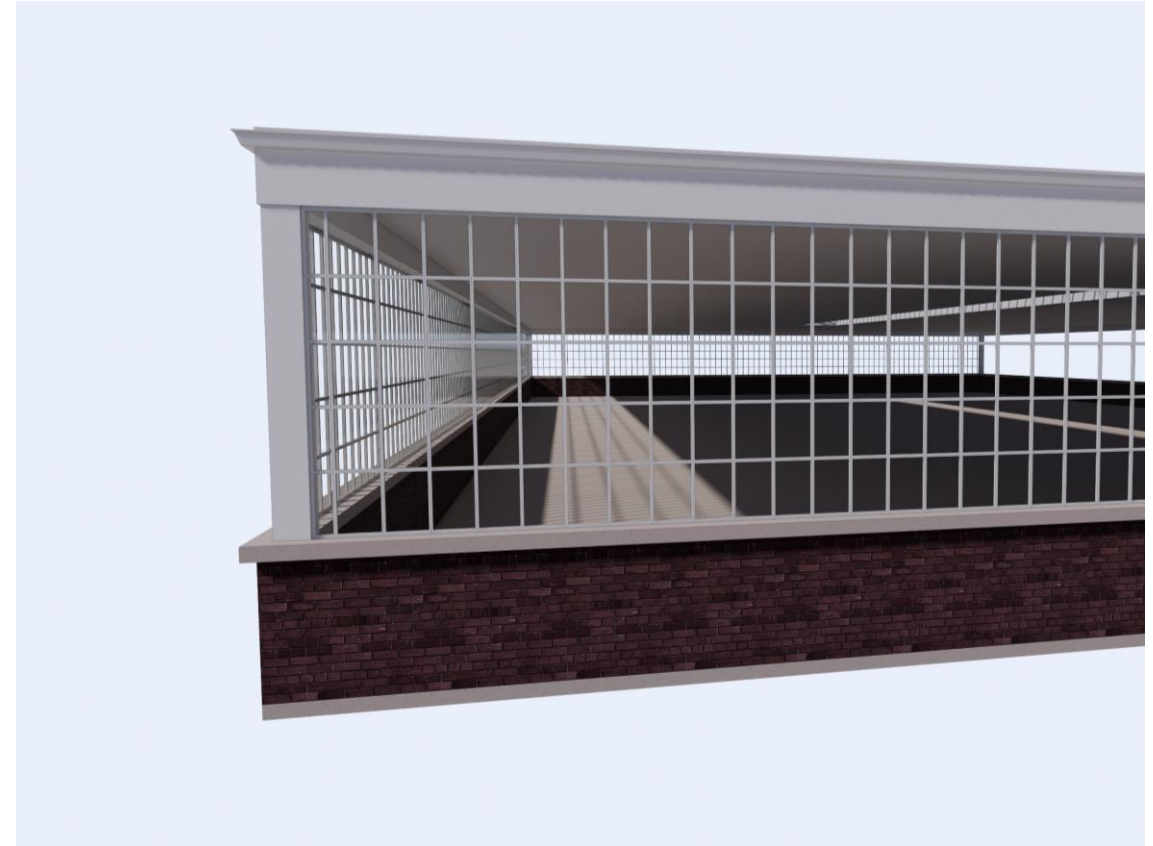
EXISTING ROOF EAVE CONDITIONS

SOUTHEAST CORNER OF THE BUILDING

PROPOSED ROOF EAVE DESIGN
