## Meadowvale Village Heritage Conservation District Subcommittee

City of Mississauga's Transportation Infrastructure Department is proposing a rehabilitation work plan for the Old Derry Road/Creditview Road Bridge over the Credit River. The HIA prepared in advance of the work has determined that the work plan represents a non-substantive alteration to the bridge. Heritage Planning note that the guardrail replacement does require a permit but that all other work is non-substantive.

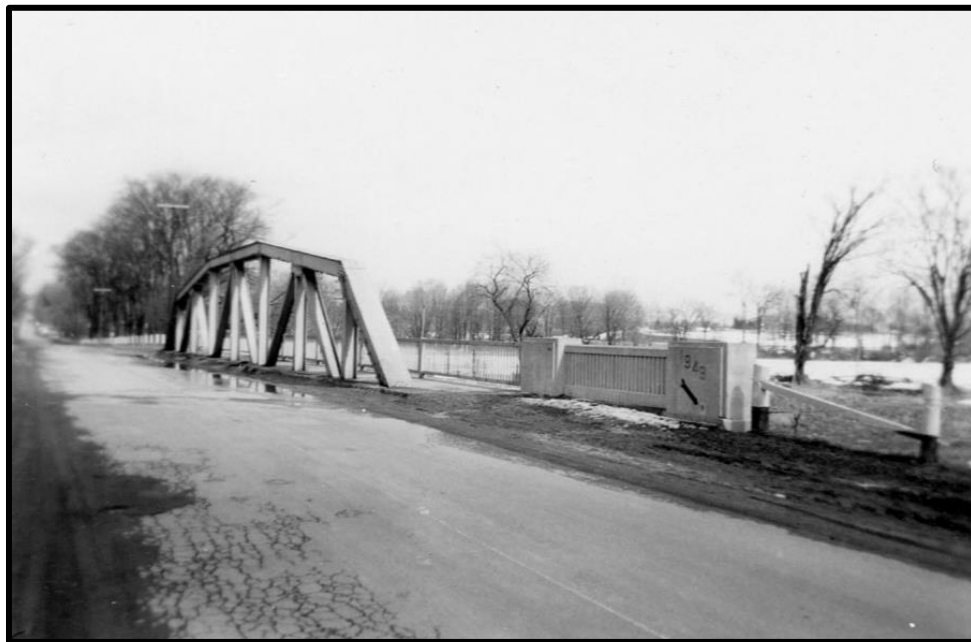
Figure 3: Archival Photo of the Old Derry Road Bridge, Note "1949" Pressed in the Concrete of the End Barrier Wall  
(Township of Toronto Fonds 1957, PAMA)

Frank Sibbald built a wooden bridge at this crossing location in the 1870s. In 1894 the wooden bridge was replaced with an iron bridge after an ice jam (see Figure 1). The current bridge was constructed in 1949, following the washout of the iron bridge (see Figure 2 and Figure 3). The 1949 bridge at Old Derry Road over the Credit River, known as the Meadowvale Bridge, was dedicated by the Premier of Ontario, Thomas Laird Kennedy (see Figure 3 and Figure 4).

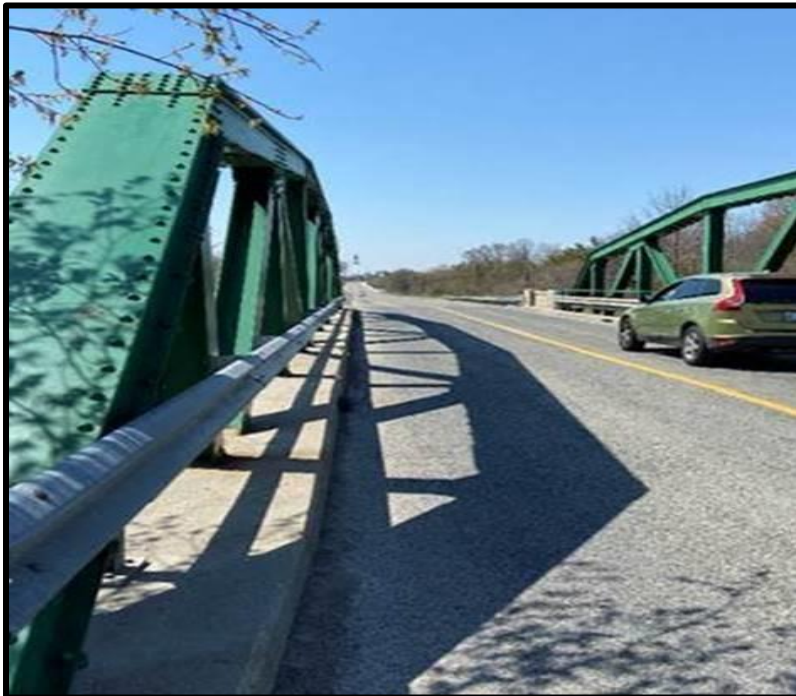
**Figure 7: Existing Guiderail affixed to the Truss Members**  
(McIntosh Perry 2021)

- Care should be taken when removing the existing guardrail from the truss members, repairs should use like materials and colour as truss;
  - Notwithstanding which Sealant Option is preferred, consider coating the concrete barrier walls with the same concrete sealant as the sidewalk in order to both protect the four concrete barrier walls as well as provide visual continuity across the entire bridge and approach;

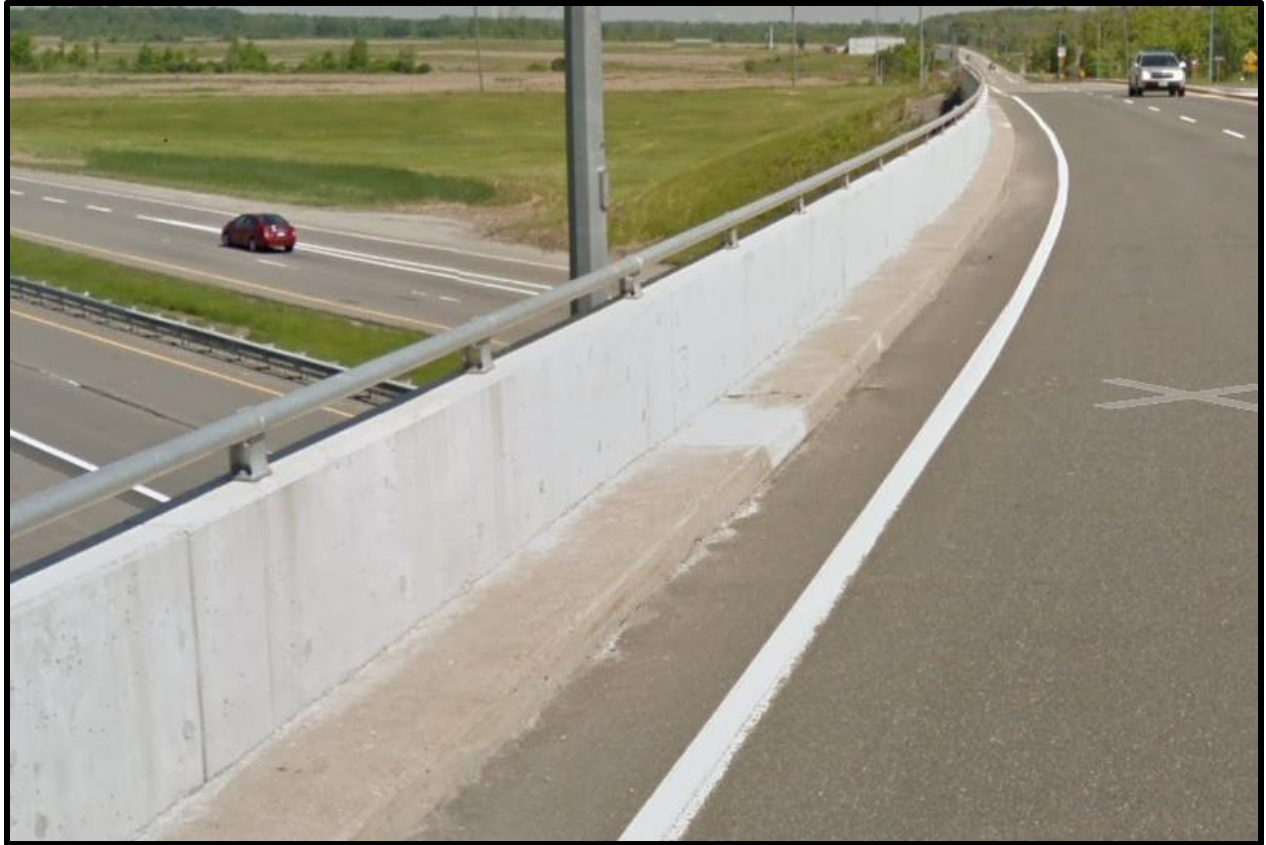
**Figure 8: Example of Guardrail Option 1: Concrete Parapet Wall**  
(McIntosh Perry 2021)

- If the replacement guardrail is to be Option 1: new concrete parapet wall consider having less concrete with a taller rail, if possible, to best retain the views;

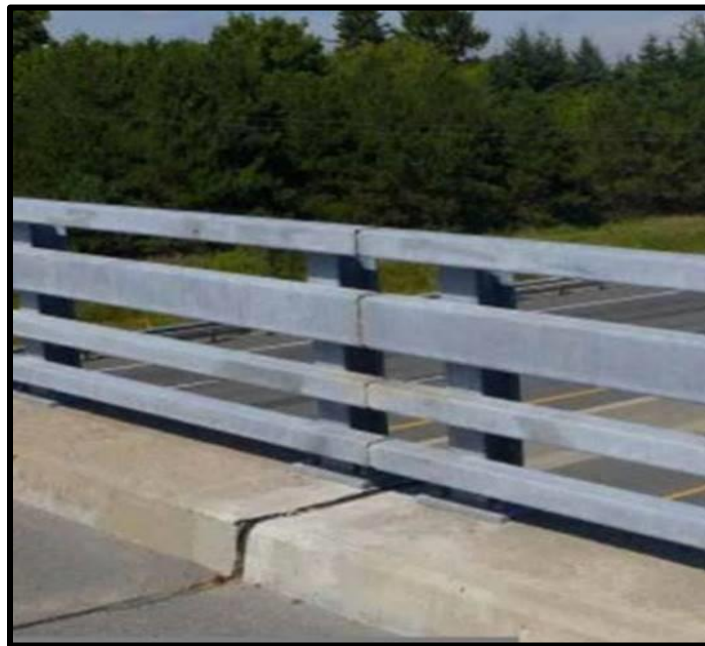
**Figure 9: Example of Guardrail Option 2: 4-Tube railing Steel Barrier**  
(McIntosh Perry 2021)

- If the replacement guardrail is to be the Option 2: 4-tube steel railing, that it should be painted in the same green colour as the truss.
  - Consider the least optically intrusive, low-profile steel railing and energy attenuators;

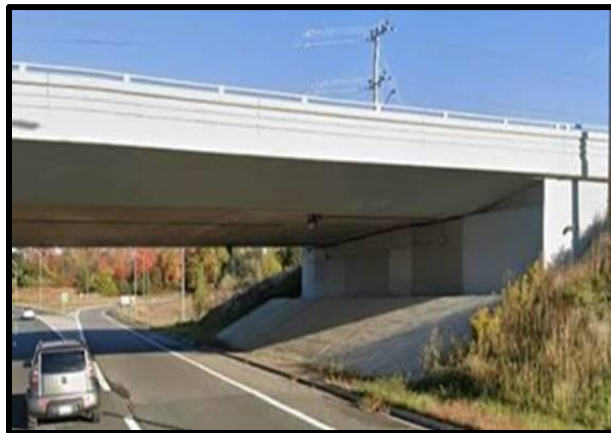
**Figure 11: Colour Option 1, Concrete-like Tone (McIntosh Perry 2021)**

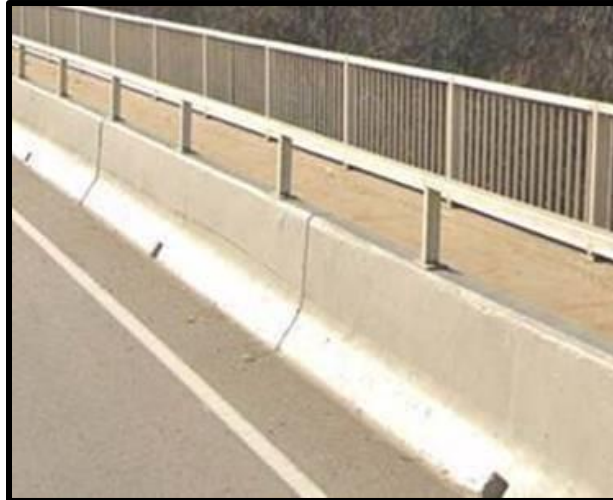
**Figure 12: Colour Option 2, Clear/Transparent**  
(McIntosh Perry 2021)

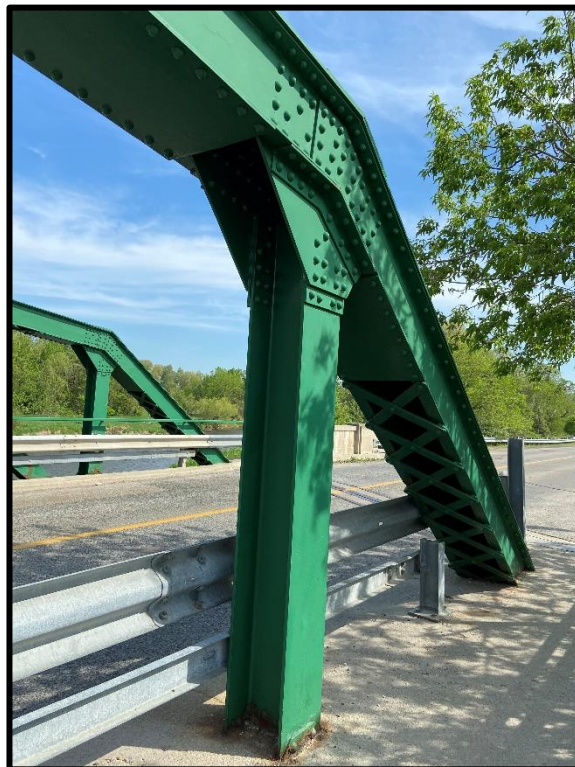
**Image 8: End Post Detail, South Side of Old Derry Road Bridge**  
(May 27, 2020; View looking North)

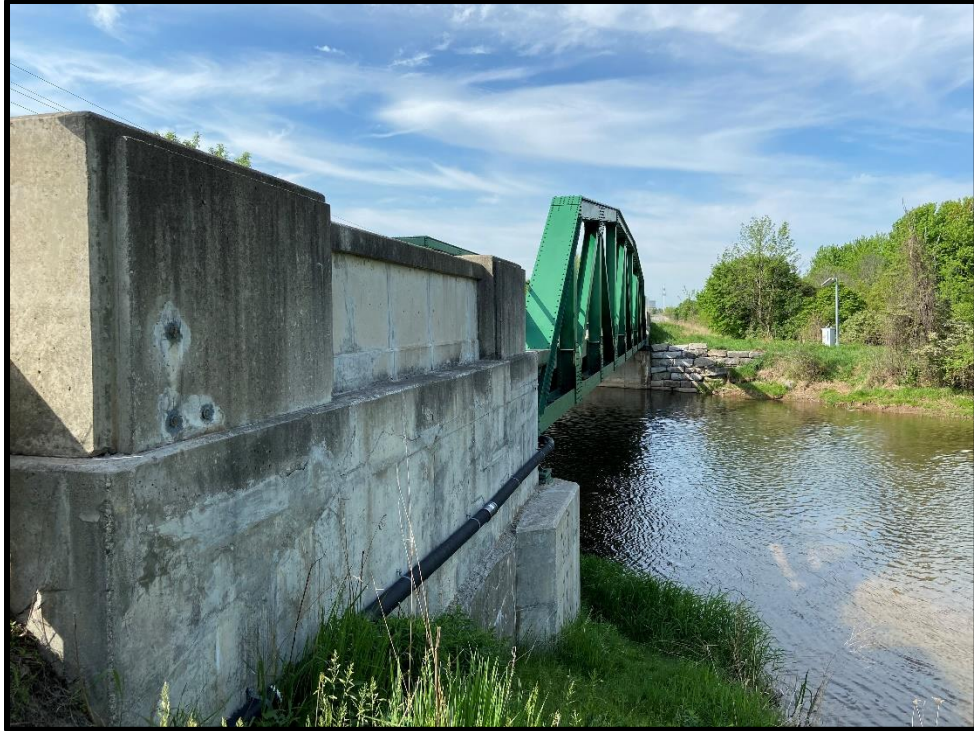
**Image 9: Detail From Southeast Corner to Abutment and North Side of Old Derry Road Bridge**  
(May 27, 2020; View looking Southwest)

The east and west abutments and wing walls are constructed of cast-in-place concrete (see Image 9, Image 12, Image 26) and the west retaining wall is a masonry gravity retaining wall (EMS 2017:5) (see Image 25). Both the east and west embankments are of soil (see Image 10). No maker's plate or date stamp were observed on the structure. "Algoma Canada" was pressed into the steel trusses, a steel producer in Ontario since 1901 (Algoma 2020). Monitoring equipment owned by the Credit Valley Conservation Authority is located on the southwest barrier wall (see Image 16). A drainage system including grates that lead to pipes exiting the underside of the bridge were observed.

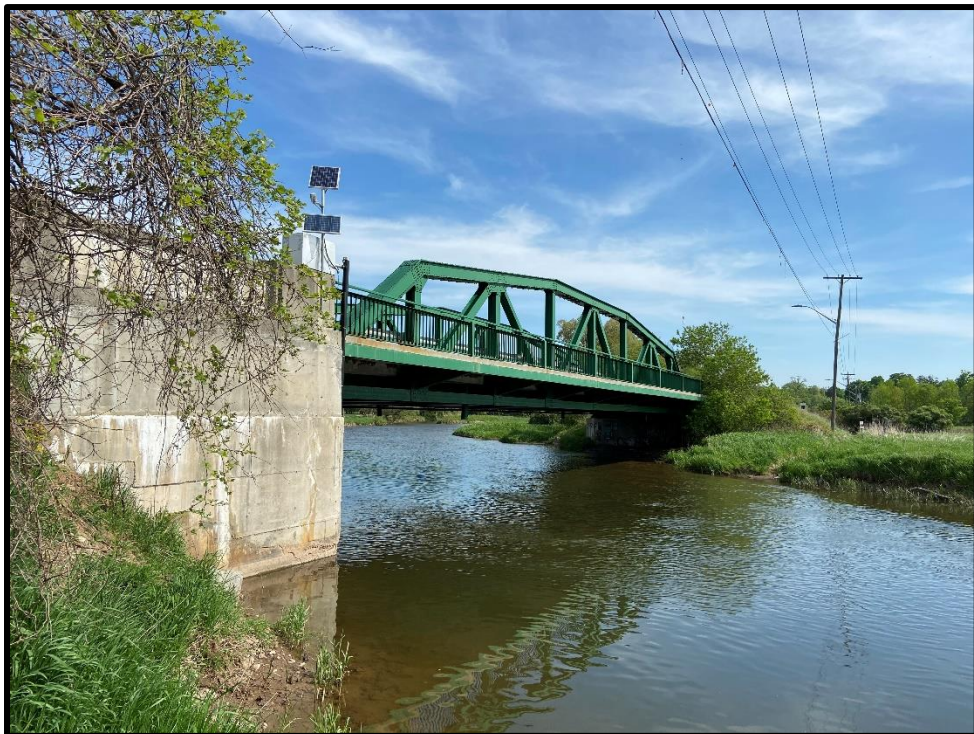
**Image 12: Old Derry Road Bridge West Abutment and South Wing Wall  
(May 27, 2020; View looking Northeast)**

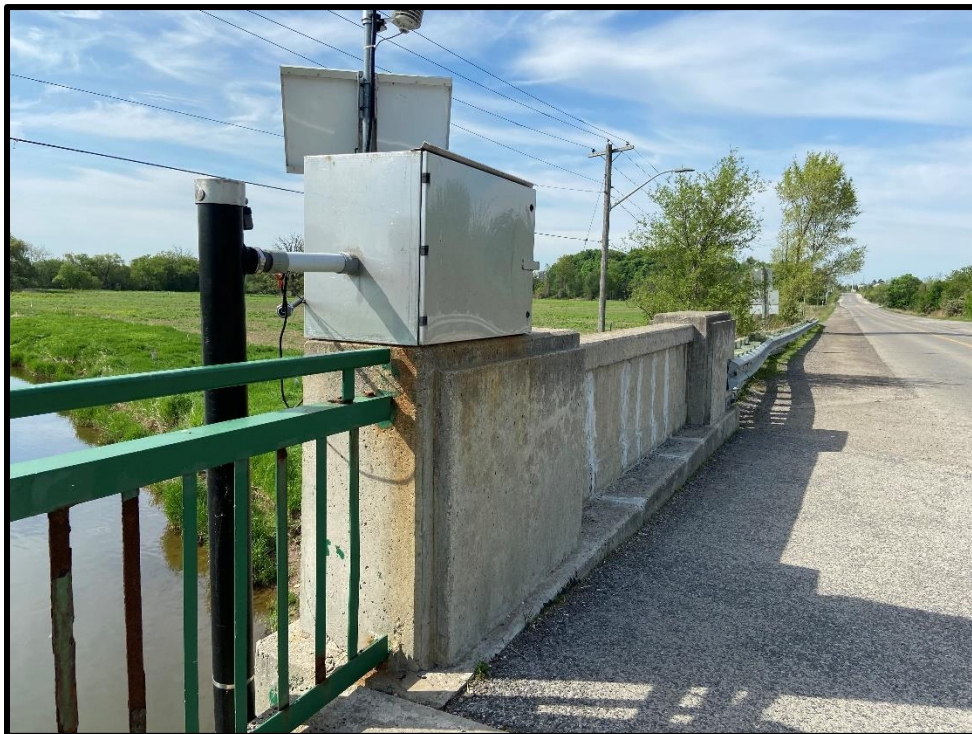
**Image 16: Detail of Southwest Barrier Wall and Monitoring Equipment  
(May 27, 2020; View looking Southeast)**

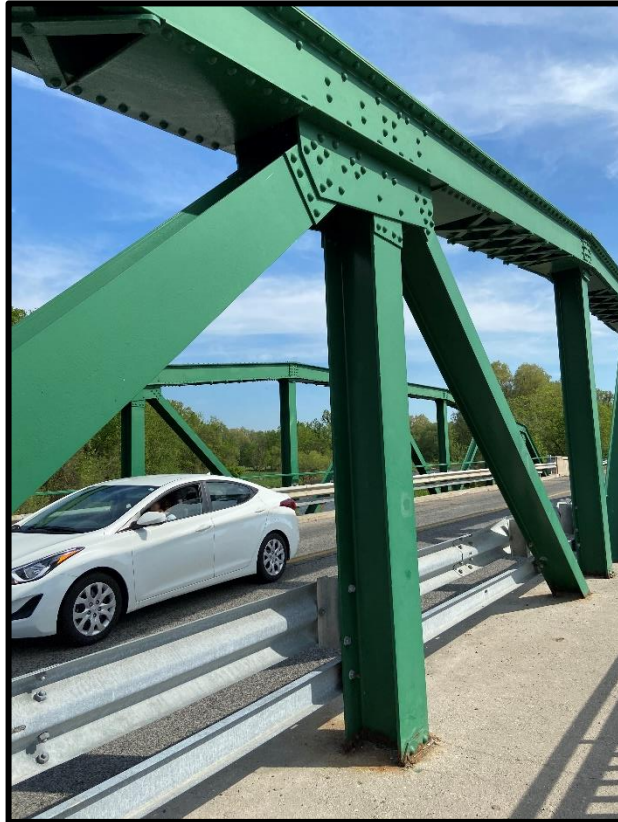
**Image 19: Detail of Diagonal and Vertical Members and Rivets, South Side  
(May 27, 2020; View looking North)**

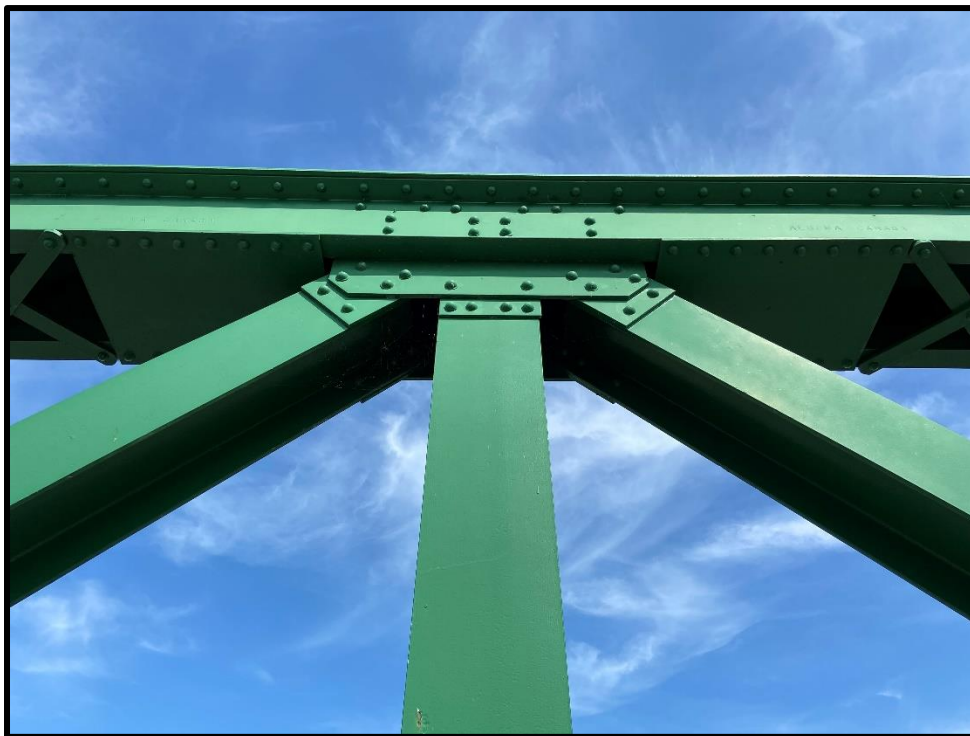
**Image 20: Detail of Top Chord Connection, South Side of Old Derry Road Bridge  
(May 27, 2020; View looking North)**

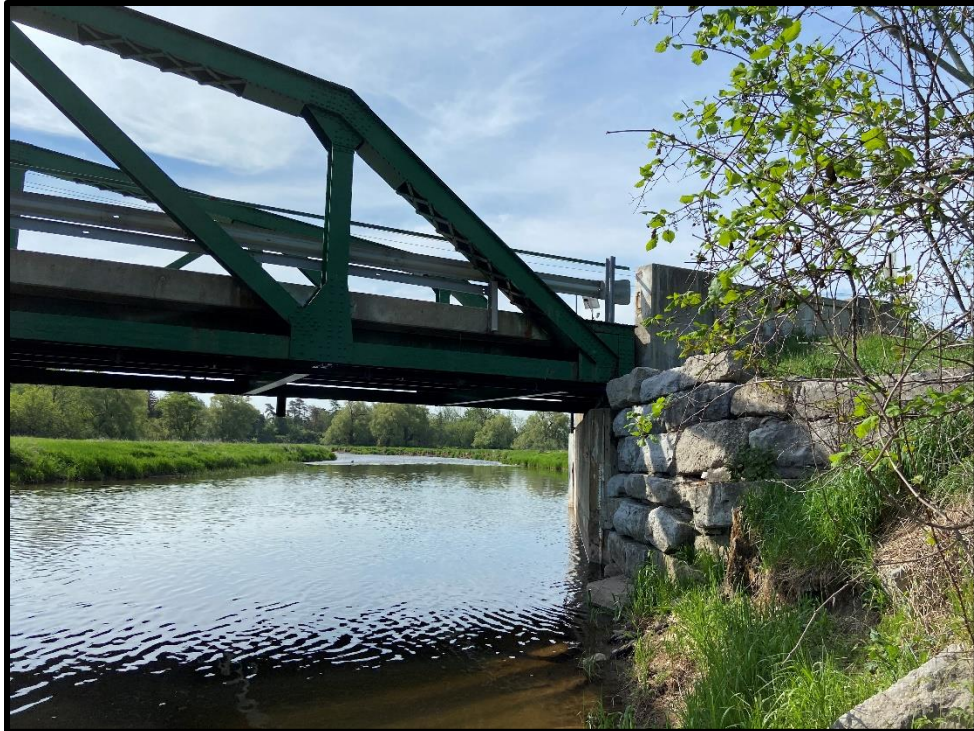
**Image 25: Detail of Masonry Gravity Retaining Wall, Northwest Side of Old Derry Road Bridge**  
(May 27, 2020; View looking Southeast)

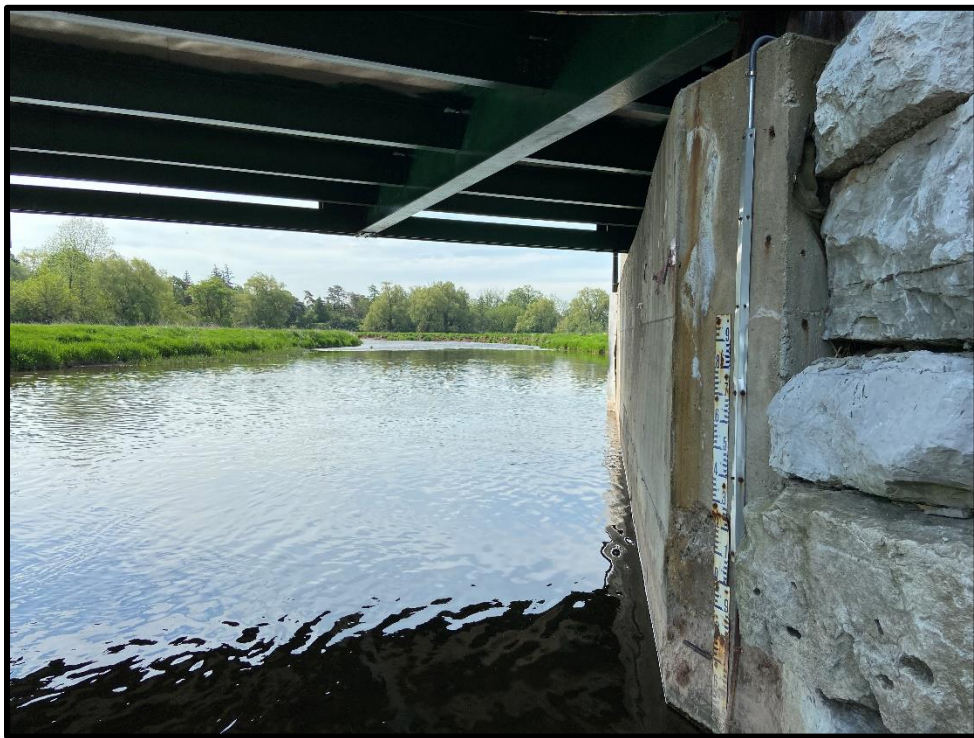
**Image 26: Detail of Old Derry Road Bridge Stringers and West Abutment**  
(May 27, 2020; View looking South)

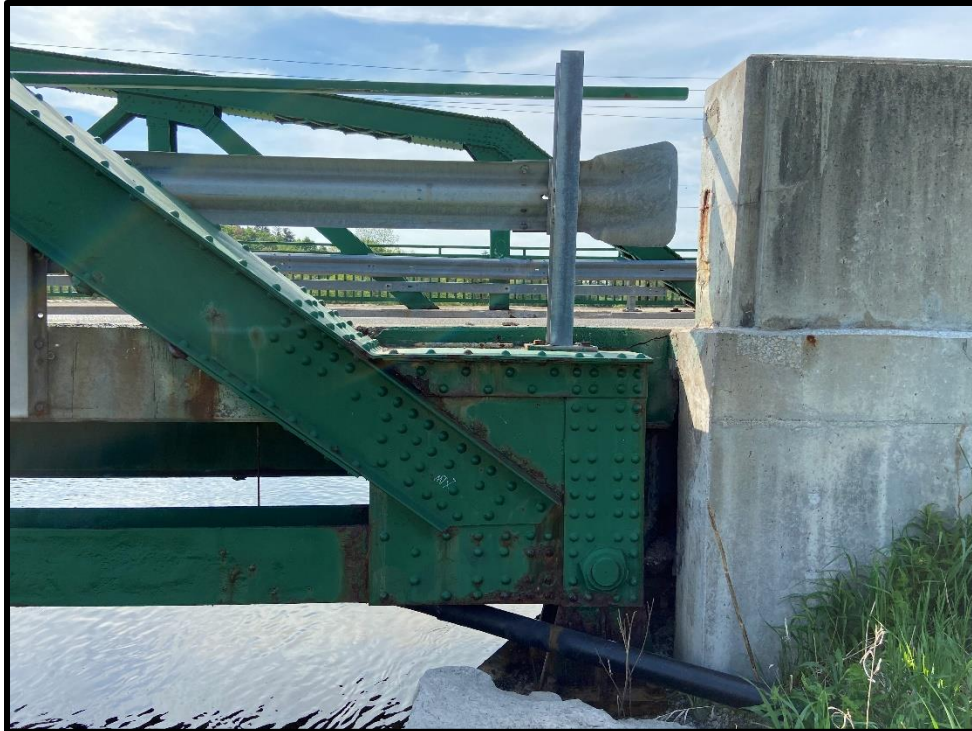
**Image 27: Detail of West Abutment Ballast Wall**  
(May 27, 2020; View looking South)

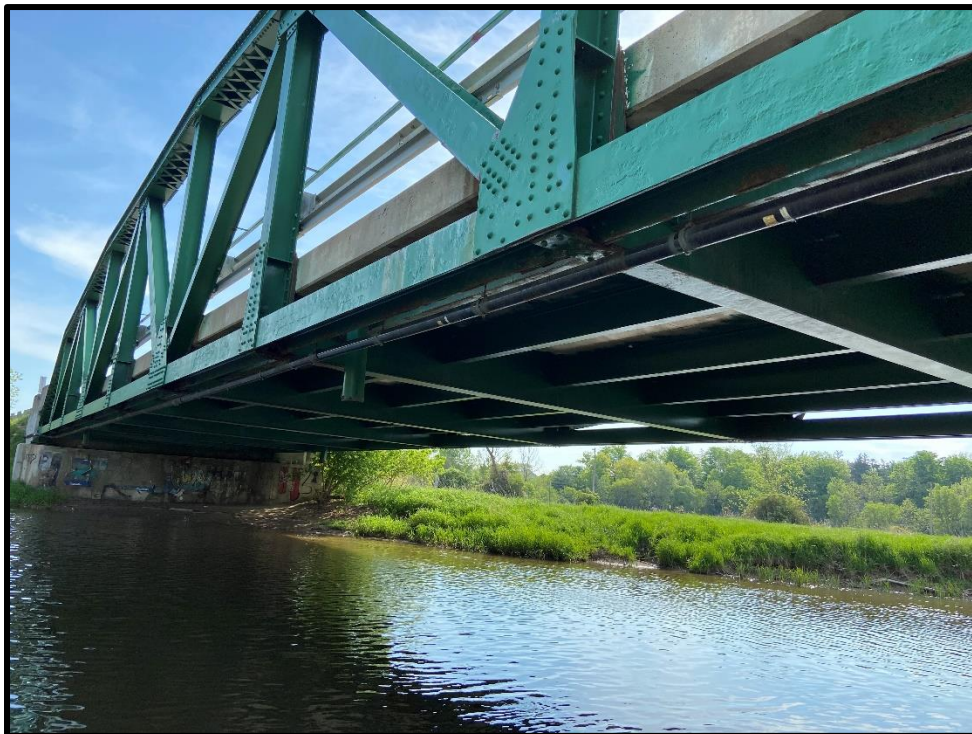
**Image 28: Detail of Floor Beams and Stringers, Underside of Old Derry Road Bridge**  
(May 27, 2020; View looking Northeast)

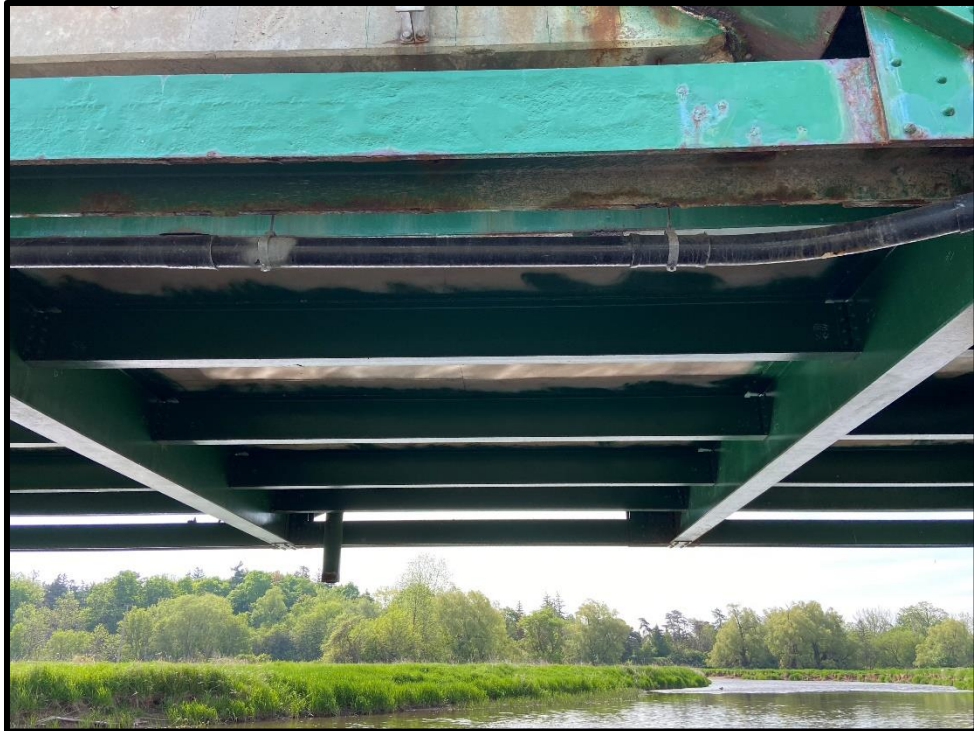
**Image 29: Underside Detail of Stringers, Old Derry Road Bridge  
(May 27, 2020; View looking Southeast)**

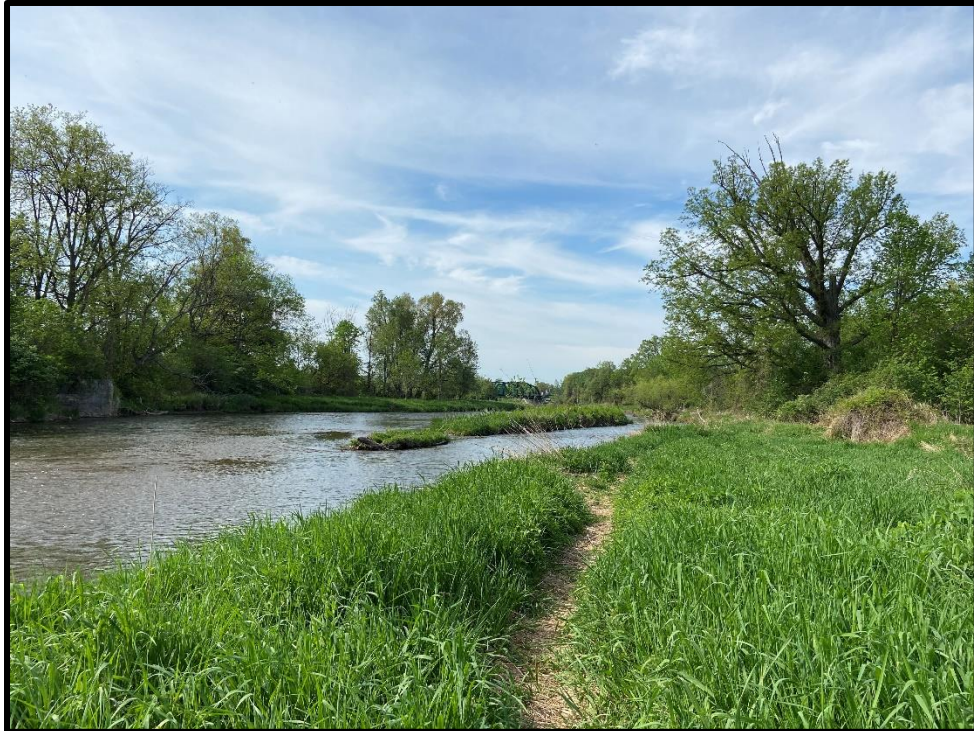
**Image 33: Abutment Ruins Northeast of Old Derry Road Bridge on Banks of Credit River**  
(May 27, 2020; View looking Southwest)

Cast-in-place concrete abutment ruins of a former bridge were observed northeast of the Old Derry Road Bridge. One abutment was located on both the north and south bank of the Credit River (see Image 33-Image 35). It is possible that this bridge ruin is associated with the former mill whose ruins, mill race, tail race and remnant mill pond are located in this area near Willow Lane and Old Derry Road (City of Mississauga 2014:20).

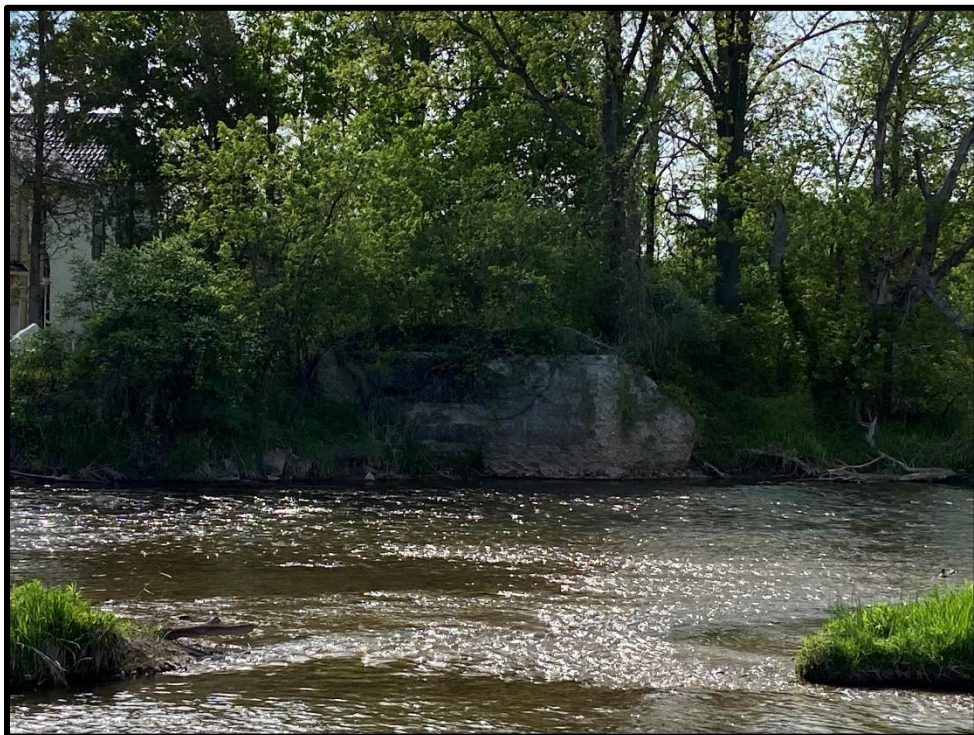
**Image 34: Detail of Abutment Ruin, South Bank of Credit River**  
(May 27, 2020; View looking Southeast)
