Kinsmen Hall Accessibility Upgrades Project Manager: Melissa Anastacio Project Architect: BSN Architects

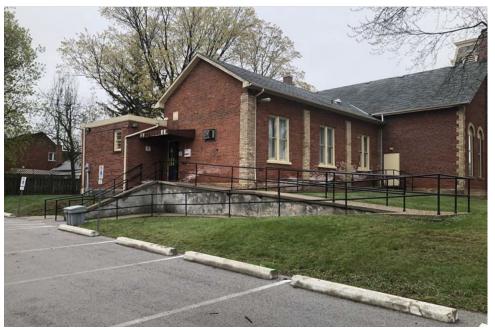
Existing Ramp Condition 1

- Ramp & Landing widths do not satisfy current FADS standards
- Tactile surface indicators not provided (fall hazard)

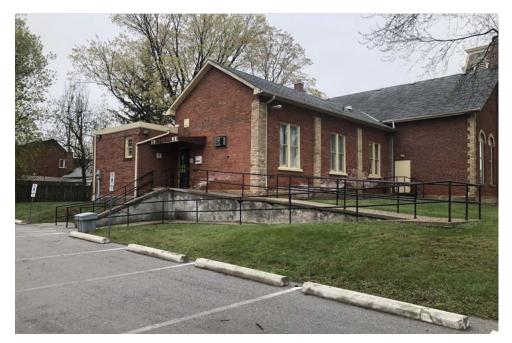
Existing Ramp Condition 2

• Entry door does not meet current FADS standards. Door requires widening to accommodate wheelchairs more comfortably

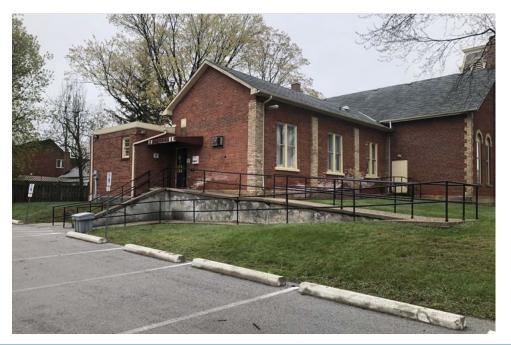
Existing Ramp Condition 3

- Entrance canopy does not provide sufficient shelter and protection from the elements.
- Canopy drains water onto stairs (slipping hazard).
