HERITAGE IMPACT ASSESSMENT

1576 DUNDAS STREET WEST, ERINDALE CITY OF MISSISSAUGA, ONTARIO

ASI File: 17CH-114

October 13, 2017 (Revised February 2020, August 2020)

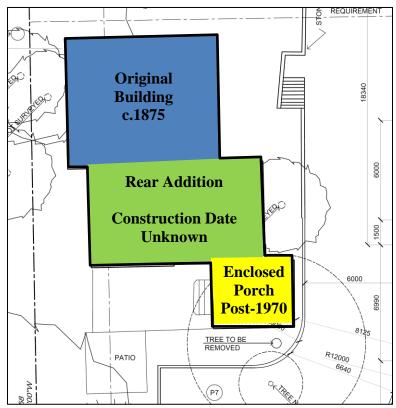
Figure 31: Layout of the Taylor-Froebel House

The structure at 1584 Dundas Street West is a two-storey Second Empire building with a rear addition (Figure 31). The building has been stuccoed and the mansard roof is covered in asphalt shingles. The building is accessed from an entry on the east elevation within one of the rear additions (Figure 32). The original entrance along Dundas Street West remains (Figure 33 and Figure 34), though there is limited space between the door and the row of vegetation between the building and the street. The first floor of the north elevation is divided into three bays with two-over-two double hung wooden windows with wooden storm windows and shutters. The centre bay contains the original entrance with "The Froebel House" on a carved wooden name plate above the door. The upper storey dormers on the second storey feature gables and pseudo four-centered wooden arches (Figure 35). The windows appear to be aluminum.

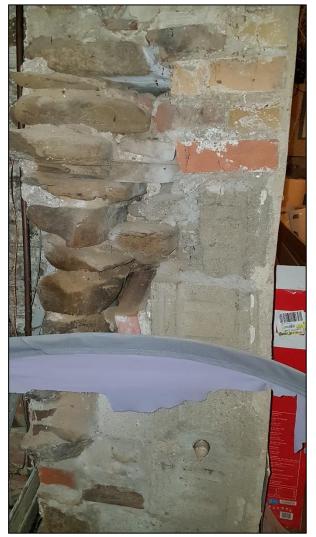
Figure 71: Portion of the foundation wall where the original stone foundation meets the concrete block foundation of the rear addition (note that portions have been repaired with brick)

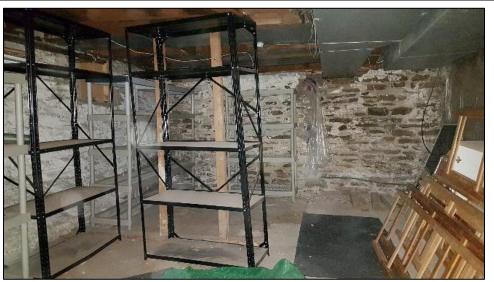
Figure 72: Unfinished basement with stone foundation walls

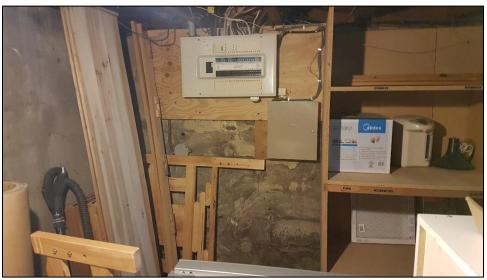
Figure 73: Basement photo showing the concrete block foundation with parging

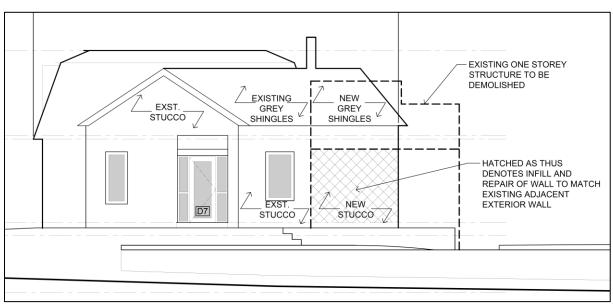
Figure 81: Elevation drawing of the south elevation showing the removal of the Taylor-Froebel House's sunroom (Weiss Architecture and Urbanism Ltd.)

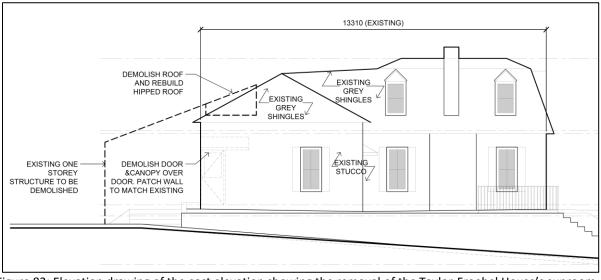
Figure 82: Elevation drawing of the east elevation showing the removal of the Taylor-Froebel House's sunroom. (Weiss Architecture and Urbanism Ltd.)

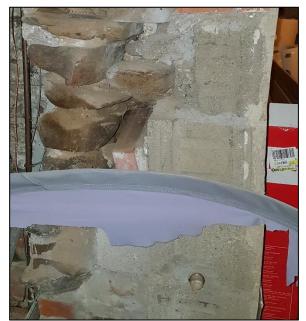
Figure 84: Photo of the stone foundation of the original building where it meets the concrete block foundation of the rear addition

- The original house was built using a stone foundation, while the rear addition was constructed using a concrete block foundation (Figure 84 and Figure 85).
- The rear exterior wall (including window openings) to the original house is present within the interior of the house (Figure 86).
- There is evidence that the mansard roof was extended in the rear to accommodate the addition. Based on this evidence, ASI does not believe that the removal of this portion of the rear addition will have a significant impact on the cultural heritage value of the building (Figure 87).

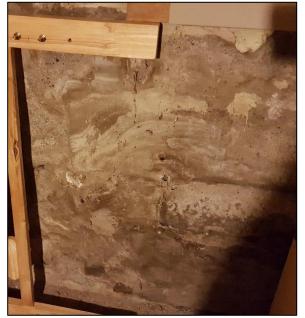
Figure 85: Concrete block foundation with parging

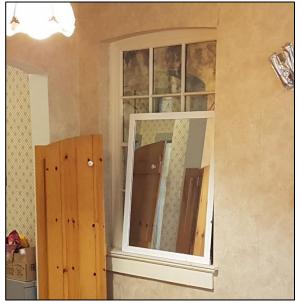
Figure 86: Photo of an original rear window, now present within the residence

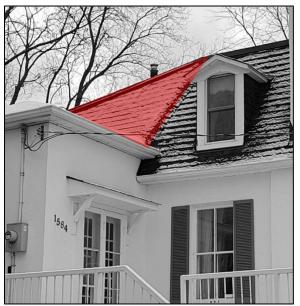
Figure 87: Photo of the extension of the mansard roof (the extension is shown in red)

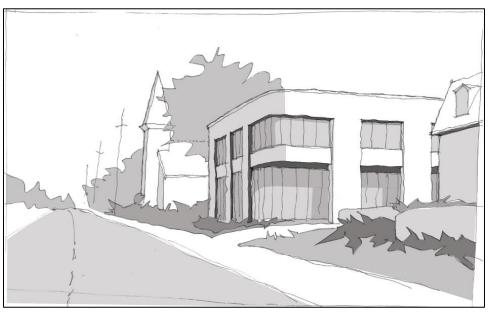
Figure 88: Sketch of the proposed addition to the Erindale Academy (Weiss Architecture and Urbanism Ltd

The proposed addition to Erindale Academy at 1576 Dundas Street West is a two-storey structure with a brick and glass façade and contemporary design, which are intended to compliment the materials of the adjacent buildings, while not mimicking or detracting from the adjacent Taylor-Froebel House and Erindale Presbyterian Church. The proposed addition is situated approximately 28m from the original c.1875 portion of the Erindale Presbyterian Church and 9.6m from the adjacent Taylor Froebel House and this distance should minimize potential visual impacts on both buildings. The Erindale Presbyterian Church is noted as a landmark on Dundas Street West and while planning staff have requested the siting of the proposed addition to the front of the existing building at 1576 Dundas Street West, the church's steeple/tower is not anticipated to be obscured significantly from the public right-of-way on Dundas Street West (Figure 88).

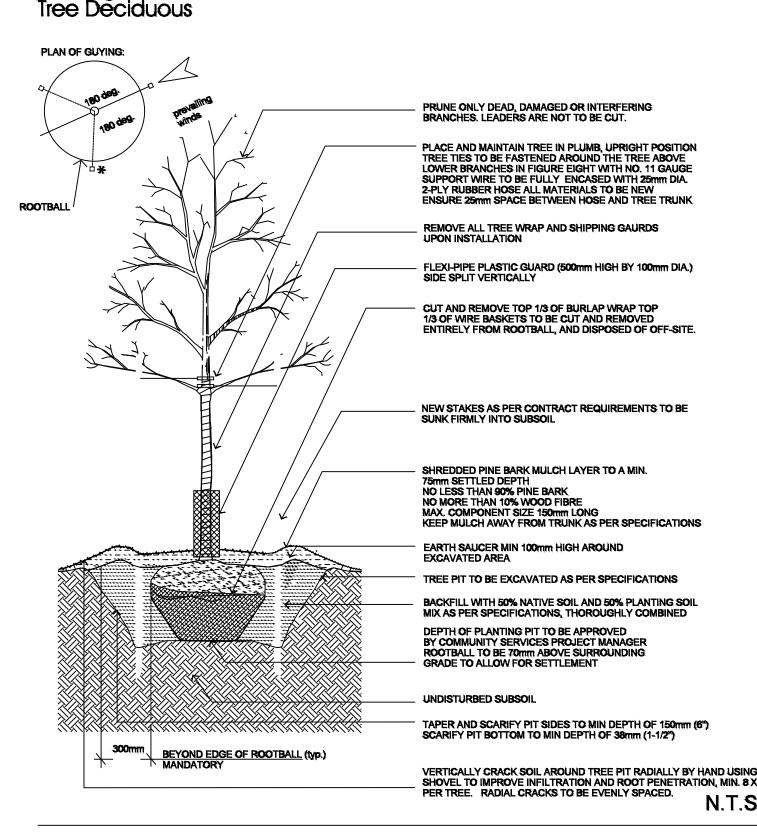
Detail: 02950-1

02950-1 Planting Tree Deciduous

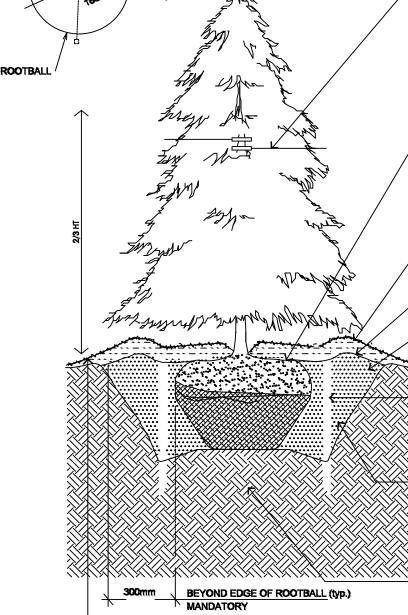
Details: 02950-2

02950-2 Planting Tree Coniferous PLAN OF GUYING

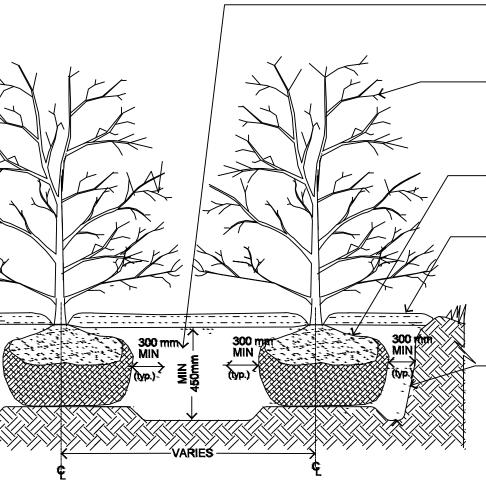
02950-6

BACKFILL BED C/W PLANTING SOIL MIX PER NOTES **PROVIDE SOIL ANALYSIS** FOR REVIEW PRIOR TO **IMPORTING TO SITE/PLACING**

PRUNE TO REMOVE DEAD. DAMAGED BRANCHES PLANTS TO BE INSPECTED PRIOR TO PLANTING COMMUNITY SERVICES PROJECT MANAGER
