City of Mississauga

Gulleden Park Redevelopment

Presentation to Accessibility Advisory Committee

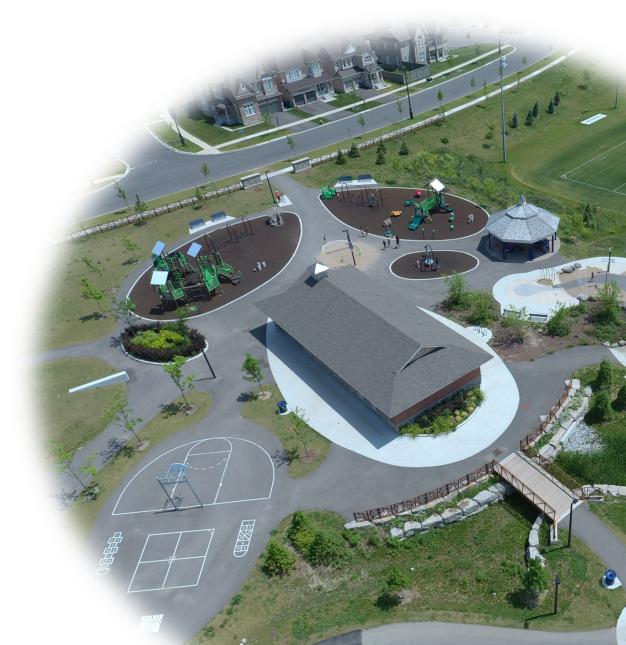
Gulleden Park Master Plan

Program Elements

- Playground
- Spray Pad
- Junior Skateboard Park
- Multi-use Basketball Court
- Pickleball
- Skating Facility with Creative Play Markings
- Park Operations Yard
- **Existing Tennis Courts**
- Fitness Area

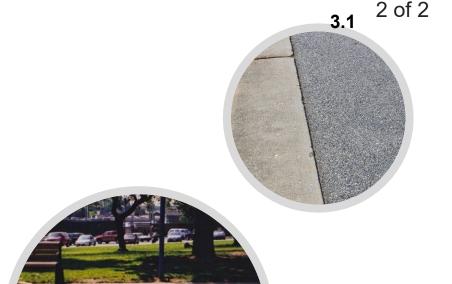
Site Furnishings

Accessible Gathering Tables

Bench Pad Extensions

Benches with Backs and Arm Rests

Gulleden Park will exceed the FADS 20% minimum requirement of accessible tables on site.
