City of Mississauga Memorandum

Date: 2023/02/27
To: Heritage Advisory Committee
From: Melissa Anastacio, Project Manager, Capital Design and Construction,
Facilities and Property Management
Meeting Date: April Heritage Advisory Committee Meeting
Subject: Port Credit Library – Masonry Wall Abatement and Renewal

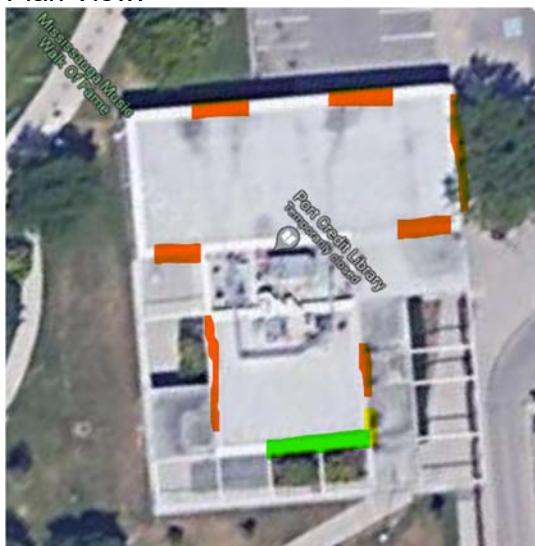
Plan View:

The following areas of masonry, highlighted in orange are confirmed as asbestos containing and will require full abatement and rebuild: Yellow area shown does not have vermiculite found at this point. Green area shown is the south wall which does not have vermiculite but will undergo rebuild to improve the design.

An environmental consultant was retained to review and provide recommendation to address the presence of asbestos containing vermiculite and the impact on ongoing masonry repairs. Because of the placement and flowing nature of vermiculite it was recommended that all of exterior masonry walls will need abatement and full replacement/rebuild.

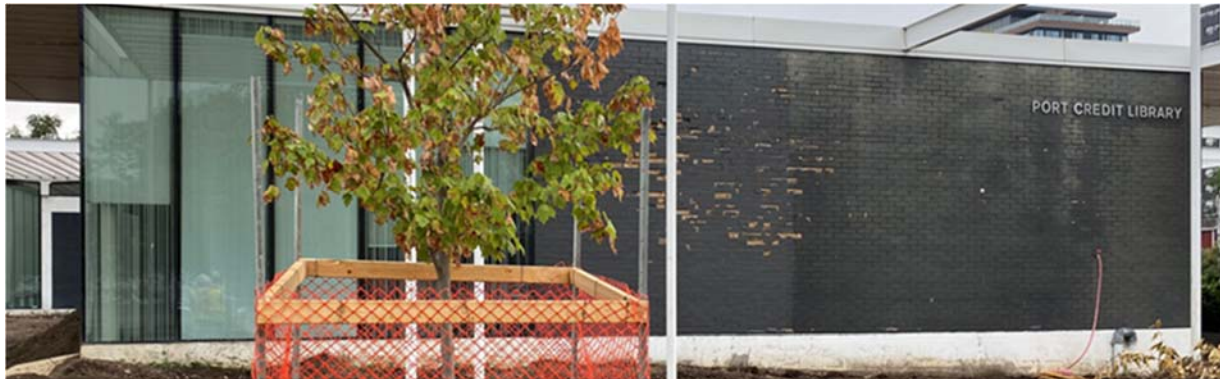
Please see below photo of a typical masonry wall at the site building. Currently the masonry has been painted black, is spalling and has discoloration occurring as well. This condition triggered the initial need for repairs, and led to the discovery of the vermiculite.

- The existing masonry walls will be completely removed and all vermiculite present removed/abated as per abatement guidelines.
- We will then clean the concrete block back up wall and apply Vapour Barrier throughout. There is currently no vapour barrier present so this will improve the building envelope system greatly.
- We will rebuild the masonry walls, complete with air gap and weep holes to allow for airflow and drainage for the wall cavities. There are currently no weep holes on several elevations, so this will greatly improve the wall system durability.

The masonry we are proposing will be black, to match the look of the current system, and will not be painted. This will greatly improve durability and longevity to the masonry wall areas and will prevent the spalling and discoloration that is present typically in painted masonry systems. The new black masonry walls will have black mortar joints installed to match the colour of the masonry for a uniform look. This will ensure we maintain the current aesthetic of the masonry walls with a uniform black appearance.
