Meadowvale Theatre Renovation – Accessibility Review Mississauga, Ontario

- Construction Documents, October 2020 January 2021
- Bidding Phase, January 2021 March 2021
- Construction, April 2021 April 2022

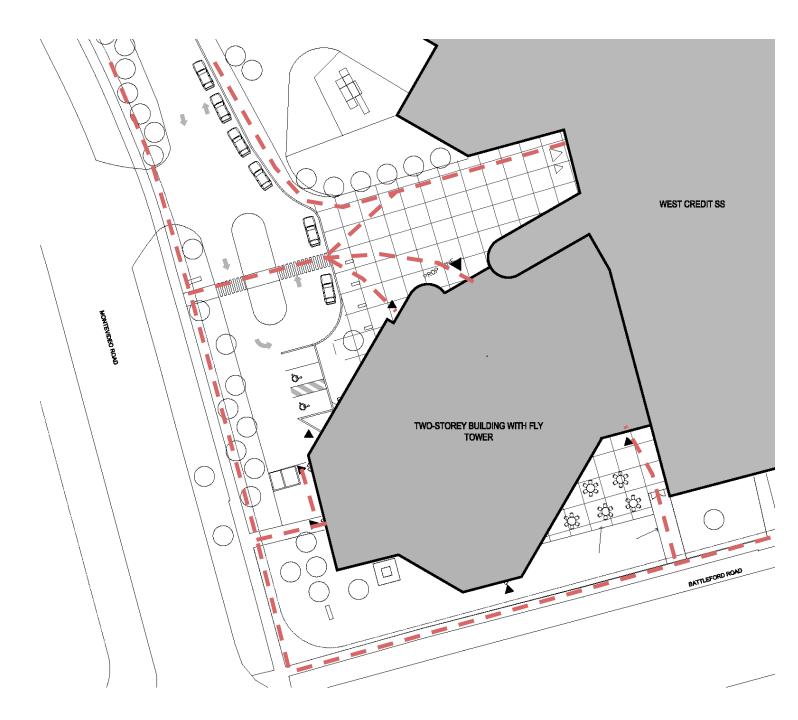
Accessible Parking Spaces & Entrances

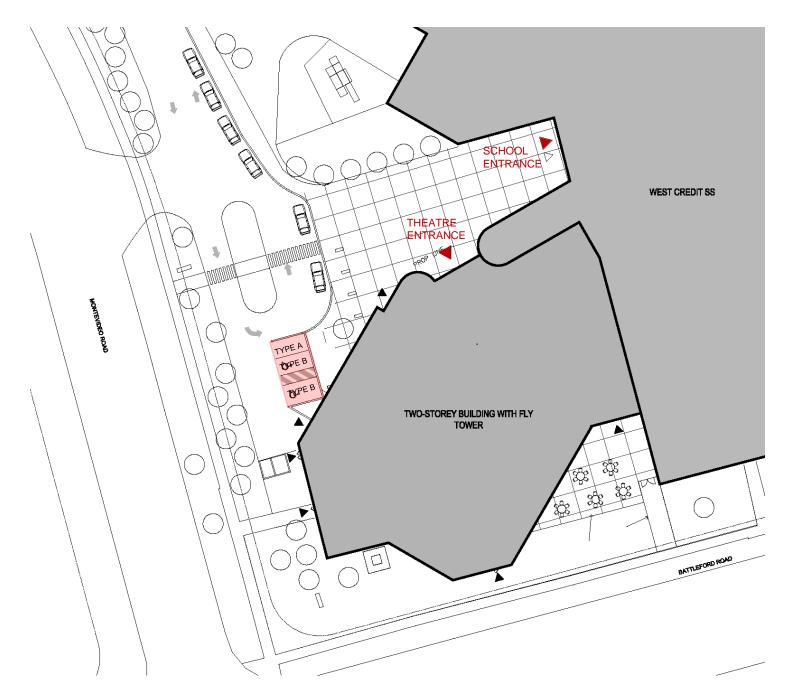
Auto Door Operators

AUTO DOOR OPERATOR

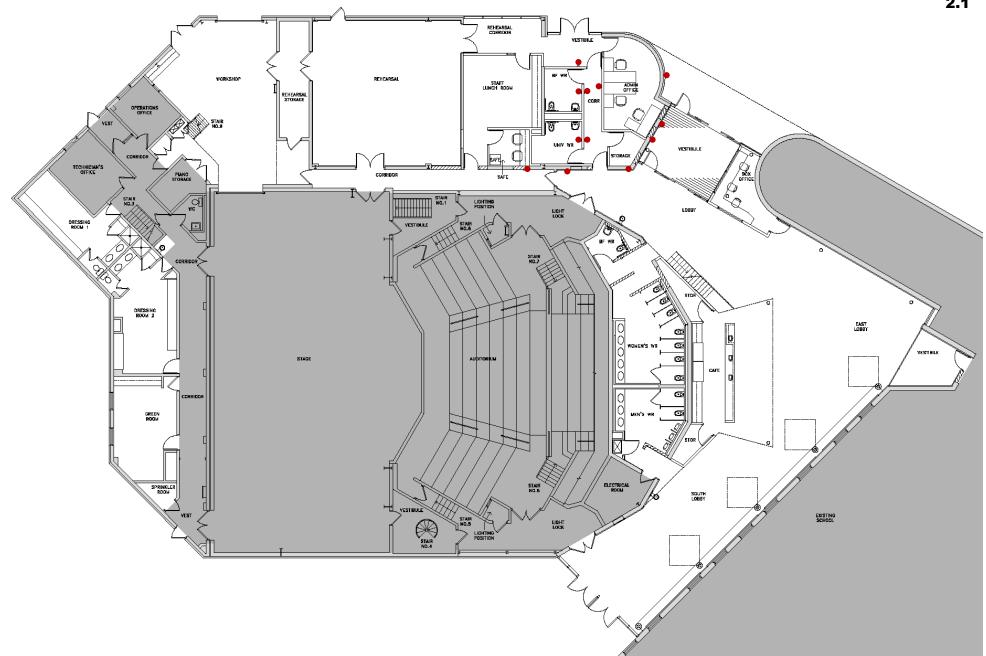
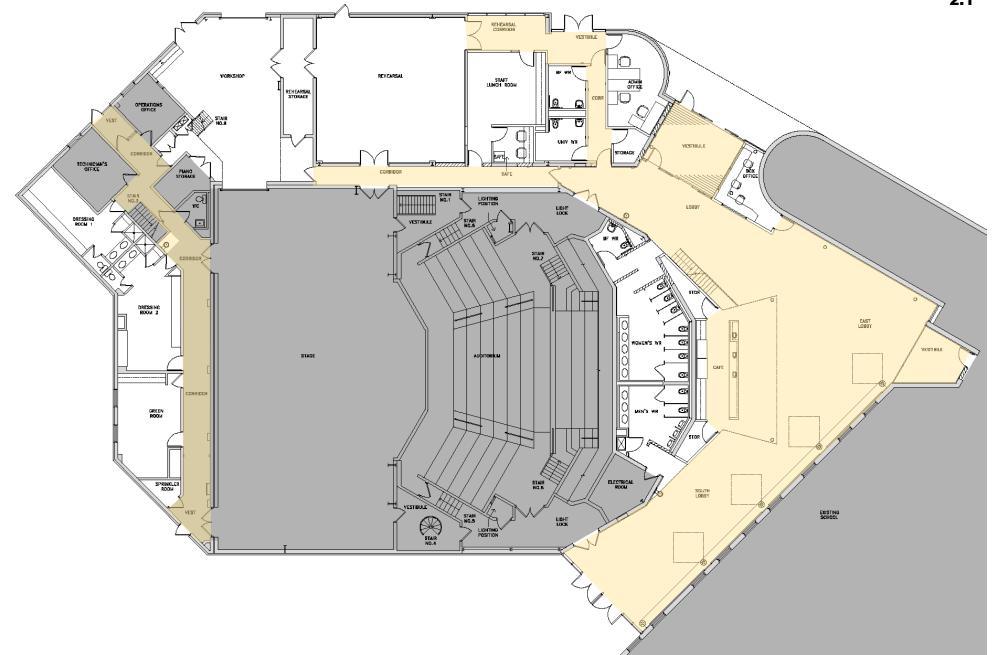
Main Circulation Plan

Main Circulation

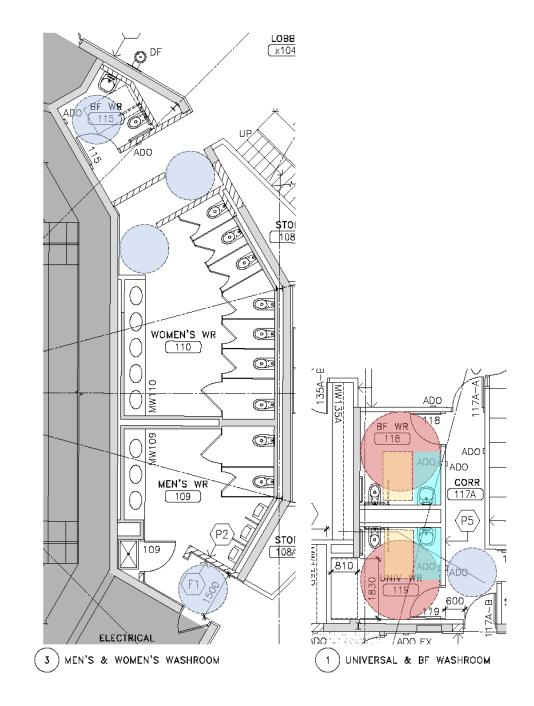
Washroom Blow-Up

- 1370 Lavatory Clearance
- 915x1500 Transfer Space
- 2440 Turning Space
- 1500 Turning Space
