HERITAGE IMPACT ASSESSMENT

**36 BAY STREET**  
MISSISSAUGA, ONTARIO

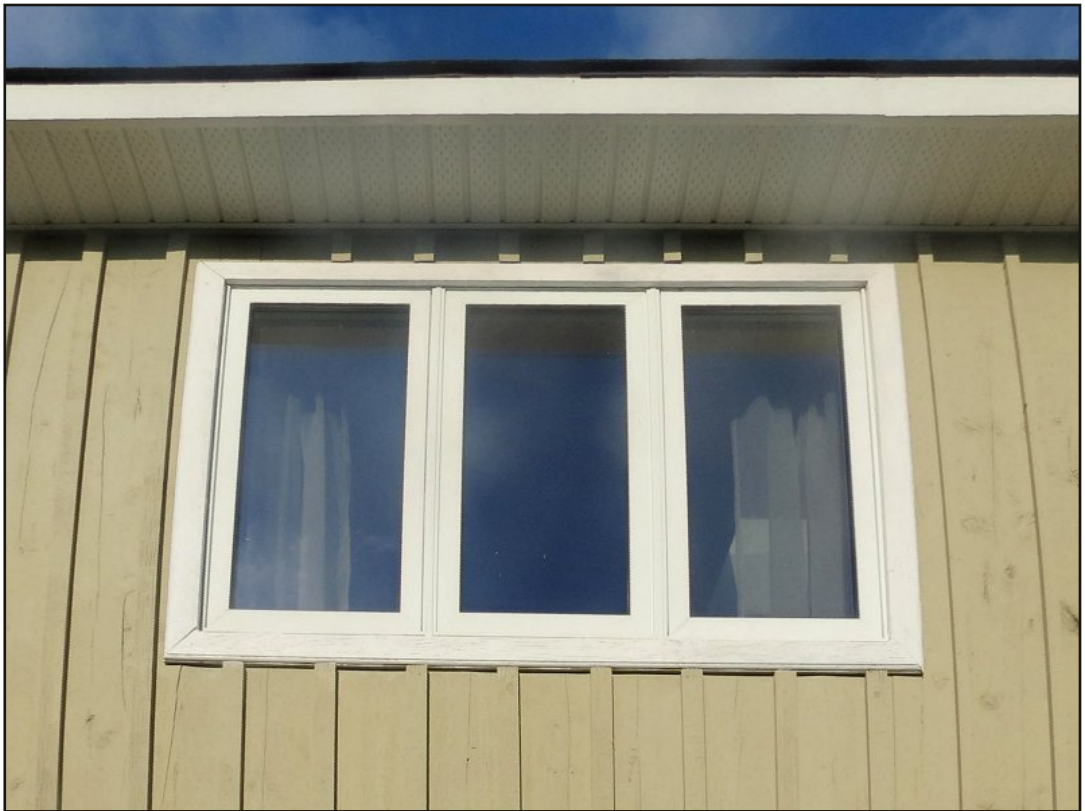
*2.3.2e: modern window - rectangular*

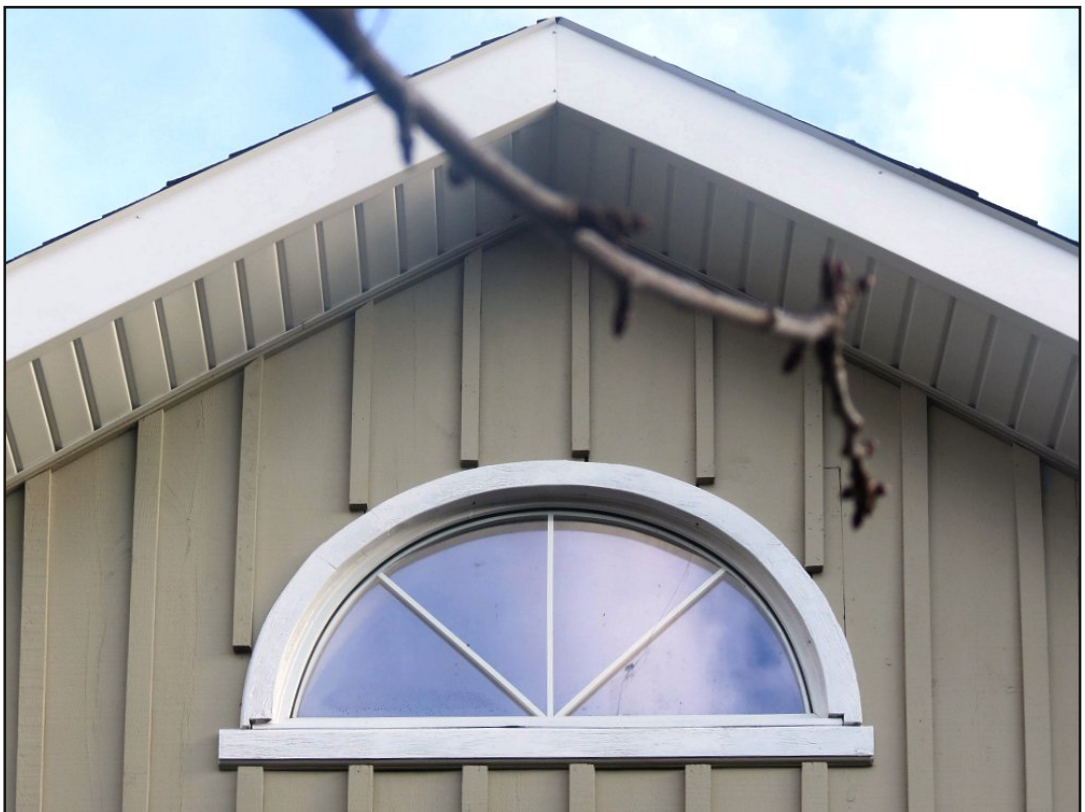
*2.3.2f: modern window - semi-circular*

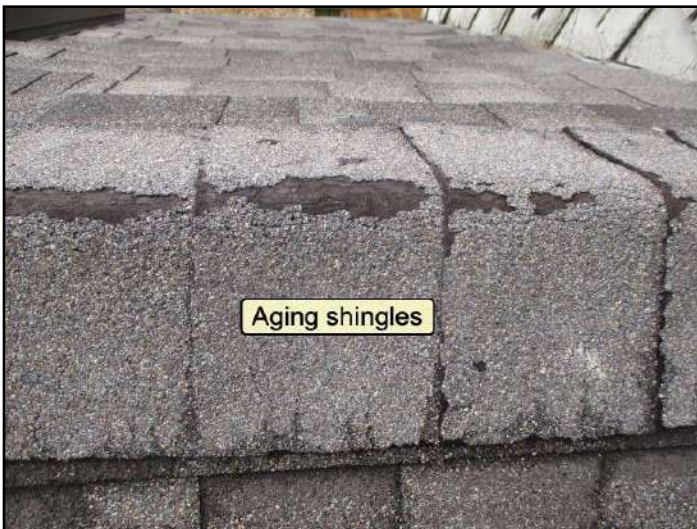
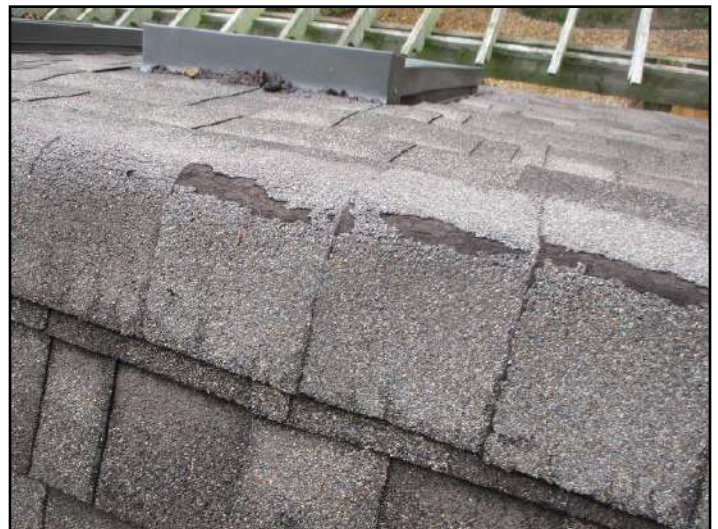
**Condition:** • Damage

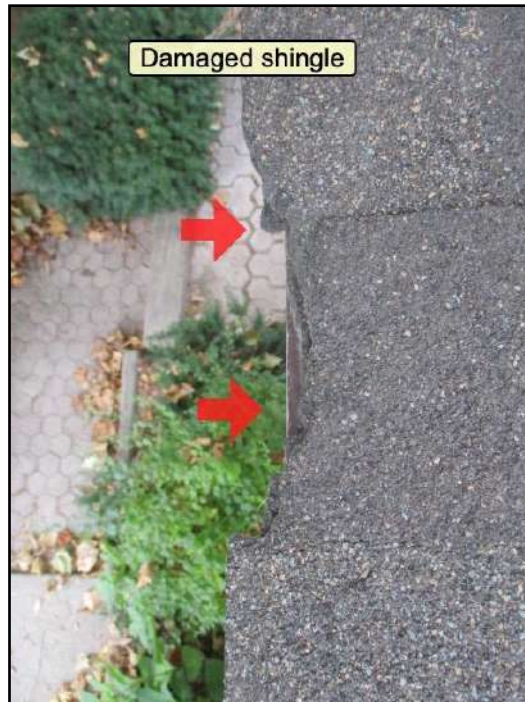
## FLASHINGS - DRIP EDGE \ 2.11

**Condition:** • [Missing](#)

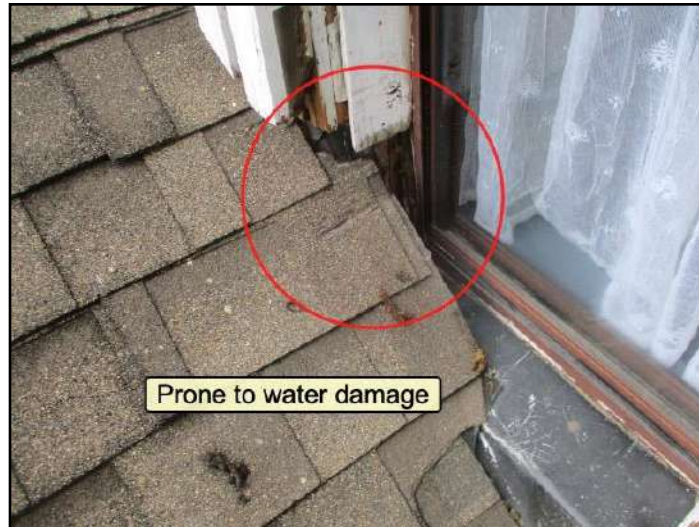
## WALL SURFACES \ 4.0

**Condition:** • [Deteriorated](#)

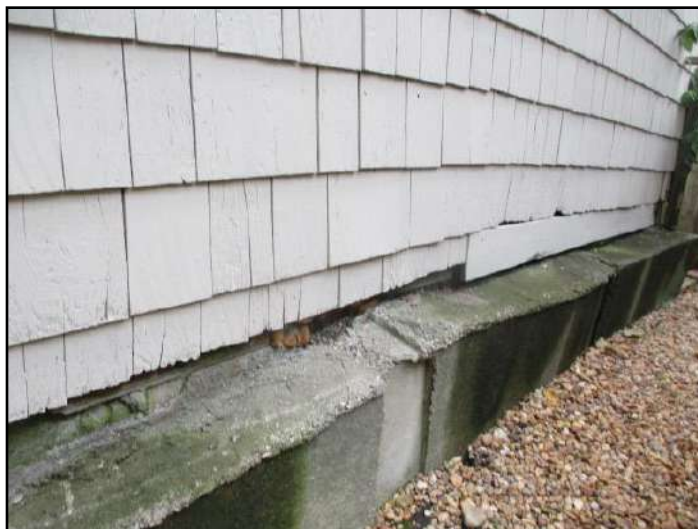
**Condition:** • Insulbrick is a brand name for fiberboard panel siding coated with an asphalt and granule surfacing similar to roof shingles. There is often a coloured pattern that looks like brick, from a distance.

This material has not been manufactured for some time, and installations are quite old, often showing damage or deterioration. Water penetration and damage to the walls behind the siding are potential problems where there are imperfections.

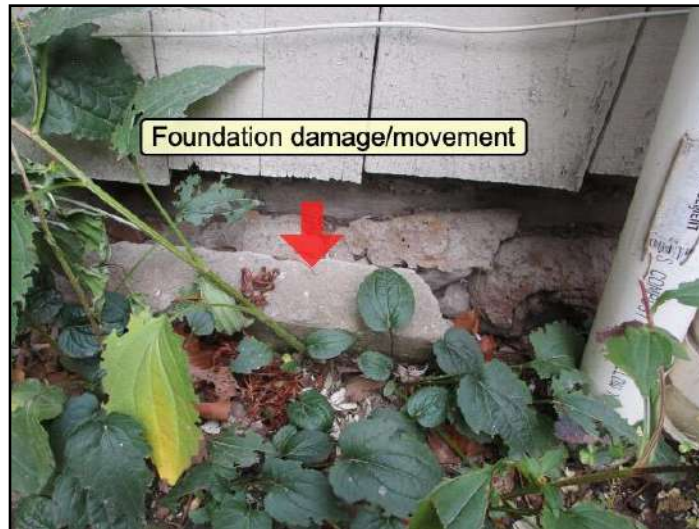
## SILLS \ 5.1

Condition: • [Suspect](#)

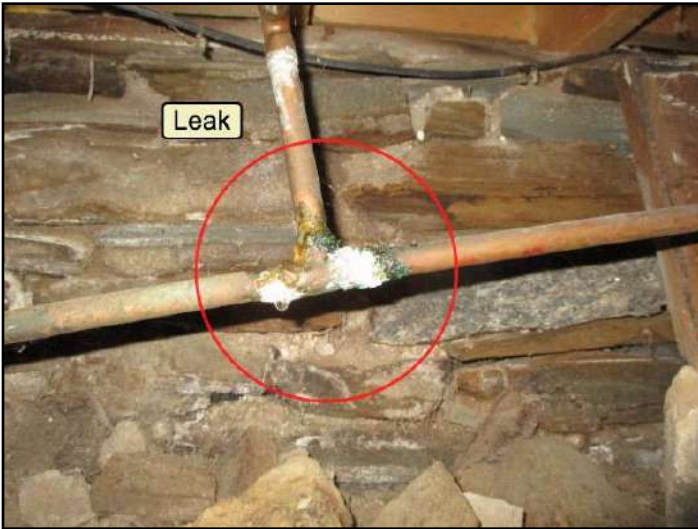
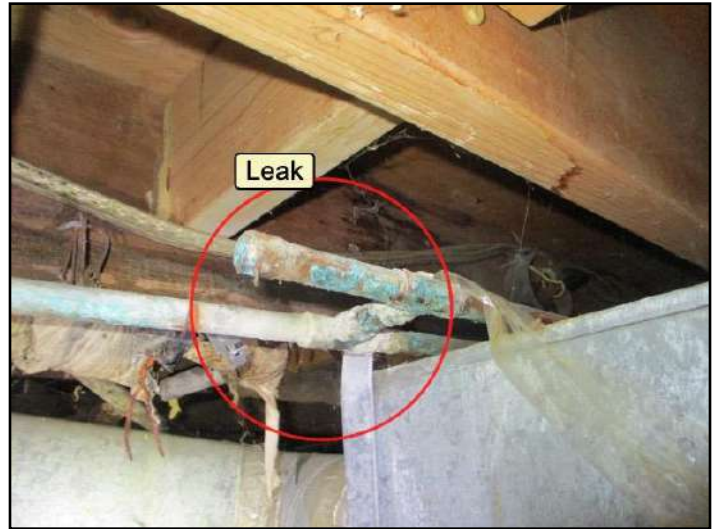
**Condition:** • Leak

**Task:** Repair

**Time:** As soon as possible

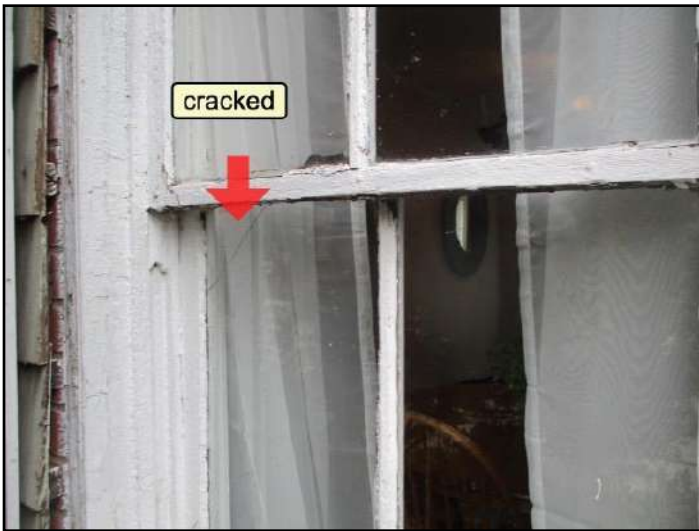
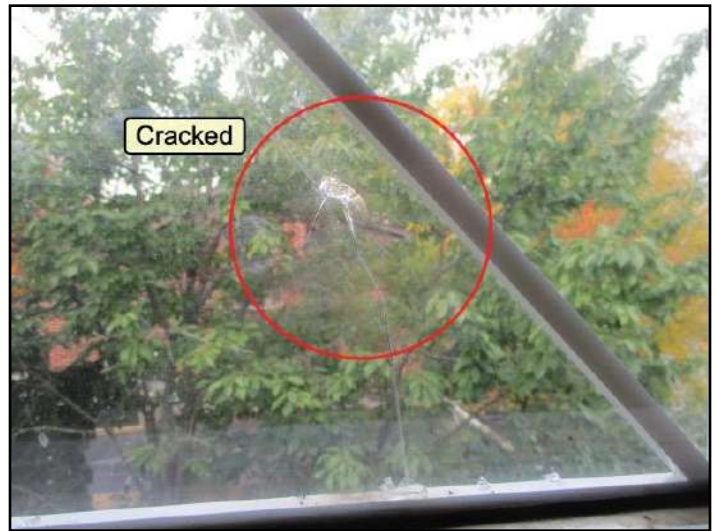
**Condition:** • [Glass cracked](#)

**Task:** Replace

**Time:** Less than 1 year
