HERITAGE IMPACT ASSESSMENT

EDITH CLARKSON HOUSE 1160 Clarkson Road North CLARKSON - CITY OF MISSISSAUGA

04 SEP 2020

MEGAN HOBSON CAHP

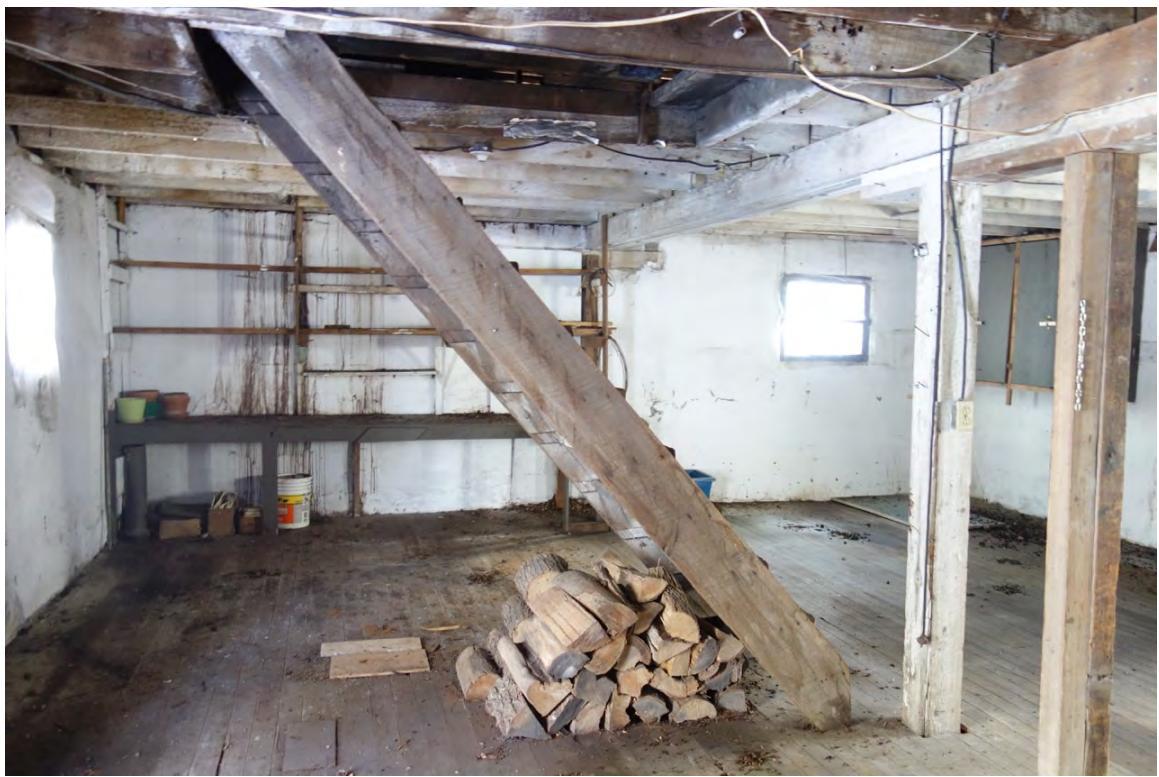
GARAGE – interior – wood framing and wood floors

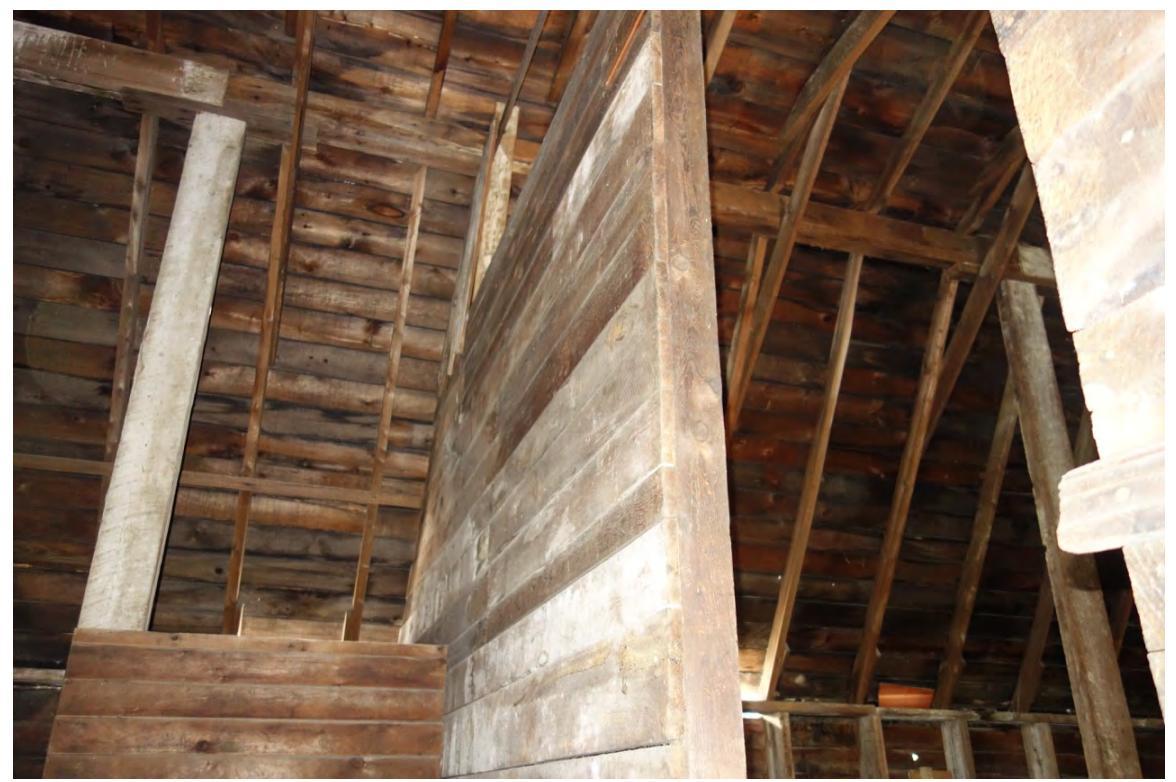
GARAGE – interior – wood stairs to upper level

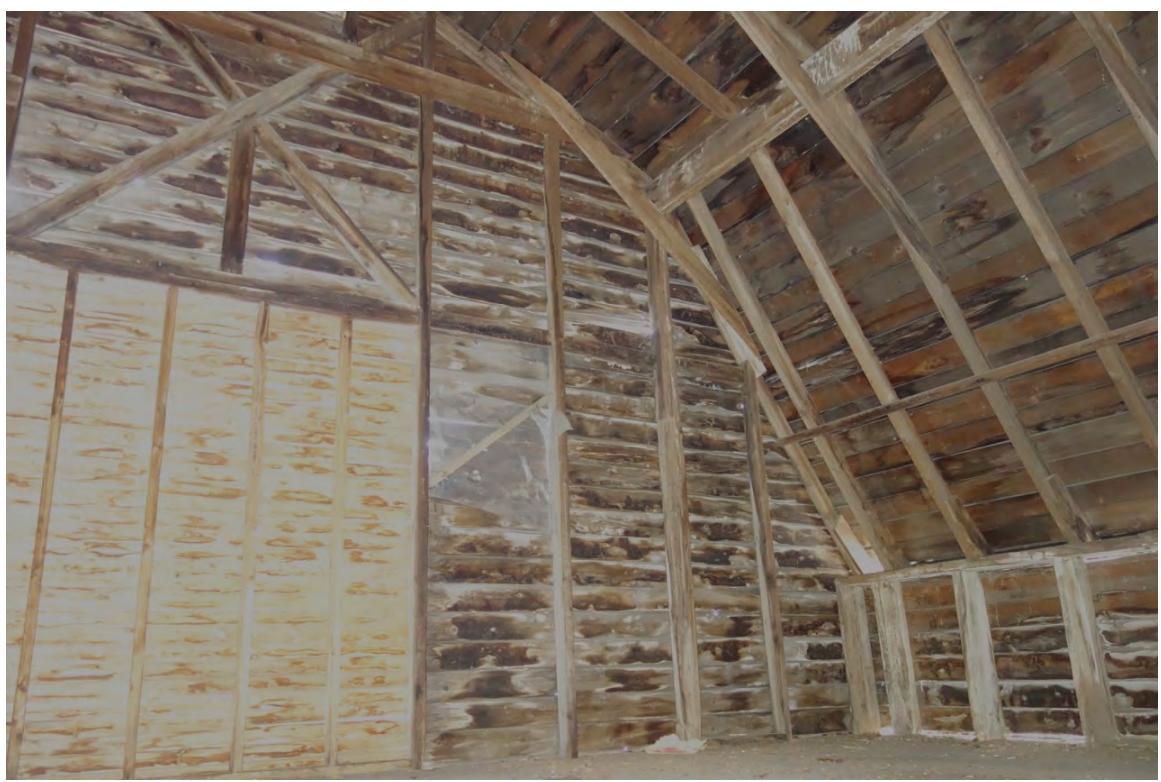
GARAGE – interior – hay loft
