HIA ADDENDUM

1141 CLARKSON ROAD NORTH
City of Mississauga

30 APRIL 2024

**RE: 1141 Clarkson Rd N, Mississauga
 Structural Condition Assessment & Moving Feasibility Study**

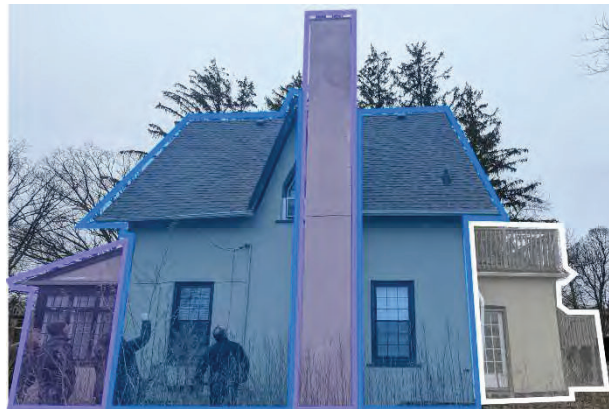
Photo #4: South Elevation, facing the backyard [JCAL 2024]
